Wear and friction modelling on lifeboat launch slipway panels

B. Thomas¹, M. Hadfield¹ & S. Austen²
¹Sustainable Design Research Centre, School of Design,
Engineering and Computing, Bournemouth University, UK
²Royal National Lifeboat Institution, Poole, UK

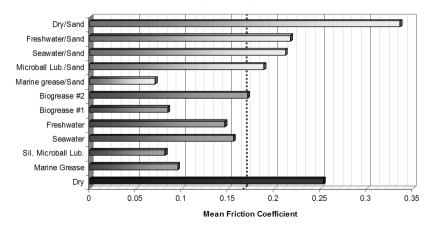
Figure 4: TE57 reciprocating tribometer: friction results.

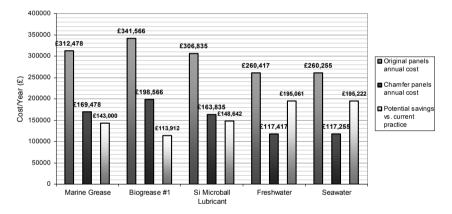
Figure 11: Slipway operating costs/year – original panel vs. chamfer panel.

current practice, a saving of 62%. This is the combined result of reduced panel replacement costs due to the reduction in panel misalignment edge effects using the chamfered panels, and the reduced cost of the lubricant itself.
