Graphitic corrosion of a cast iron trunk main: implications for asset management

R. Logan¹, M. J. Mulheron¹, D. A. Jesson¹, P. A. Smith¹,
T. S. Evans², N. Clay-Michael² & J. T. Whiter³

²*Innovation, Thames Water Utilities Ltd, UK*

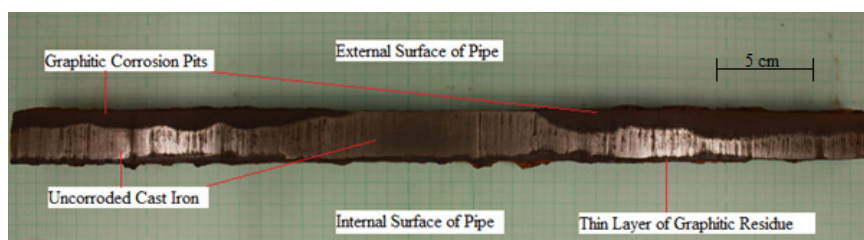
It is an important observation in trunk main, that graphitic corrosion is highly localised, with significant variation in the depth of penetration at the sub metre scale [3]. It is common to find a severely corroded section of pipe adjacent to uncorroded cast iron (Figure 1).

Figure 1: Section of corroded cast iron trunk main.

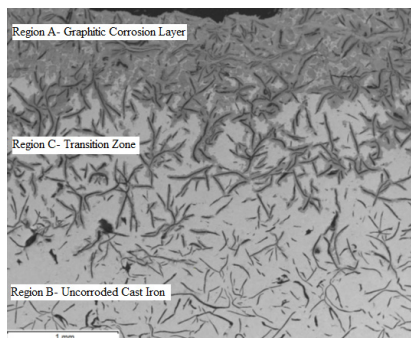
A typical cross section of corroded cast iron pipe is shown in Figure 3. It is possible to identify three distinct areas of interest:

1. The fully transformed (“graphitised”) product of the graphitic corrosion process – “Region A”;
2. The original (uncorroded) cast iron – “Region B”; and
3. A “transition zone” that lies between the uncorroded and fully transformed material – “Region C”.

Figure 3: SEM image of cast iron cross section.

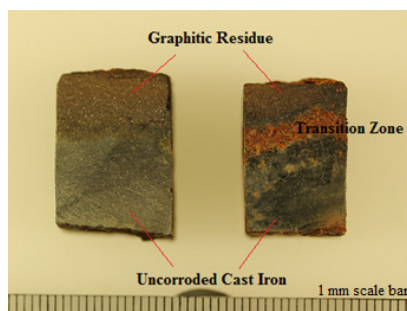
It is an interesting observation that when a corroded cast iron sample is first sectioned and polished the presence of the transition zone is not obvious to the naked eye. Instead it appears that there is a single, distinct, interface between the original metal and the fully graphitised material (Figure 4). However, after 3 weeks exposure to air under ambient conditions an orange-coloured deposit forms on the surface of the cut metal in the region directly adjacent to the fully corroded layer (Figure 4). This surface deposit thickens and darkens with time, becoming a red/brown colour, whilst the bulk of the adjacent cast iron remains uncorroded. This region corresponds with the transition zone seen in Figure 3.

When polished this transition layer is easily removed, but returns after several days if left exposed to air, indicating that this interface region is hygroscopic and capable of supporting further corrosion reactions [11, 23].

Figure 4: *Left:* freshly cut cast iron. *Right:* cast iron sample after 3 weeks in ambient conditions

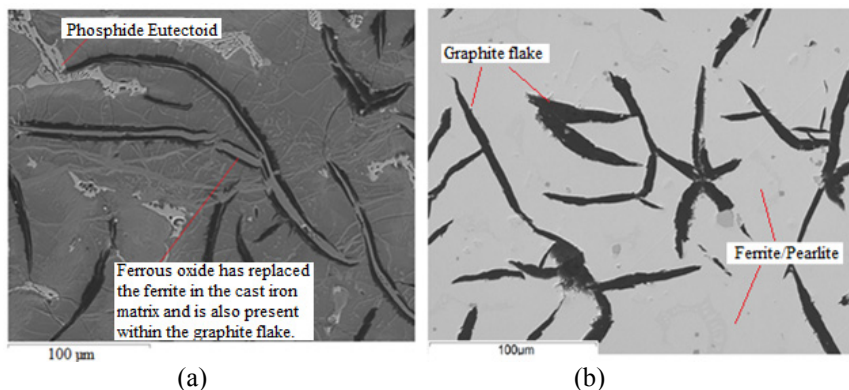
The product of the graphitic corrosion process (within Region A of Figure 3) can be seen in greater detail in Figure 5(a).

It can be seen by comparison with the image of the uncorroded cast iron in Figure 5(b), that the original (ferritic) iron matrix has been replaced entirely with a compact iron oxide product, leaving behind a “skeleton” of graphite flakes and areas of uncorroded phosphide eutectoid stringers. Something clearly evident in this image that was not originally expected is that the graphite flakes have also deteriorated. The centre of the graphite flakes appear to be filled with the iron oxide corrosion product, giving them a “hollowed out” appearance. It also appears in this image that some graphite flakes have deteriorated. This is an interesting, and potentially important, observation. This suggests that the graphite flakes do not act exclusively as an inert cathode in the corrosion process but rather takes an active part in the deterioration mechanism.

Figure 5: (a) SEM image of Region A. (b) SEM image of Region B.

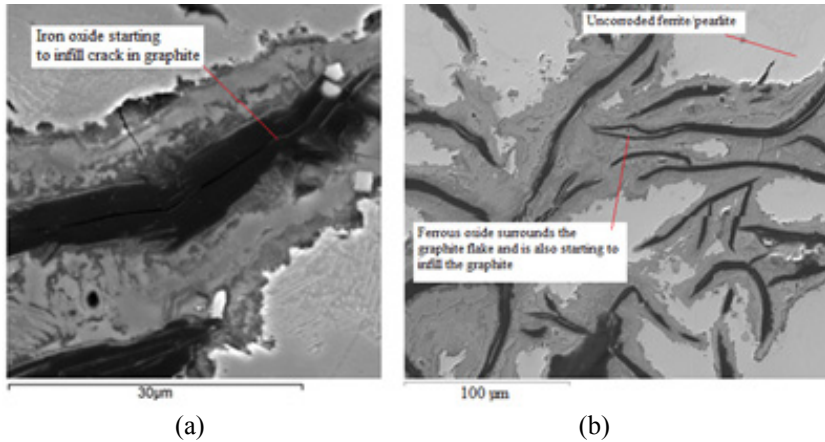
Figure 6: (a) SEM image of Region C. (b) Lower magnification of same area.

At even higher magnifications (Figure 6(a)), it is evident that during the corrosion process the graphite flake appears to be delaminating and undergoing significant changes in physical form. It is important to note that there are cracks within the graphite flakes which were not found in the bulk metal. Evidence that these cracks are not caused by the mounting process is shown by images of the iron oxide corrosion product in the process of filling these cracks.

Moving down into the transition zone, Region C, the graphite flakes are still in the process of delaminating/deteriorating (Figure 6(b)). One of the most interesting features has been found in the transition zone of four of the nine pipes examined. In the SEM image in Figure 7(a) there are bright features on the external surface of the iron oxide surrounding some of the graphite flakes.

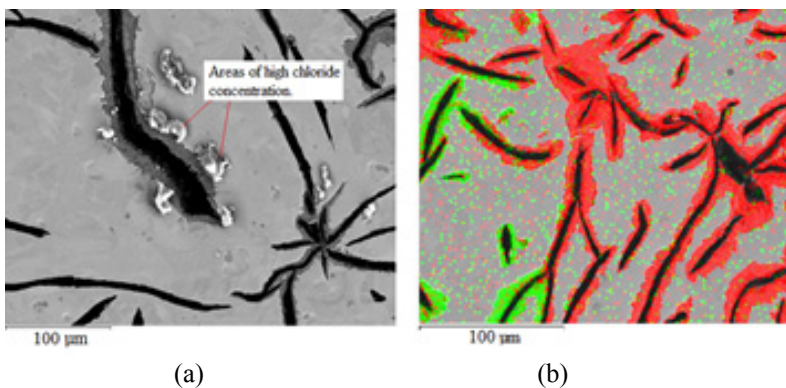
Figure 7: (a) SEM image of Region C. (b) Mixed EDX element map of Region C. Elemental chlorine surrounding the flake in the left side of the image is coloured green. Elemental oxygen is coloured red.

EDX spot analyses of these bright features reveal that these areas contain a high concentration of chloride ions, (between 5 and 11% by atomic weight). These features were only found in the transition zone of severely pitted cast iron. Element mapping by EDX of the cast iron samples also seems to confirm that these chloride concentrations are only found at the transition zone and not in the graphitic corrosion layer or the uncorroded bulk metal (Figure 7(b)).

Element mapping by EDX has shown chloride and silicon are present in high concentration within the oxide surrounding the graphite flake. The silicon concentration in the oxide material can be attributed to silicic acid that forms when the silicon originally present in the iron is oxidised. This suggests that the chloride ion plays a significant role in the corrosion process and is being concentrated at the leading edge of the transition at active anode sites. The ready (re)appearance of the transition zone in apparently “dry” samples left exposed to ordinary air post polishing is an observation also present in archaeological tests in relation to the protection of stored iron artefacts [11].
