# INVESTIGATION, MONITORING AND MANAGEMENT OF DOWNSTREAM GROUNDWATER IN THE TAILINGS STORAGE FACILITIES OF NUI PHAO MINE, VIETNAM

#### QUAN NGUYEN, RICHARD KITCHENER & CRAIG BRADSHAW Nui Phao Mining Company Limited, Vietnam

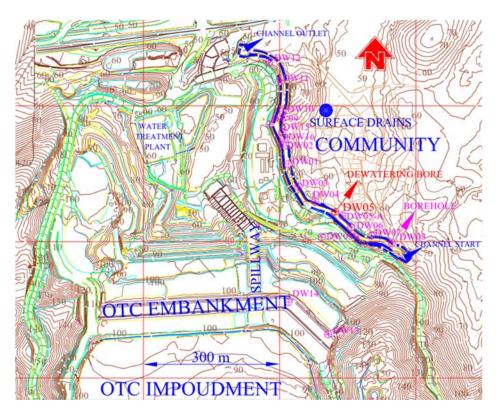
Figure 3: Location map of boreholes and drainage cut of trench.

Community concerns were first raised in relation to rising groundwater levels at the end of the wet season (April–October) in the north-east boundary area of the TSF in October 2015. The concerns reported were about surface seepage and flows not seen previously. During 2015, the water level within the OTC operating pond was at approximately 83 mRL. The elevation of the community paddy fields adjacent to the TSF boundary area range from 60–54 mRL. At this time some areas within the community lands witnessed water "boils" in natural ground, and other surface expressions. As a temporary measure an open channel drain system was installed in the garden of the households at the lowest elevation (Fig. 3).

The flow rates observed in these drains ranged from 2-3 L/s. The drains were excavated to approximately 1 m in depth. However, there was still community concerns regarding the impact on their wells and concern that the well water might not be suitable for general use.

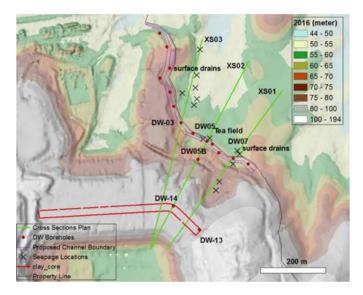
Figure 4: Observed seepage and modelling sections.

NPMC decided to develop a transient seepage and contaminant transport model to assist the understanding the groundwater flows and the migration of sulphate species. The water levels in the OTC impoundment were assumed for February 2017, i.e. when the modelling using a finite difference code VS2DTI was undertaken, and modelled through to ultimate embankment height at the end of the mine. Three sections were selected for the modelling work as shown in Fig. 4.

The results of the analysis modelled indicated that the groundwater could be lowered to historic levels by simply constructing a cut off channel at 52 m RL. The drainage channel solute transport model also predicted the sulphate concentration on the community ground surface would be reduced and would meet the statutory limit of 0.4 g/L.

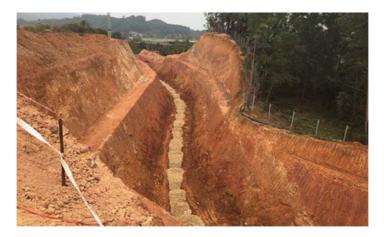
Figure 6: COT construction in progress (March 2018).

The construction started from 15 December 2017 and by the time of writing this article (i.e. April 2018) 477 m of drainage pipes have been installed. While the project has not been completed (Fig. 6) to the total design target of 500 m pipe, the surface and community ground water issues have been successfully resolved (Figs 8, 9). The drainage trench has certainly helped the situation and it is expected to achieve full functional goal when the drainage system is scheduled to be accomplished by the end of June 2018.

Due to deteriorating condition of COT walls greater than 8 meters in height and space limitations (property boundary, agriculture, and surface infrastructure) when excavated down to the bottom of the COT, the COT design was modified to include a buried drainage system in the base of the COT. This modification to include a buried drainage system allowed the equipment to work at higher elevations with wider working widths and reduced the ground disturbance at the toe of the cut slope. The buried drain collects seepage water into a corrugated-perforated HDPE pipe and transports water to the pump station. (Fig. 5). The corrugated-perforated HDPE pipe was supplied with "easy-fix" male and female ends. This offered quick, easy and safe constructability which provided time and cost advantages over conventional over rolled steel corrugated pipe, or concrete culverts. Since the corrugated-perforated HDPE pipe is flexible, it can accommodate the contours of the ground, direction changes and adapt to underground obstacles more easily than rigid pipe. The pipe is available in 6 m lengths and 450 mm inner diameter. Final trench cutting (1.5 m wide and 2 m deep) followed by pipe laying and then post filling with cobbles was performed progressively in 6 m sections to minimize the linear extent of the potential slope slumping during the final and deepest cut of the trench to the design base.

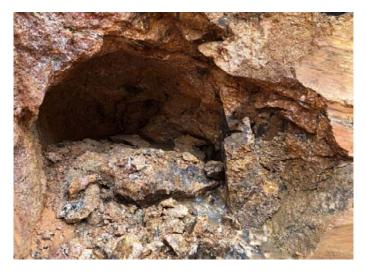
As predicted from the modelling, the seepage was observed running along microgranite dikes and their contacts distributed throughout the both sides of the excavation (i.e. the community side and the mine site). Some mine workings were encountered at higher elevations and dry; however, one exception was encountered near the middle of the channel at 52 mRL (Fig. 7). The flow in this artisanal working was estimated to be steady over 24 hours and in order of 3 L/s. This historic tunnel was later backfilled with gravel and rockfill (i.e. free draining).

Figure 7: Water coming from old mine working during COT construction (February 2018).

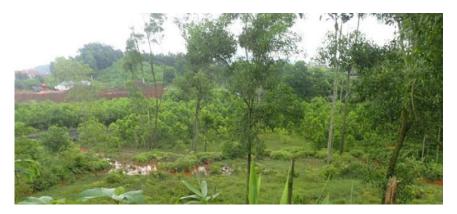
Figure 8: Community land area (wet) before COT construction (March 2017).

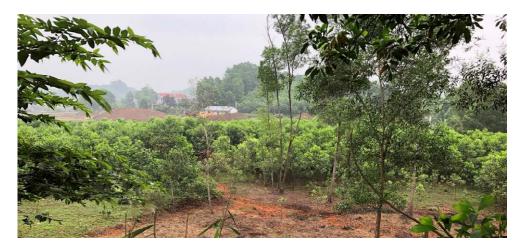
Figure 9: Community land area (dry) after drainage construction (March 2018).

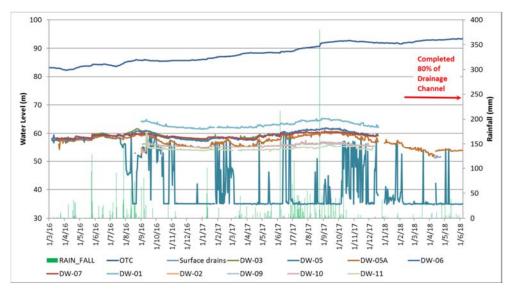
Figure 10: Groundwater level monitoring.

The groundwater levels started showing the achievement of the dewatering when the construction was about to be completed (Fig. 10). The acidity (pH) generally varied within the limits set in the Vietnamese Standard (i.e. in the range from 5.5-8.5) [1]. The total dissolved solids (TDS) were high in OTC (3–4 g/L) but within the specifications for groundwater with 1 g/L in community area and 1.5 g/L in the dewatering bore DW05 over the 2-year period. The bi-weekly to weekly chemical test results have indicated a minor

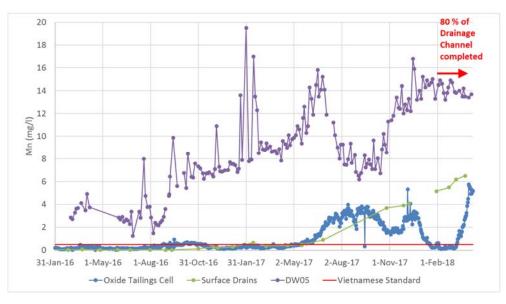
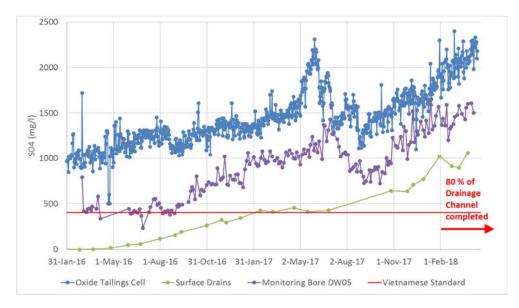
change in manganese and sulphate (Figs 11, 12) since the construction of the drainage trench. It is expected these elements will be diluted by rainfall recharge to the groundwater and show some improvement after 2018 wet season. The improvement is expected to result from the high rainfall during the coming wet season to gradually dilute the groundwater through recharging and bringing the chemistry back to levels similar to prior to the commissioning of
