In situ measurements of site effects and building dynamic behaviour related to damage observed during the 9/9/1998 earthquake in Southern Italy

M. Mucciarelli,⁽¹⁾ G. Monachesi,⁽²⁾ M.R. Gallipoli⁽³⁾

Abstract

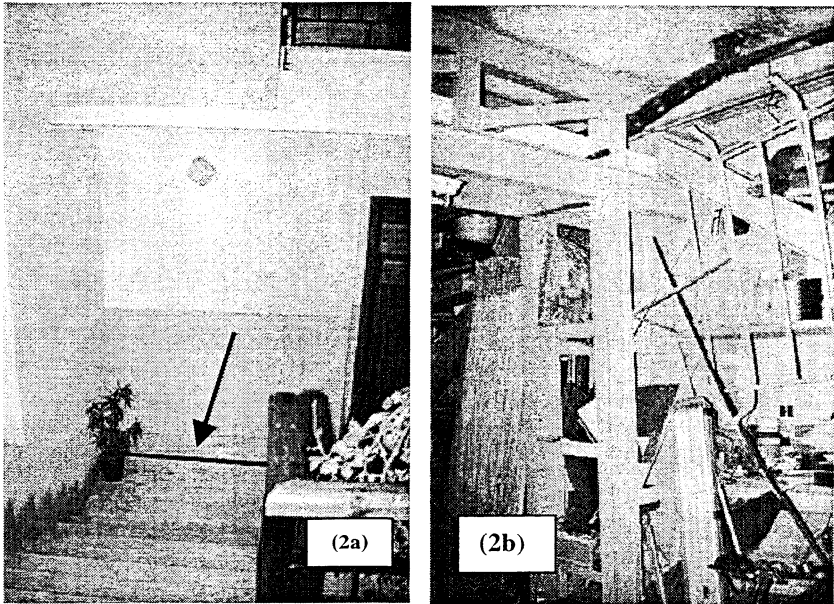
great damage during the 1980 Irpinia earthquake which had worsened the pre-existent instability. Following the 1980 earthquake, the building n°77 had not structural re-arrangements; on the contrary the building n°59 had structural reinforcements such as internal stiffening with steel beams. In fig.2a it is possible to see a dynamic joint inserted in the stairwell. Only the ground-floor was stiffened with steel 'double T' beams, fig.2b.

The foundation plinths had caged into steel beams. These two buildings have different dynamic behaviours due to different structural retrofitting.

Figure 2: Photograph (2a) showing a dynamic joint inserted in n°59 building's stairwell (Lauria) following the 1980 earthquake. In the same building the ground-floor had stiffened with steel 'double T' beams (2b).

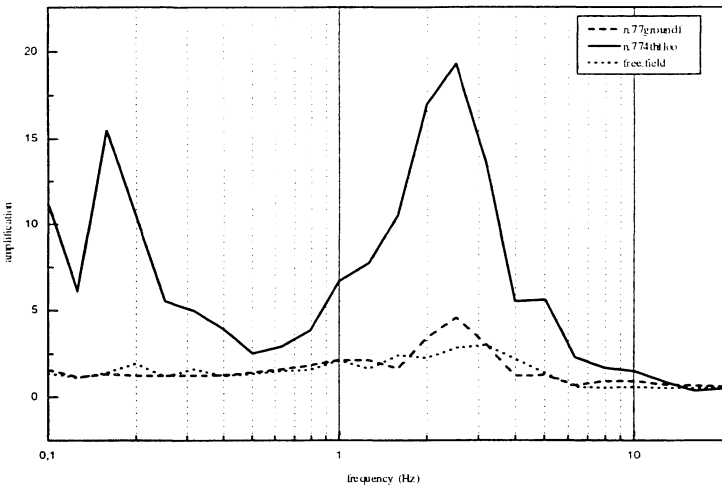
Fig.3a shows the amplification functions of building n°77, while Fig.3b shows the ones made at n°59. Because building n°77 had not structural adjustments following 1980 earthquake, displacement rate between floors is larger than the one of building n°59, which had important rearrangements. Ground-floor of building n°59 was stiffened with steel beam, then the part free to swing is shorter than the one of building n°77: for this reason the building n°59 presents its main peak at higher frequencies. Building n°59 has a sharp peak at about 4 Hz while building n°77 at 2.5 Hz. Building n°77 shows cracks at ground-floor while building n°59 has slight damage at first floor, where there are points with different stiffening: Fig.4 clearly shows the different amplification rate between building n°77 and n°59 at first and fourth floors.

Figure 3a: Amplification functions measured in n°77 building (Lauria Sup.) on ground floor, on fourth floor and free-field. The sharp peak at 2.5 Hz for the building is close to the maximum amplification frequency range observed for free-field. The peak at 0.2 Hz is probably due to the less of resolving power at low frequencies. As shown by Mucciarelli 1998, below 1 Hz very low values of vertical component, in low noise area, may be due to instruments limitations and may give rise to spurious high ratio value.

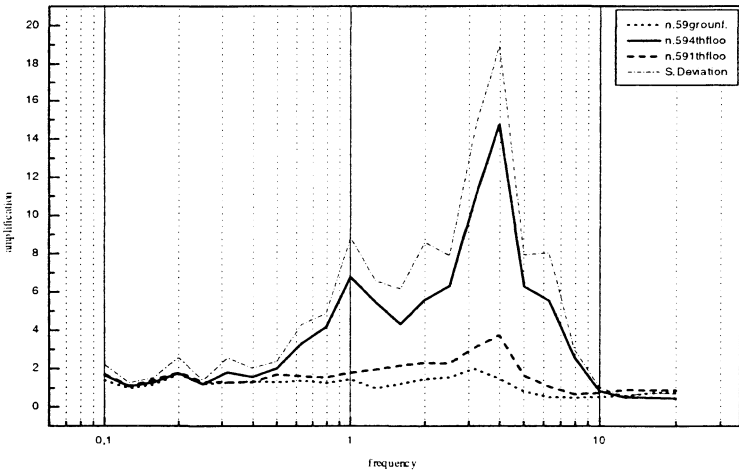
Figure 3b: Amplification function measured in n°59 building (Lauria Sup.) on ground floor, on fourth floor and free-field. Also 1 standard deviation is reported to show how dispersion is very low when HVSR is applied to buildings.

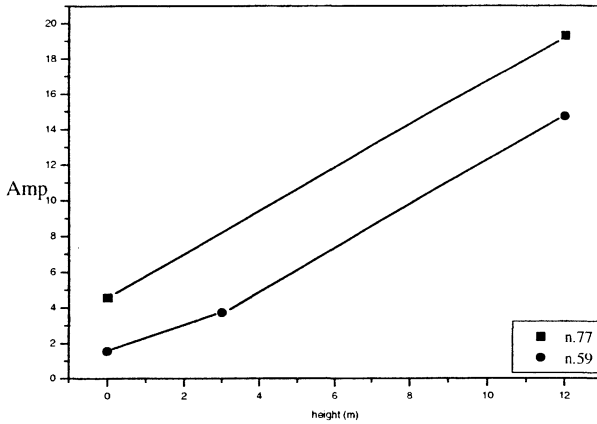
Figure 4: Diagram showing in abscissa the height at which the measurements were performed in buildings (at ground, first and fourth floor) and in ordinate the different amplification rate between building n°77 and n°59 in Lauria. Building n°77 shows a bi-linear behaviour due to the larger stiffness of ground-floor caused by reinforcements made after the 1980 earthquake.

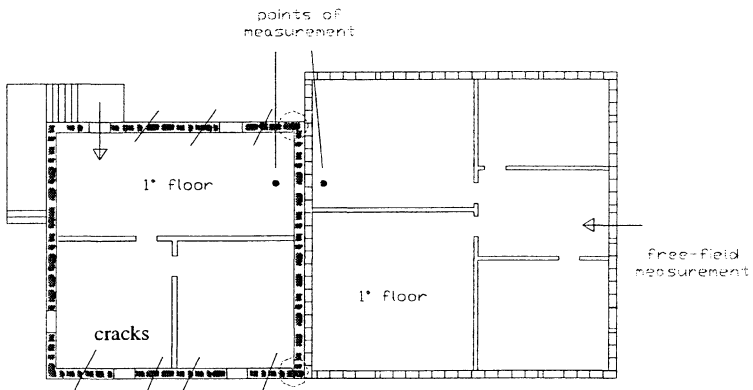
➤ **Perricchio–Latronico.** In Perricchio heavy damages are present in an old stone house, with passing cracks through two parallel walls. The house is adjacent to another house built with a reinforced concrete frame, showing only slight damages. Fig.5 shows a schematic plan of this interconnected system composed by two different building typologies.

Figure 5: A schematic plan showing interconnected system composed by two different typology houses in Perricchio (Latronico), the points of measurements and location of damage.

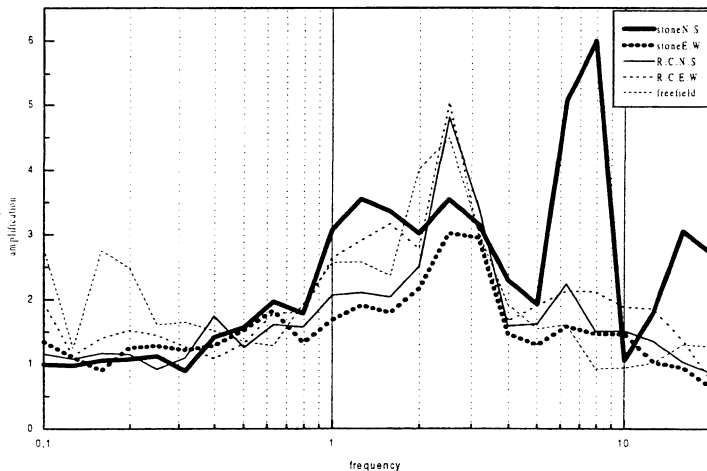
The measurements were performed at two houses' first floor. Fig.6 shows amplification functions of stone masonry and reinforced concrete house: both measurements had been processed separating N-S amplification functions from E-W one, where N-S is identifying the most elongated direction of the building. E-W amplification function of damaged stone house shows a peak at about 2.5 Hz, very close to the maximum amplification frequency range observed for free field. On the contrary the N-S amplification function has another sharp peak at about 7 Hz. The amplification function of reinforced concrete house has in both components a sharp peak at 2.5 Hz, close to the free-field frequency. This house has a peak at the same frequency in N-S and W-E direction as expected from a square house with equal stiffening distribution in all the directions. The stone masonry house is on its turn showing an almost square floor map. The reason for the noticeable difference of frequency in two orthogonal directions (7 and 2.5 Hz) may be due to the interaction with the reinforced concrete house, which is having as expected a lower fundamental frequency. The presence of damage only in two parallel walls could be explained invoking a forcing mechanism caused by the motion of the reinforced concrete building which is discharging on the less resistant element of the system the energy transmitted by the amplified ground motion. In other words: the free-field measurement shows an amplification at about 2.5 Hz; The reinforced concrete house has both fundamental frequency near this value, but the damage is all transferred on the less resistant member (the stone masonry house) whose fundamental frequency (7 Hz) is altered in the direction subjected to the interaction with the reinforced concrete house.

Figure 6: Amplification functions of stone and reinforced concrete house separated in orthogonal components. See text for details.

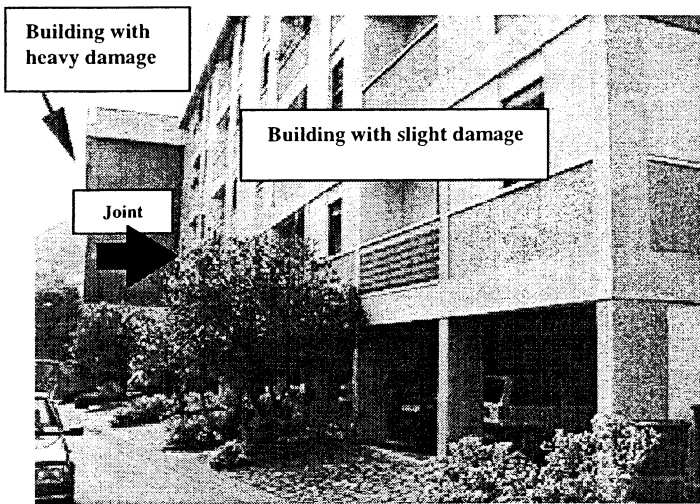
➤ **Castelluccio Inferiore.** In spite of slight damages present in the most part of the buildings in the ENEL neighbourhood (Fig.7a) some of them show higher damages, together with a recent building on the other site of the same street. The damaged ENEL building is a complex built in the late 1950s. It is composed by two identical part separated between them by technical joint, 4 storeys high with reinforced concrete frame and brick fillings. Only one part of this complex is now unfit for use: in fact, it has not only heavy damages at the infills but also it presents cracks at the first floor beams.

Figure 7a: Photograph showing two part of a damaged building (Castelluccio Inferiore), one of these is unfit for use, the other has only slight damages. The two parts are jointed.

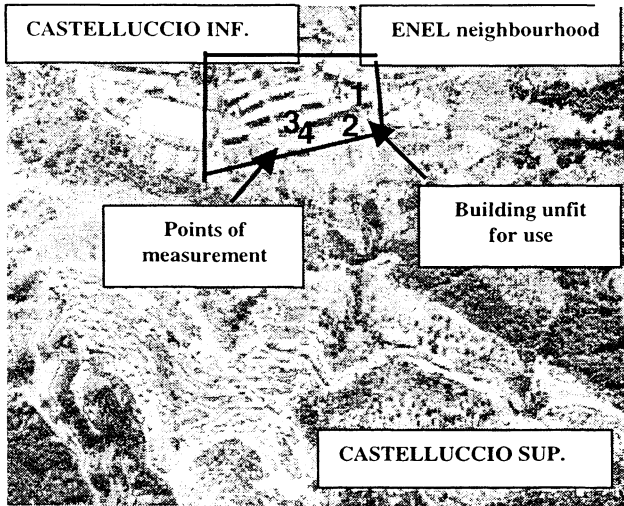
The damages to the ENEL building and to the house in front of it probably are due to an impluvium that can be clearly seen in the aerial photograph (Fig.7b). The measurements undertaken, are reported in the same photo (Fig.7b):

1. at fifth floor of building which is considered unfit for use;
2. free-field measurement behind the heavy damaged building;
3. at fifth floor of building with lesser damages;
4. free-field measurement behind the less damaged building.

Figure 7b: An aerial photograph reporting points of measurements in Castelluccio Inferiore.

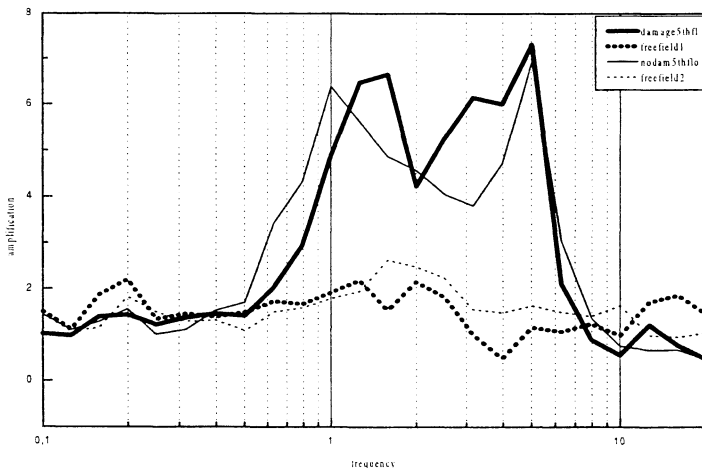
Fig.8 shows the amplification functions at the fifth floor of the two buildings together with the free-field. It is possible to see how inside the buildings there is a common peak at about 5 Hz. Another frequency peak is different in the two buildings. It will be interesting to see with ongoing studies if this difference is due to the damage observed in only one of the buildings or if different frequency reflects a different construction technique that might have led to a differential damage.

Figure 8: Diagram showing amplification function for free-field and fifth floor for the two part of the building showing different damage.

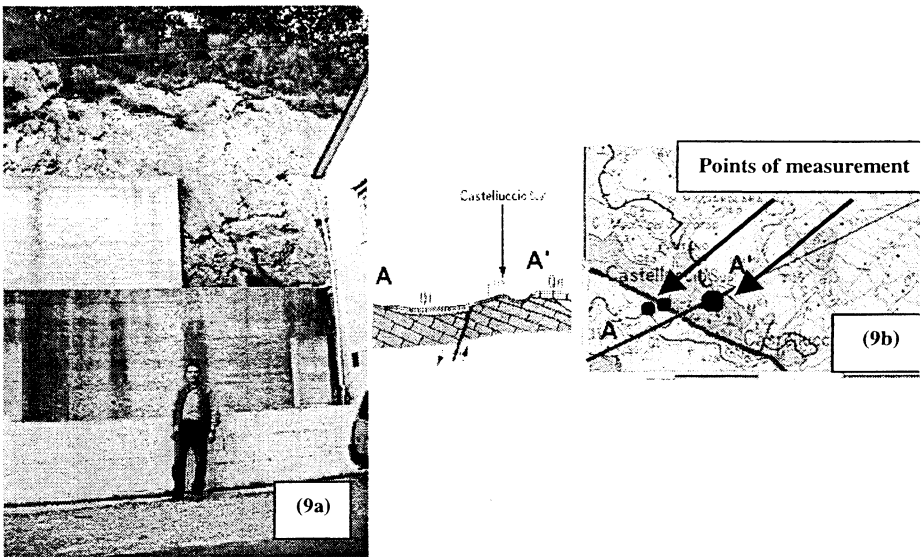
➤ **Castelluccio Superiore.** The geologic map points out a normal fault in Castelluccio Superiore that separates limestone from conglomerates. Fig.9a shows the fault plane at the entrance of town. The heaviest damaged buildings are Our Lady's church and the historical centre's church. Our Lady's church lies on conglomerates while most of the town of Castelluccio Superiore lies on limestone. In fig.9b three points of measurement are located on the geologic map:

1. on conglomerate;
2. on the fault plane;
3. on limestone.

Figure 9: Picture of the fault plane at the entrance of Castelluccio Superiore, which separates limestone from conglomerate (9a). Geologic map showing the three points of measurement across the fault (9b).

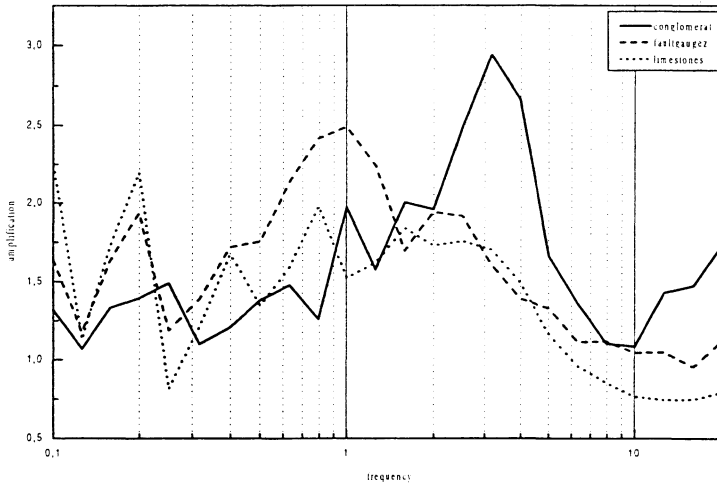
Fig.10 shows the three amplification functions: the free-field amplification function measured on bedrock is substantially flat, the amplification function measured on conglomerates has an evident peak at 3.5 Hz and the fault plane one has a peak at 1 Hz. It is interesting to note how the limestone close to the fault, in the fault gauge zone, shows an amplification peak which is not present on the undisturbed limestone, few hundreds meters away.

Figure 10: Three amplification functions in Castelluccio Superiore: on conglomerate, on limestone and on fault plane.

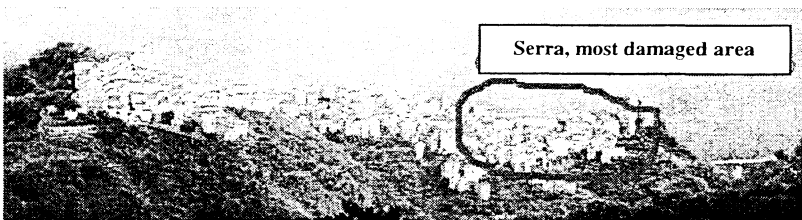
➤ **Rivello.** This town is composed by three parts: Serra, Motta and Poggio. Fig.11 points out Serra quarter, which was the mostly damaged. This affected area is located upon a crest parting from the principal ridge and so the cause of damages could be possibly attributed to topographic effects. The typology of damaged Serra houses is similar, with two floors, brick/limestone block bearing walls and almost identical dimension. The worst damages consist in falling of the tiles, collapse of the roof-tops and partial collapse of stone masonry in old buildings.

Figure 11: Picture of the ridge Rivello lies on, with Serra neighbourhood that had important localised damage.

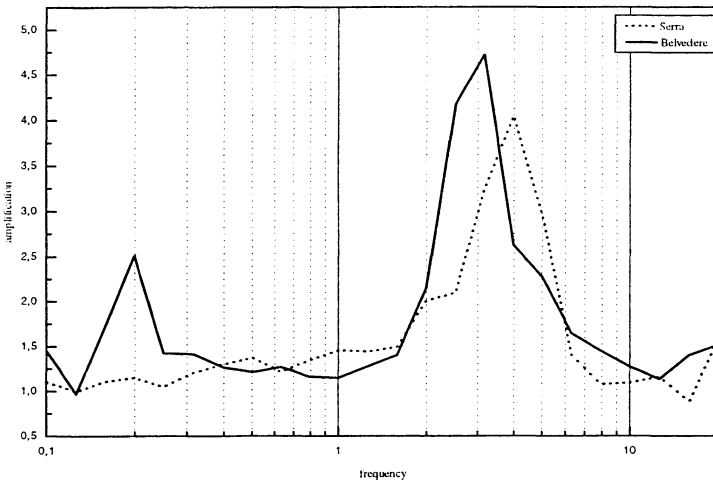
The first free field measurement was undertaken in Serra Square near the most damaged buildings. The North of instrument was perpendicular to the most elongated direction of the crest. The second measurement was made in Motta's Belvedere where there no damage occurred. The two free-field amplification (fig.12) functions, possibly due to a morphological amplification are similar for both sites: Belvedere's free-field has a sharp peak at 3 Hz and Serra free-field at 4 Hz,. The cause of heavy damages in Serra square buildings could not be easily

attributed to ground amplification or building vulnerability. Probably the localised damage is caused by geotechnical reasons, such as conglomerate constipation or slope instability, which cannot be detected by the microtremor technique.

Figure 12: Free-field measurement taken near the house at n°42 in Serra Square, in front of damaged buildings, compared with the measurement made in Motta's Belvedere where there are no damages. The two free-field amplification functions are similar for both sites, thus leading to invoke other geotechnical problems.
