Inland and estuaral navigation safety system for small craft based on the SGNI/CEVNI standards

M.F. Smith

British Waterways North East Region, 1 Dock Street, Leeds, UK

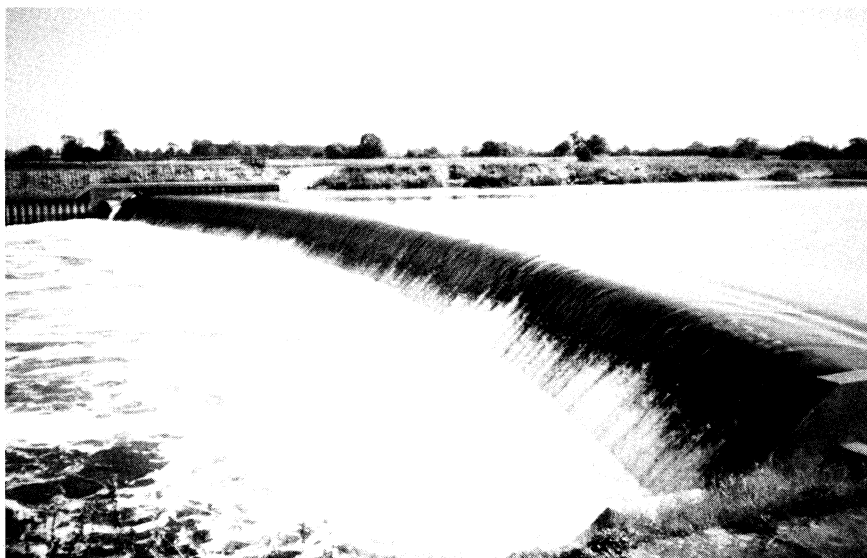
The 100m long weir at Cromwell (Figure 1), is curved in plan and has a fall of 3m. The crest of the weir is sharp with a steep apron, ending in a submerged toe wall. Objects passing over the crest are generally retained in the turbulence, giving rise to the local name of the weir, Witches Cauldron.

Results of British Waterways Investigations revealed that due to the construction of the weir at Cromwell, under certain conditions, there did not appear to be any visible break in the surface of the river at the position of the weir which could be seen clearly from a small craft. Furthermore, many of the signs on the river were misleading either by their positioning, or the fact that they were not prominent enough and had insufficient directional arrows (Figure 2). There was also evidence that British Waterways presumed that those using the river would be aware of the local dangers.

Figure 1: The weir at Cromwell (The Witches Cauldron).

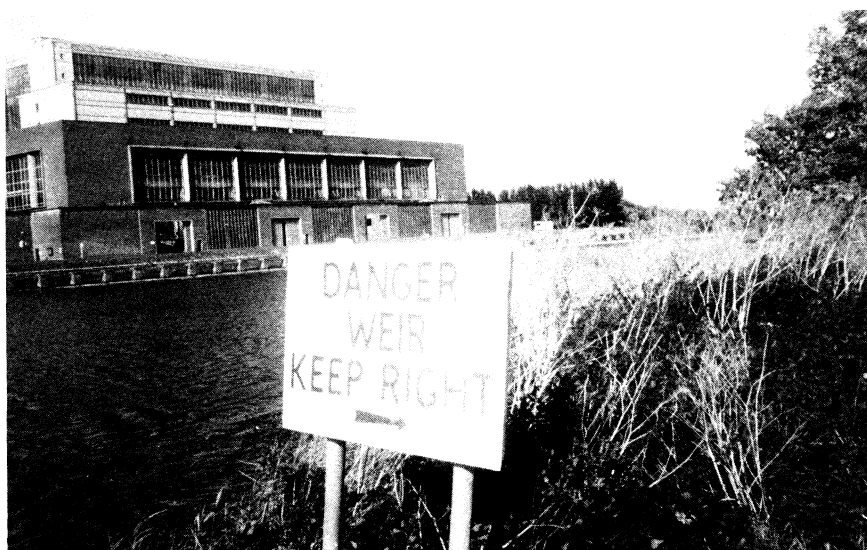
Figure 2: One of the old style warning signs
- Averham Weir.

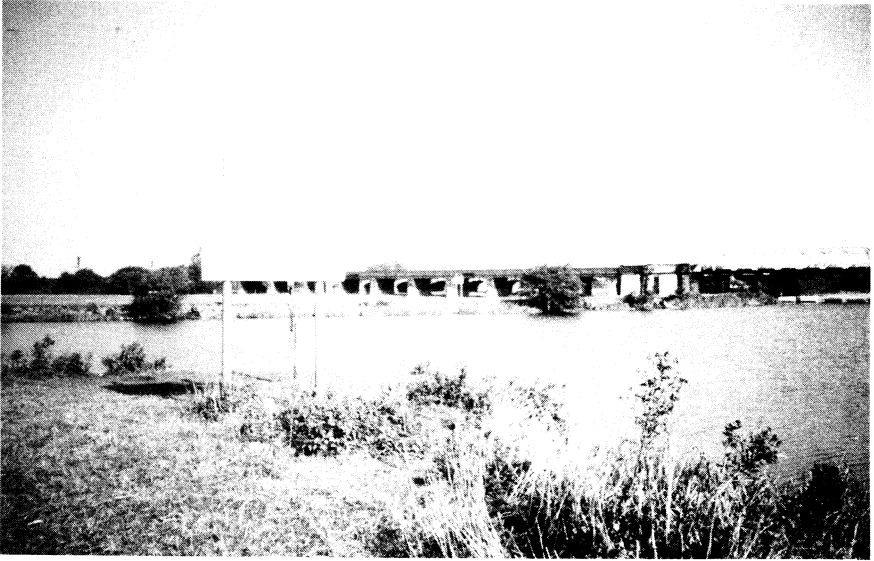
The Department of Transport's Traffic Signing Manual had previously been used to sign a junction of 3 navigations on the River Trent in a similar manner to class A trunk road (white on a green background), (Figure 3). During our investigations I spoke with a French family who were holidaying on a hire boat, and they commented on how clear these signs were.

Figure 3: Route signing at Trent Lock.

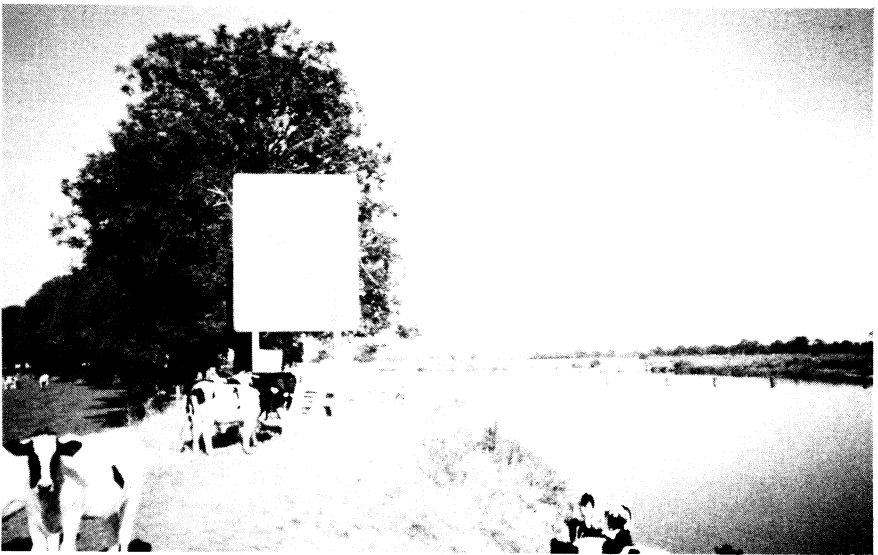
Figure 4: New warning sign at Cromwell Lock, also showing the buoys and boom in position on the right.

The main modification we made was to produce composite signs with a white background on which, by way of broad black lines, (Figure 4), the change of course necessary was shown. Legends were added to give the distance from the hazard and other information. Plates roughly conforming to those contained in sections 5.1 in SIGNI for Mandatory signs, 5.3 for Restrictive signs and 5.4 for Information were added. The Weir 5.4.10 sign

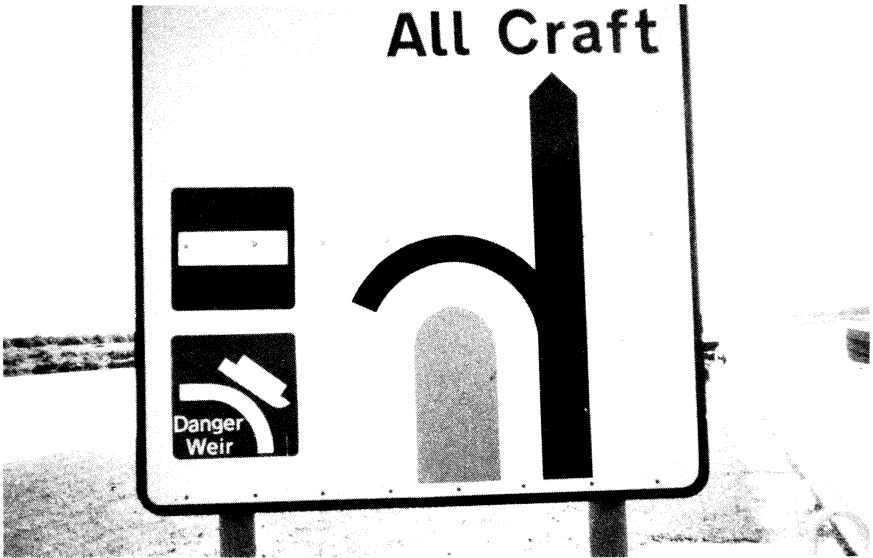
Figure 5: Sign at exit to Cromwell Lock heading upstream. Note modified pictogram for "Weir".

was modified to show a craft about to go over the crest of a weir for easier recognition, (Figure 5). The 'No Entry' sign consisted of a square red background with a horizontal white bar.

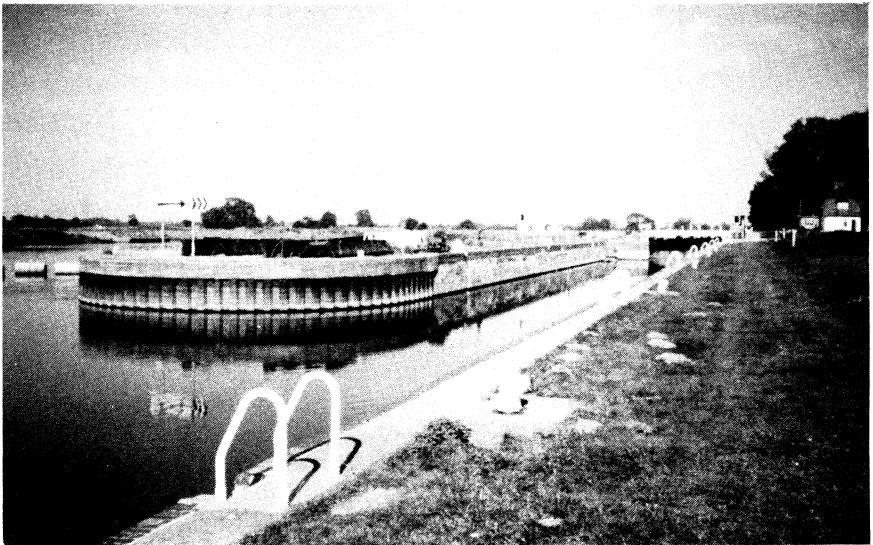
Figure 6: Upstream approach to Cromwell Lock. Note chevron on bullnose between weir and lock.

As further emphasis, the final marker on the bullnose was to be an arrow, as suggested by Plate 5.1.5. of SIGNI. This was not considered to have sufficient impact, and a chevron sign in the same colours was devised (Figure 6).
