Assessing damage for Herkenbosch, The Netherlands, due to the Roermond earthquake of April 13, 1992

P.M. Maurenbrecher, G. de Vries

*Faculty of Mining and Petroleum Engineering, University of
Technology, 2628 RX Delft, The Netherlands*

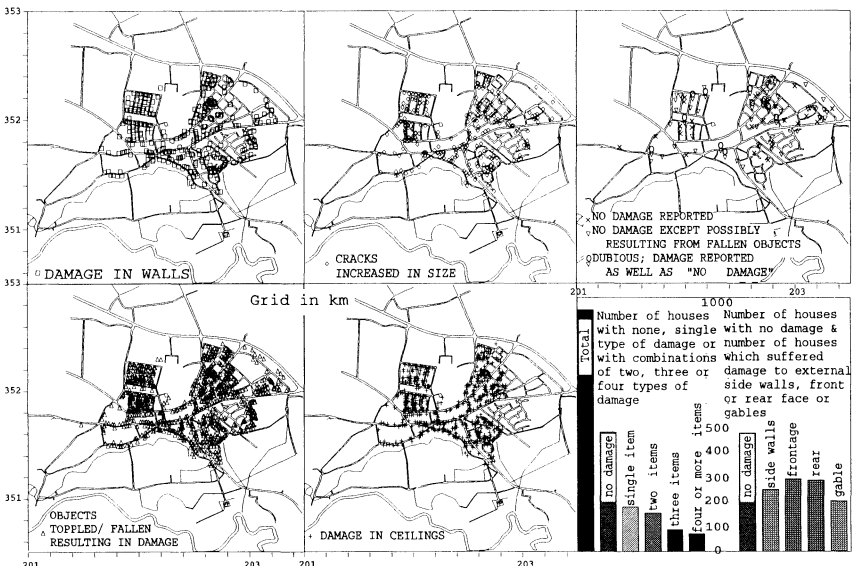
Figure 2: Results from earthquake survey questionnaire showing geographical distribution of various types of damage.

The maps were combined to conform to the topographical map³ Amersfoort coordinate system. Examples of geographical and statistical distribution of types of damage based on database selection criteria are given in Fig. 2. The geology map in Fig. 3 depicts the same geographical features as the thematic maps so as to enable comparisons with the type of information presented in Fig. 2.

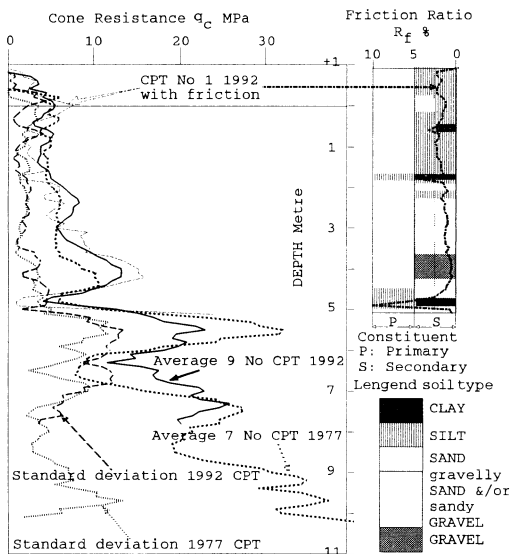
Figure 4: Comparative cone penetration tests (CPT) logs at site A (see Fig. 5), 1977 and July 1992. Note increase densities in sandy/ gravelly zones. Soil type based on $q_c - R_f$ values taken from Searle's chart¹³

correlations more pertinent. An example of ground condition analyses is given in Fig. 4 which shows the results from a site investigation in 1977 and a subsequent site investigation after the earthquake event in July 1992.

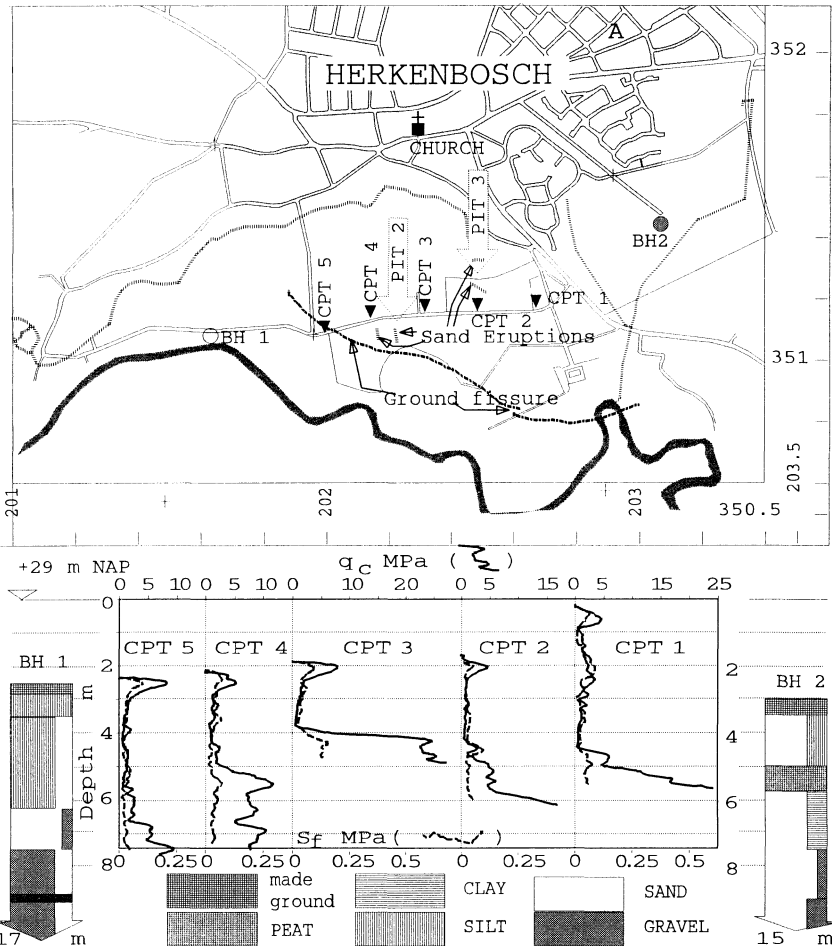
Figure 5: Cone penetration tests (CPT) logs along Ohé weg at sand eruptions (dewatering injection structures) locations and borehole soil constituent profiles indicating variation soil profiles southern flank of Herkenbosch.

Additional investigation by boreholes and cone-penetration tests (CPT) are necessary to study those areas with insufficient information. A number of CPT's were performed along the Ohé weg, Herkenbosch, to determine the soil profiles at the location of the sand eruptions⁵, Fig. 5.
