Failures due to long-term behaviour of heavy structures: the Pavia Civic Tower and the Noto Cathedral

L. Binda, A. Anzani & A. Saisi

DIS - Dept. of Structural Engineering, Politecnico di Milano, Italy

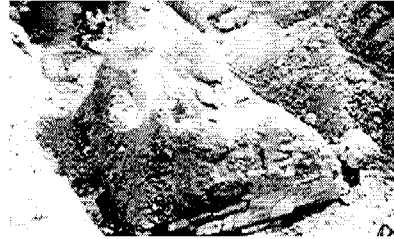
Figure 1: The Civic Tower of Pavia after collapse

On the one hand, settlements and chemical-physical damage were ruled out as causes of the collapse. On the other hand the following information were found:

- the lower part of the Tower was subjected to high stress values under its own weight: maximum values of 1.7 to 2.0 N/mm² in compression were found by a FE elastic model, against experimental strength values, obtained on 400 x 600 x 700 mm prisms, ranging between 1.8 and 3.5 N/mm².

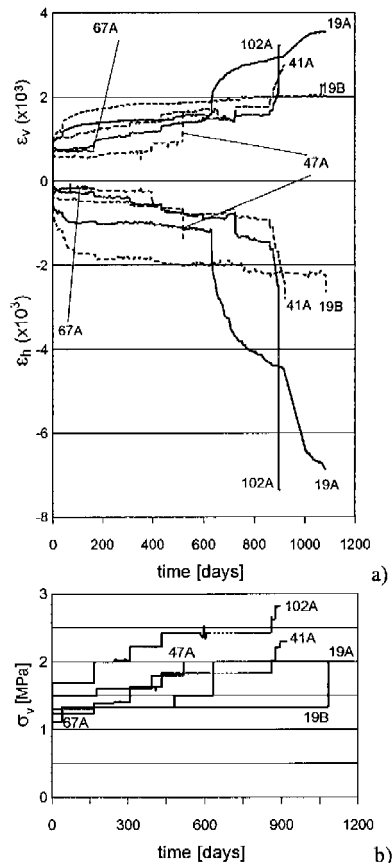
As an example the last set of tests carried out on the material from the Tower ruins is described below. Six prisms of dimensions 300x300x510 mm were tested in compression for creep behaviour in controlled conditions of 20°C and 50% RH, using hydraulic machines able to keep constant a maximum load of 1000 kN [4]. All the test results are reported in Fig. 3a, b; in Fig. 4 the strain vs. time diagrams of one of the prisms tested are shown.

Figure 3: Long term tests on the masonry of the tower of Pavia: average strain components a) and nominal stress b) vs. time for all the prisms tested.

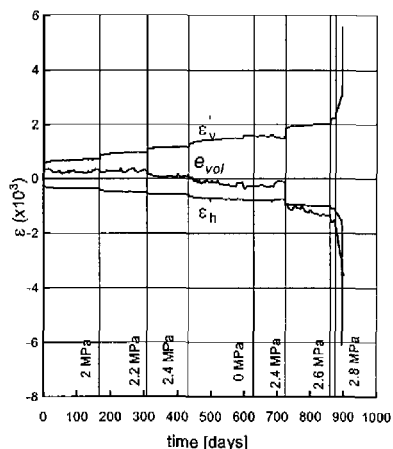
Figure 4: Deviatoric and volumetric strain components vs. time on prism 102-30A.

expansions due to fracturing and crack opening are of course negative, The volumetric strain seems nearly constant during the first phases of the test, then it starts to decrease markedly until collapse is reached; a negative volumetric deformation indicates that the effect of the horizontal strains are prevailing on that of the vertical one, therefore an apparent overall dilation is taking place. The creep behaviour is evident since the beginning from the deviatoric strain plots.

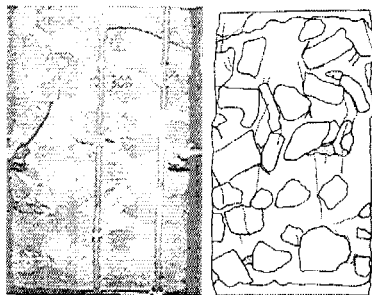
Figure 5: Prism 102-30A: face A at the beginning of the test and face B at the end of the test.

In Fig. 5 two faces of the same prism at the beginning and at the end of the test are shown. The highly irregular texture of the wall is evident, with a great part of the masonry being occupied by mortar. The crack pattern is characterised by the presence of vertical and sub-vertical cracks.

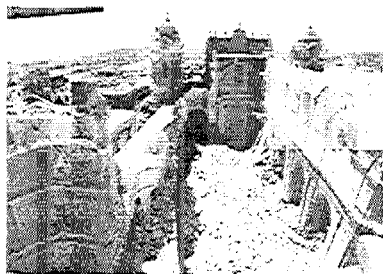
Figure 6: Interior of the Cathedral of Noto before the removal of the ruins.

On March 1996 the collapse of the Cathedral of Noto (Sicily), a town considered a jewel of the baroque style and therefore under the protection of UNESCO, involved 4 piers of the right hand side of the central nave, one of the 4 piers sustaining the main dome and the transept, the complete roof and vault of the central nave, three quarter of the drum and the dome with the lantern, the roof and vault of the right hand side of the transept and part of the small domes of the right hand side nave (Fig. 6).

On March 1996 the collapse took place (Figs. 6-8); it seems very likely that it was initiated by the yielding of one pillar and then propagated to the other pillars involving the vault, the lateral domes and the central dome and transept. The hypothesis might be formulated that the effect of propagation was very extensive due to the presence of the reinforced concrete floor connecting different structural elements, although this cannot

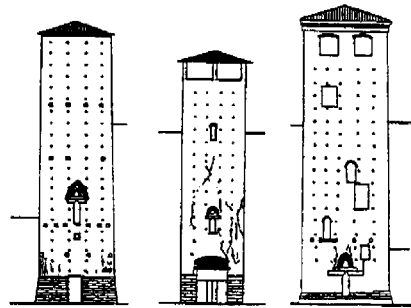
Depending on the degree of brittleness of the masonry, which in turn depends on the constructive technique, the material used, the geometry of the structural element, an excess of compression may result into major cracks clearly visible, or into a net of vertical flaws, cutting the bricks, or the stones, and continuing along the mortar joints (Fig. 10). In all cases, the crack pattern needs to be considered worthy of care and not neglected [9].

Figure 9: a) Torre Galluzzi, b) Torre Alberici, c) Casa-torre Uguzzoni in Bologna (Italy)

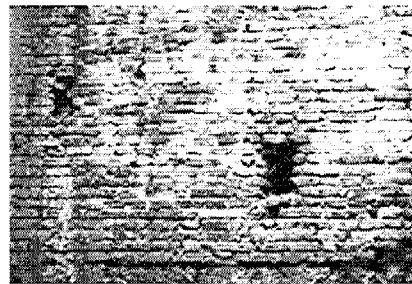
Figure 10: Detail of the crack pattern of Torre Galluzzi.

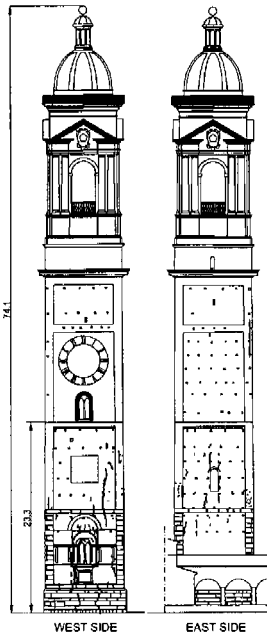
Figure 11: Crack pattern survey of the Bell Tower of Monza.

The Bell Tower of the Cathedral of Monza is a XVI century building made of solid brick masonry, at present subjected to a repair intervention. Its walls were showing large vertical cracks crossing the whole transversal section of the walls on the West and East sides (Fig. 11), which were continuously opening at a constant rate [10]. These cracks were certainly present before 1927, when started to be roughly monitored. Wide cracks were also present in the corners of the tower at a height of 30 m, together with a damaged zone at a height of 11 to 25 m with a multitude of very thin and diffused vertical cracks.

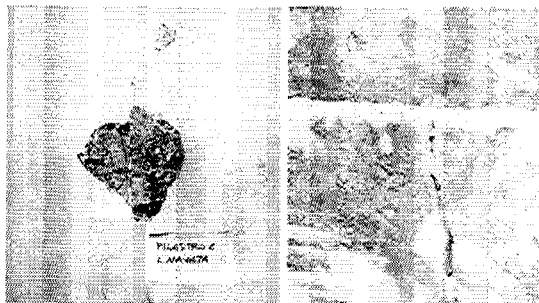
After the collapse occurred to the Noto Cathedral, other churches damaged by the 1990 earthquake were investigated. Among them the SS. Crocifisso Church in Noto itself [12]. In view of a strengthening and repair intervention, an investigation program was planned. The program included coring, boroscopy, flat jack tests and sonic tests on the masonry structures, the characterisation of mortar and stone and an investigation on the foundations. During the first phases of the survey, after local removal of the plaster, an alarming state of damage was observed on the pillars that showed a series of vertical cracks cutting the stones and continuing through the mortar joints (Fig. 12). The presence of a grey patina on the stones underneath the plaster indicated that it was not original. A lack of adherence to the masonry was noticed, given an inadequate mechanical preparation of the support; in the area of the deep cracks, the plaster looked particularly thin and completely detached.

Figure 12: Church of SS. Crocefisso: crack appearance (a) before and (b) after removal of the plaster from a pillar

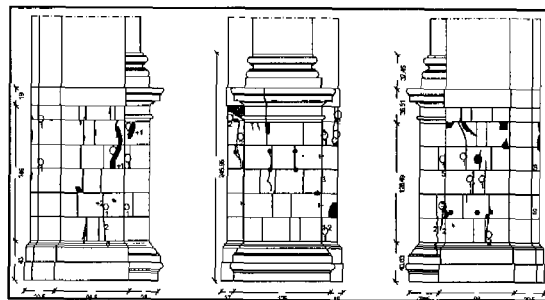
After assessment of the damage, the removal of the plaster from all the pillars up to a height of 3 m was planned, in order to carefully surveying their crack pattern, plotted as an example in Fig. 13. As can be seen in the picture, the cracks are diffused over the whole face, and concentrated in the corners. In some cases, the fissures have been filled with mortar and the corners reconstructed. This fact suggests that the crack pattern was present before the plaster was applied [12]. The design of the strengthening intervention was urgently up-dated and the pillars were confined by cross-shaped stainless steel reinforcements laid at every two courses.

Figure 13: Church of SS. Crocefisso: crack patterns on the base of the pillars.

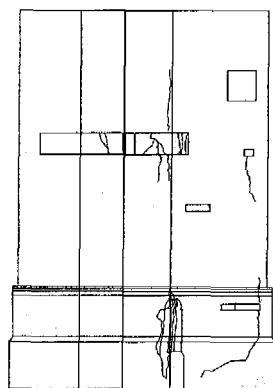
Later, similar damage symptoms were found in the Church of SS. Annunziata in Ispica (Fig. 14) and S. Nicolò l'Arena in Catania (Fig. 15), the Cathedral of Siracusa (Fig. 16) and the Church of S. Andrea in Campi (Umbria).

Figure 14: SS. Annunziata Church. Crack pattern of a pillar

After this survey a decision can be taken on a more accurate investigation based on static and dynamic monitoring, non destructive and slightly destructive on site techniques and laboratory characterisation of the materials. In the most risky cases (SS Annunziata in Ispica, St. Nicolò L'Arena in Catania) provisional

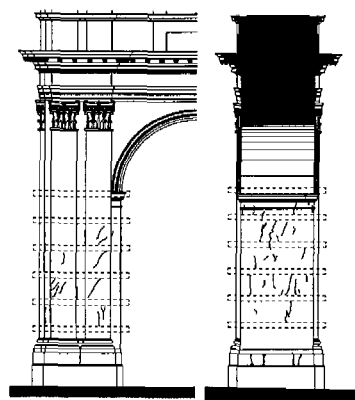
Figure 15: Crack pattern of a pillar at S. Nicolò.

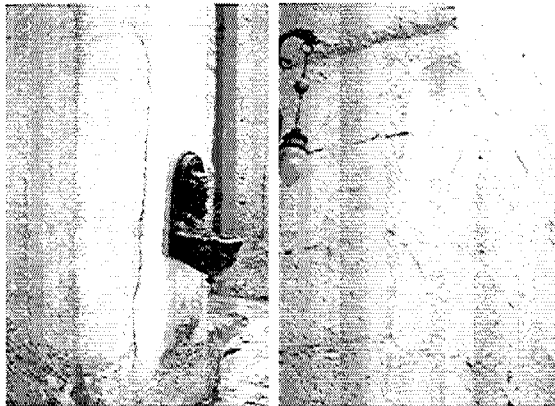
Figure 16: Siracuse Cathedral. Crack pattern of a pillar
