# **Structural defects and solutions: A case study of Fort Cornwallis, Penang, Malaysia**

## **Abstract**

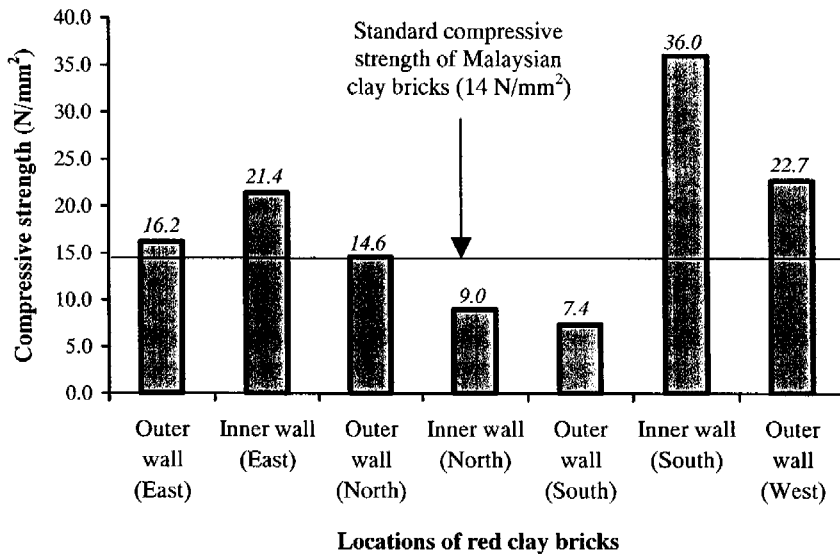
Most of the old red clay bricks used on the Fort's walls were handmade and were of different sizes. The old bricks measured between 20.3cm and 24.7cm in length and between 9.0cm to 12.7cm in width. Several compressive strength tests were carried out on selected brick samples taken from each side of the Fort's walls in order to ascertain the strength of the existing red clay bricks. The test results had shown that the compressive strength of the Fort's clay bricks were mostly higher compared to Malaysia's normal standard of clay brick compressive strength which is  $14 \text{ N/mm}^2$  (Figure 3).

Figure 3: Compressive strength of the old red clay bricks at Fort Cornwallis.

To re-establish their original structures, all collapsed and demolished walls were reconstructed using thousands of salvaged red clay bricks from abandoned old terrace houses in Georgetown built between 1892 and 1928 as well as salvaged red clay bricks from the Fort Cornwallis itself. Reconstruction was carefully done by laying down the salvaged bricks according to the original brickworks. Prior to this, the salvaged red clay bricks from the abandon terrace houses had been tested for their compressive strength. Results had shown that all of them had a high level of compressive strength ranging from  $24.0 \text{ N/mm}^2$  to  $47.8 \text{ N/mm}^2$ , which compatible to the compressive strength of the existing red clay bricks found at the Fort Cornwallis.

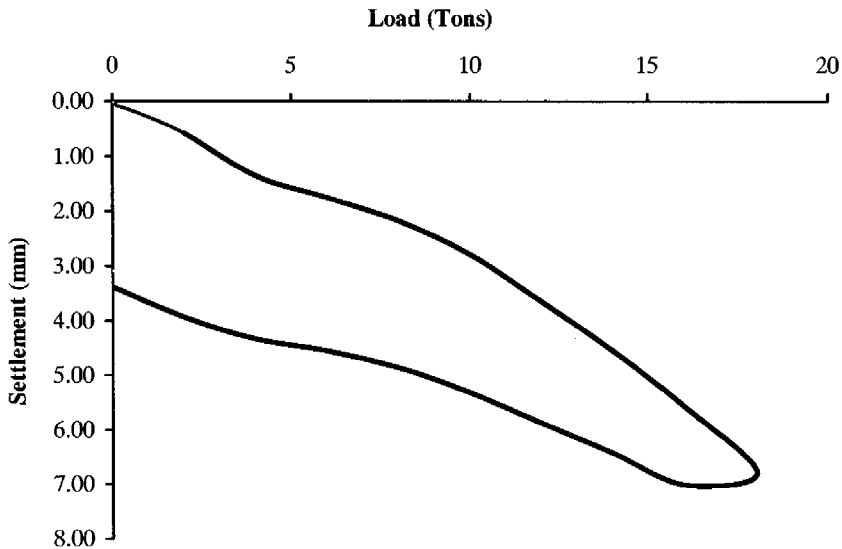
The purpose of the foundation load tests was to validate the strength of the remaining structures found at the west zone after the excavation work so that any rectifications such as reconstruction activity on the existing foundations could be undertaken. As the walls on the west site of the Fort have been demolished earlier, several load tests on the remaining structures mainly the wall foundations were carried out for the purpose of reconstructing the demolished walls. Six different points of load testing were identified along the existing wall foundations to ensure their strength in supporting the load of the new walls. The true load bearing capacity was derived from the loading of the existing walls by measuring the area of the walls and the block's self weight. The maximum test load was maintained for 24 hours and time-settlement reading was continuously monitored and recorded. Loading was released gradually and the rebound readings were later taken. Throughout the excavation works, the old Fort's foundations were found embedded about 1.5m beneath the ground. Results showed that the total residual settlement taken from 6 different load tests ranged between 0.7mm and 3.36mm. Example of the load test results taken from one of the six identified locations is shown in Figure 4. Failure shall be considered when the total residual settlement after removal of the test loads exceeds 6.5mm or the total settlement under the design load exceeds 12.5mm. Results from the load tests indicated that the foundations of the west zone walls were structurally sound and capable of supporting any new wall structures.

Figure 4: Results of the foundation load tests from one of the six identified locations.
