Extraordinary maintenance work carried out on the arch of Titus in Rome

Abstract

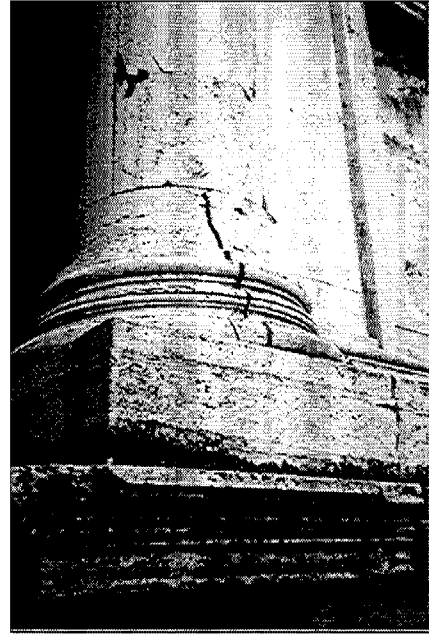
Figure2

Our detailed assessment of the monument made it possible to establish the state of deterioration of the travertine slabs incorporated by Valadier. The principal cause was the action of atmospheric agents which have not only corroded the external surface of the stonework but also caused the various components to become disjunct. This has led to infiltration by rainwater, causing the thick metal brackets inserted to fasten the slabs to the original masonry to become rusted. One of the travertine slabs was removed, revealing both the swelling of the metal brackets, causing localised fractures in the slab, and also the excellent state of conservation of Valadier's integration of the ancient stonework to provide a smooth bed for the new facing (figure 1). We found that the rusting of the metal brackets was the prime cause of the deterioration of the modern facing. This could be observed both in its manifest effects and by means of a large magnet with which it was possible to locate all the brackets and ascertain that they corresponded to the crack patterns. The deep fracture in the base of the column on the side facing the Colosseum was also found to be due to metal elements inside the structure, but this was not investigated more closely for fear of causing further damage (figure 2).

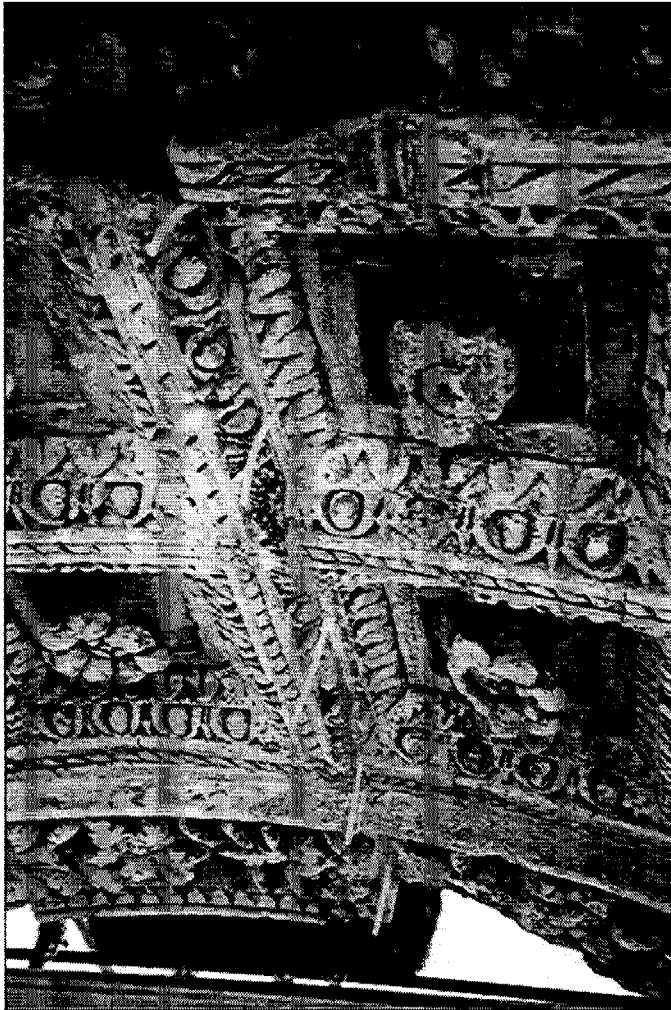
Figure 3

The restoration work comprised cleaning the various materials, eliminating the caking of grime, consolidating the decaying areas and filling in and plastering over the gaps that had opened up (Figure 3).

Cleaning: the surfaces both of the marble and the Travertino have been cleaned with atomized water, in a diversified process, of the more exposed Travertino parts, going from the simple rerinse to the an application 4 hours long. More tenacious encrustations have been treated, after the Atomized water treatment, with compress of a watery ammonium-carbonate solution kept in suspension

with cellulose pulp. Not soluble residuals or calcareous encrustations or not suitable stucco or overedging stucco insisting on the original surface, have been mechanically removed with Vibro-engraver, micro-drills or manual tools. Consolidation, on the South side, of the capital seriously fractured, supported by unsuitable coupling element made in copper: cleaning and consolidation of the object with ethyl-silicate after the disassembly of the unsafe fragments ; reassembly of the smaller fragments with Epoxy resin; anchorage to the structure of the three greater fragments with as much pivots in Titanium (cm 12 x 22). In this way we avoided any unjustified or radical attempts at substituting parts of the structure. The traditional appearance of the monument was left untouched, for it has undoubtedly acquired its own *raison d'être* over the last century and a half.

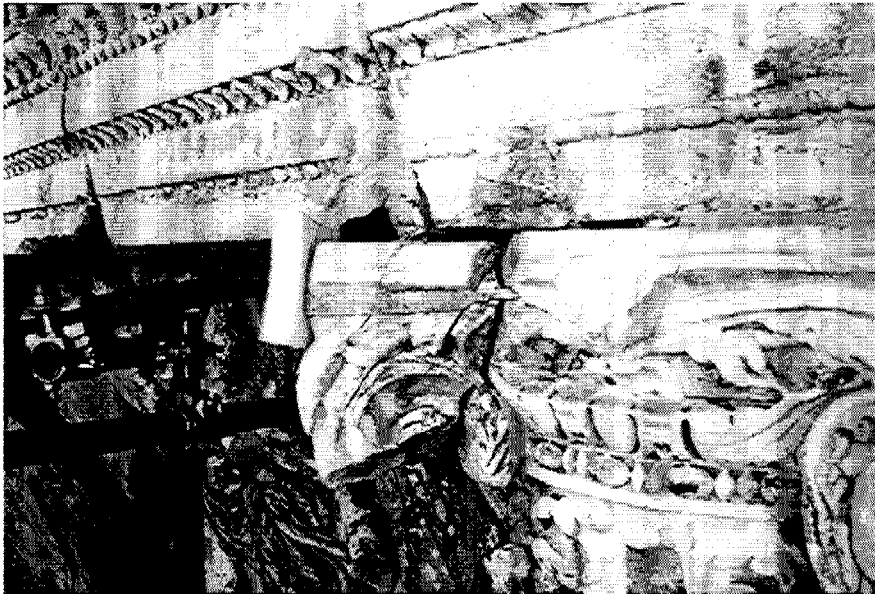
Figure 4

One substantial intervention had to be carried out on the right capital, east side. A corner section had fractured into several pieces and was held in place by two copper brackets that were badly rusted and only tenuously joined to the capital itself (figure 4).

Other parts of marble were held together by cement, which filled up and sealed the cracks, but which had come away from the surfaces. Unfortunately it was not possible to find any evidence of the previous restoration work. Once the cement rendering had been removed it was found that the metal brackets had virtually no hold on the ancient structure. The fragments were dismantled, and this revealed a metal pin which was also badly rusted and had to be removed. The fragments were cleaned and consolidated; the larger ones were stuck together using epoxy resin. At this point we were faced with two alternatives: the fragments could either have been put on display in a museum, or put back on the monument after reintegrating the capital. Conservation in a museum would have ensured a longer life for some of the original fragments, but seen out of context they would have been meaningless.

Whereas putting them back meant avoiding a drastic mutilation of the capital, and programmed maintenance of the monument offered sound hopes of conserving them for a long period of time. It was decided to replace the capital *in*

situ. The volute, in two fragments, was bound together by three titanium brackets. It was then fixed to the capital using two further titanium brackets.
