Seismic rehabilitation of cathedral towers in Peru

D. Torrealva¹, A. Blanco¹, G. Tumialan² & A. Nanni²

Abstract

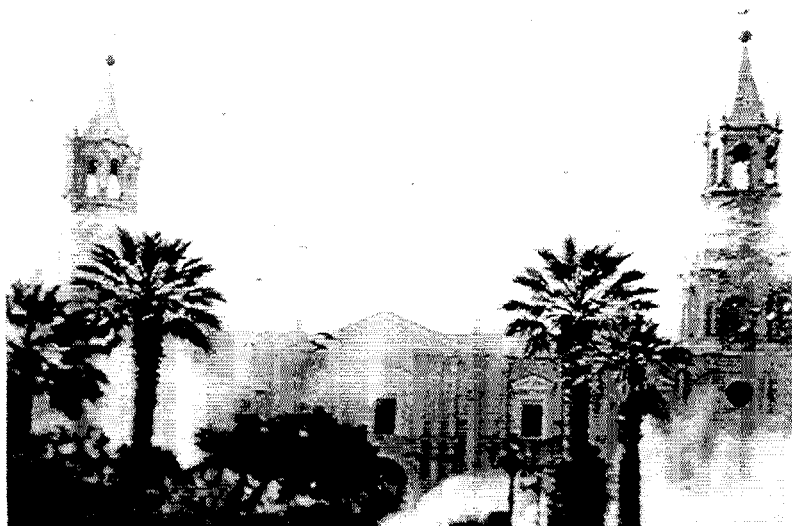
Figure 2: Precise moment of Earthquake. June 2001

Due to their slenderness ratio, and being located at the top of the church main body, the towers of the cathedral can be considered as appendices of the main structure. This implies that their dynamic behavior is almost independent of that of the main structure, but with bigger dynamic amplification (Fig.2). Based on this characteristic, the dynamic analysis of the towers was performed independently of the main structure and with a fixed base as a boundary condition.

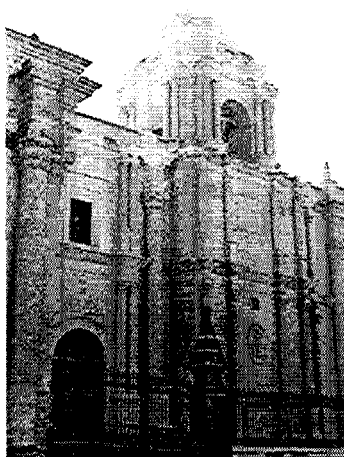
Figure 3: Left Tower Damage

The third body, due to its lesser plan dimensions, behaves in a certain way, also as an appendix of the rest of the tower. This brings as a consequence a stress concentration at the base of the third body where, due to the tensile stresses and the horizontal acceleration, the sillar stones fell out of position causing ultimately the collapse of the left tower. This behavior is congruent with the damage observed from past earthquakes, that were documented in 1983. The third body of the left tower collapsed as a rigid body on top of the roof of the church causing a partial roof collapse (Figs. 3 and 4).

It can be concluded then, that the weakest part of the tower has been the second body or transition zone, because of cumulative damage from past earthquakes, perhaps not appropriately repaired, and because of the stress concentration immediately under the base of the third body.

The left tower that had suffered the collapse of the third and part of the second body, had to be rebuilt, and so, the complete reconstruction of these two bodies was proposed. For this, it was necessary to completely dismount the remaining part of the second body until the upper level of the first body. This solution was modified during the construction process by means of horizontal holes through the remaining part of the second body to avoid the dismantling of this part. Through those holes, the proposed reinforcement was placed. (Fig. 6).

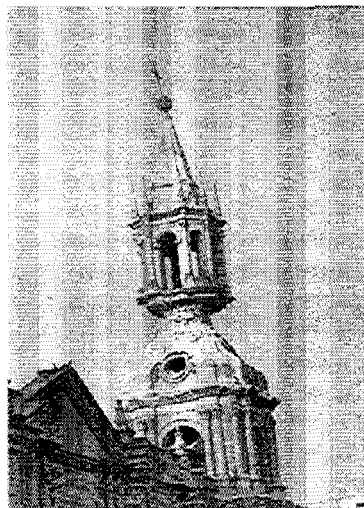
Figure 4: Right Tower Damage

The right tower also suffered extensive damage, being the most dramatic, the loss of section due to the falling of the sillar stones, finally standing in an unstable equilibrium condition (Fig.5). The bottom pillars are the elements that take the seismic overturning moment and shear forces at the base. In the last earthquake, their behavior was acceptable; however, some small cracks were observed at the base of the pillars just in the exterior corner that was not reinforced.

The structural intervention consisted on the reinforcing of the bottom pillars with RC columns as described for the left tower, and the rebuilding of the missing mass in the second body. The second body was strengthened with Carbon Fiber Reinforced Polymer (CFRP) laminates, which were used to provide tensile strength and confinement .

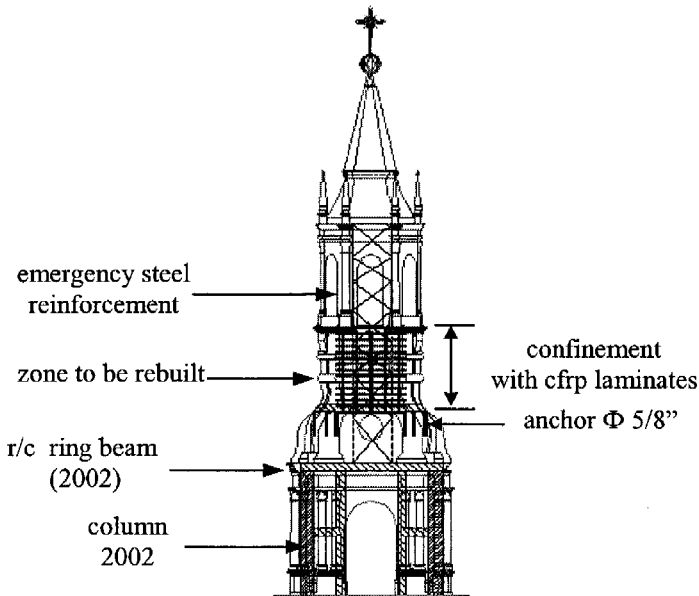
Figure 11 : Structural reinforcement in right tower

The right tower suffered extensive damage in the second body, losing part of its mass, and finally staying in an unstable equilibrium condition. For this reason, an internal steel structure was placed in order to stabilize it for possible aftershocks. In a joint coordination meeting with representatives from the Municipality, INC and the contractor, it was decided to leave the internal frame so the dismantling of the second and third body of the tower was not necessary.

to that section of the tower (Fig.11). The laminates were installed using a manual lay-up technique. The CFRP laminates had a tensile strength of 3.45 GPa and a modulus of elasticity of 206 GPa. Based on the numerical model, normal tensile stresses in the range of 100 Pa, acting on the second body, were considered to determine the amount of FRP reinforcement. Due to the nature of seismic forces, reinforcement was required to be placed vertically along the circumference of the second body. The member was analyzed as a tubular section having an outer diameter of 4.20 m. and an inner diameter of 2.60 m. Trial and error was conducted with different amounts of CFRP reinforcement until the flexural capacity of the strengthened member was larger than the flexural demand associated to a tensile strength of 100 Pa. The strengthening called for vertical 25 cm.-wide CFRP strips spaced at 55 cm. on center around the circumference of the member. The design took into consideration provisions specified by the Committee 440 of the American Concrete Institute (ACI 440, 2002).
