# Earthquake structural problems and urgent measures undertaken to support the Katholikon of Dafni Monastery in Athens, Greece

<sup>1</sup>*Directorate for the restoration of Byzantine and Post-Byzantine monuments, Ministry of Culture, Athens, Greece.*

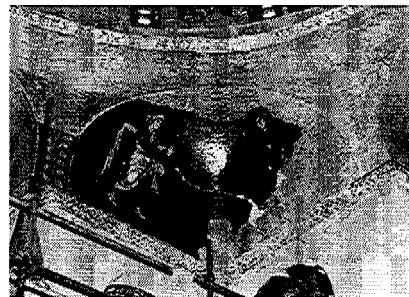
Figure 4: NE squinch heavily damaged.

The structural condition of the dome's area, concerning the drum itself and the load bearing structures underneath, was assessed as extremely critical [8]. In fact, the drum's piers situated perpendicular to the direction of the earthquake present horizontal bending cracks on the top and the bottom, whereas those situated parallel to it present diagonal shear cracks. In all cases the cracks are running through the thickness of the piers, thus creating very often an inclined slide plan and local dislocations of masonry's parts. The crack pattern revealed that the drum could not any more behave as a whole. Fortunately, the existence of the external upper metal tie-rod encircling the dome near the springing level averted severe cracking of the hemispherical shell. Moreover, all the arches are also cracked near the crown or the haunches, while the NE and NW arches under the squinches present severe dislocation near their crown, with consequently out of plane deformations of the squinches themselves.

Taking into account the above pathology, it was assessed that, in a case of a severe aftershock, the possibility of a complete collapse of the two already dislocated squinches, which support the dome, and the activation of a dome's collapse mechanism could not be excluded. This assessment was supported not only by the historical pathology of the Dafni's Katholikon itself, but also by the fact that a lot of well known octagonal Byzantine churches do not preserve any more their initial dome in our days, probably due to similar damages.

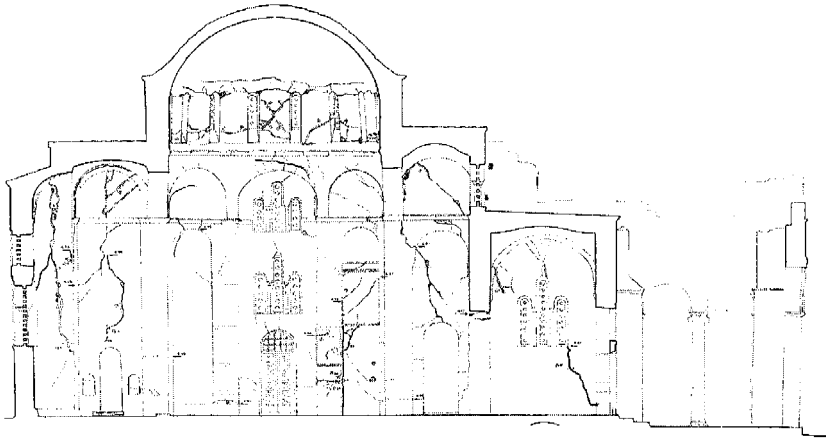
After the earthquake, an extensive network of shear and bending cracks appeared on the vertical walls and piers and on the arches and groin vaults, affecting both the structural safety of the building and the mural mosaics (Fig. 5). The damages are more extensive in the higher parts, especially on the piers of the drum of the dome, the squinches, the arms of the cross and the sanctuary (Fig. 3, 4, 5, 6). The most defective parts of the lower levels comprise the structural dislocation and outwards split of the external walls of the NE corner, and the appearance of vertical cracks in the corner piers of the free standing walls of exonarthex. On the external walls of the bell tower, older cracks were enlarged and new ones appeared. The last remains of the internal staircase collapsed.

Figure 5: E-W longitudinal section - Crack pattern on the southern elevation.

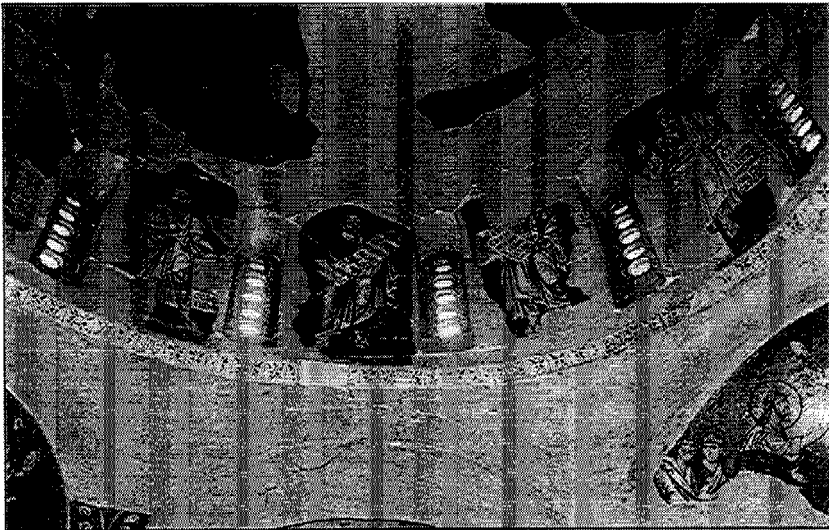
Figure 6: View from below of the piers of the southern part of the dome's drum.

Regarding the drum of the dome, specific measures of strapping the piers in two levels and bracing its openings were decided, by means of specially designed steel elements (Fig. 12,13). The final geometry and form was based on in situ measurements for each deformed pier and opening, while special care was taken to assure the assemblage of all these structures without harming the mural mosaics. Only in the south pier the mosaics were partially removed.

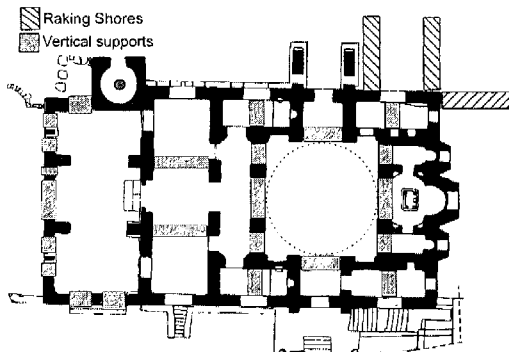
Figure 7: Areas where raking shores and vertical supports were placed.

Thus, a system of three interconnected double-framed metallic raking shores was constructed (Fig 7, 9). The raking shores were designed to act as distinct independent new elements and not as integral parts of the structure. They behave as cantilever beams and are able to carry horizontal seismic forces to the specially designed reinforced concrete foundation elements.

In the interior, vertical props were built up beneath the main arches in order to provide vertical support to their cracked structure and relieve the disrupted piers from the heavy loads of the dome. These steel props were designed to act as distinct independent new elements and not as integral parts of the structure; they have no firm contact with the piers in their sides (Fig. 10). That is why they were not anchored in the ground by means of foundation elements. This solution was chosen in order to avoid excavations and destruction of the marble floor.

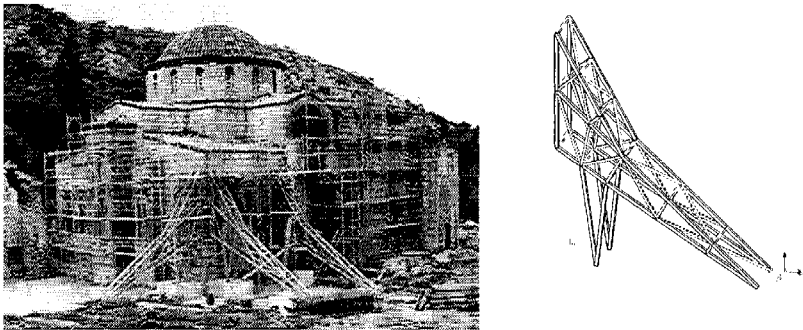
estimate the approximate dimensions of such steel props have indicated that the new structures and especially the surface foundations to anchor them on the ground had to be of substantial dimensions. On the other hand anchoring the props in the ground by piles was excluded due to the existence of archaeological substrata. Furthermore, there was a general hesitation for the implementation of such massive constructions that may act in some cases as battering rams causing local destruction of the elements they are supposed to support. Therefore, such structures were installed only in the NE corner of the building, where a pronounced tilting of the external walls has been noticed. In this area, the telltales installed just after the earthquake, indicated further opening of cracks, i.e. a tendency of the corner to detach.

Figure 9: Northeastern view of Katholikon with metal raking shores.

The metal framework was constructed using simple rectangular hollow steel beams, protected against rust. Each framework was founded on two concrete "feet", laid out partly under the ground surface in especially excavated pits, after carrying out all the necessary archaeological investigations. The front connection of the framework was anchored with special devices in the bottom of the feet, to take the best profit of their mass since it acts as a kind of counterweight, while the back foot was articulated. Between the metal framework and masonry walls, a 12cm full layer of wooden beams and wedges (together with a 3mm soft packing) were inserted, to provide better contact with the masonry while allowing relative movement, unless the corner did start to move outwards.

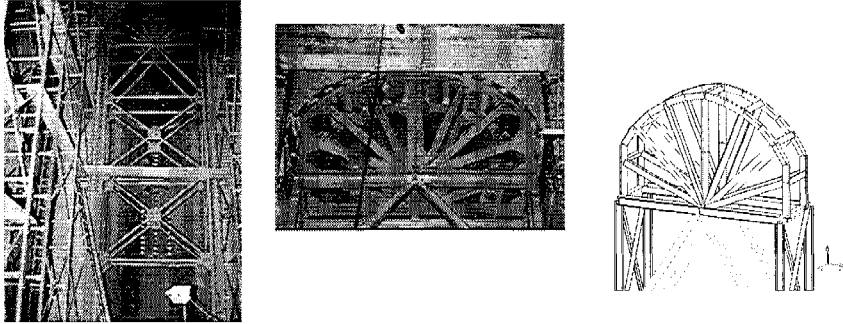
Figure 10: Steel vertical props to support the arches.

The use of steel shapes, suitably protected against rust, instead of timber, was adopted in order to reduce the dimensions, provide better fire resistance and avoid dimensional changes due to moisture variations and creep effects [9]. The steel elements were executed based on in situ measurements and moulds to fit the deformed geometry of the arches. Smaller pieces were connected by means of electrical welding in a worksite outside the monument, whereas larger elements were constructed and carefully transported in the interior, where the final structure was assembled by screwing the joints. Especially the vaulted upper parts of wide arches were set up in two parts (Fig. 10) with screwing joints in order to provide easy transport and partial disassembling. The smooth contact between the masonry and the steel beams was achieved by inserting a very dense layer of wooden beams and wedges, together with 3mm soft packing. The whole system permitted to follow the relief of the masonry without harming the surfaces, while allowing relative movement.

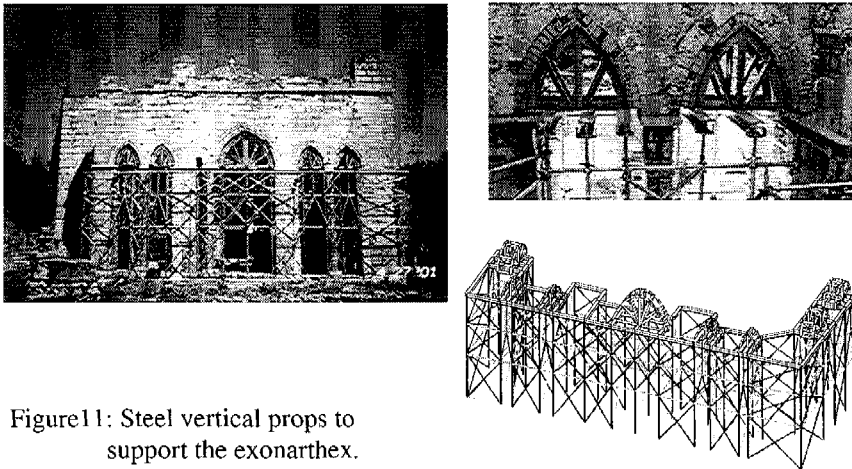
Figure 11: Steel vertical props to support the exonarthex.

exonarthex and the major arches of narthex (Fig. 7). In the case of exonarthex, only the upper parts were constructed, using steel normal profiles (Fig.11).

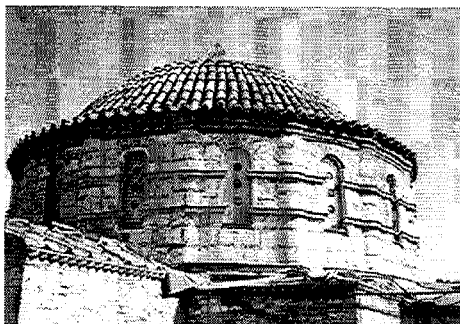
Figure 12: External and internal view of the dome after the interventions.

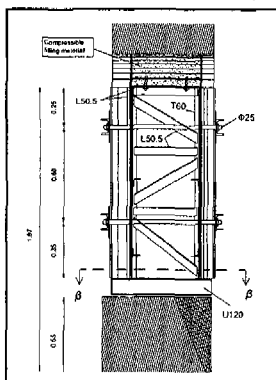
Figure 13: Internal view of the interventions of the dome. Drawings of the metal structure.

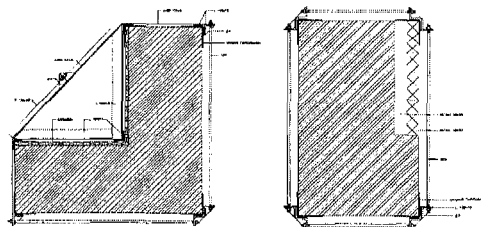
Figure 14: Steel straps to support the exonarthex corners.

Strapping techniques were also applied in the two corner piers of the exonarthex and the bell-tower, as shown in fig 14.
