The Naviglio Grande in Milan: a study to provide guidelines for conservation

Abstract

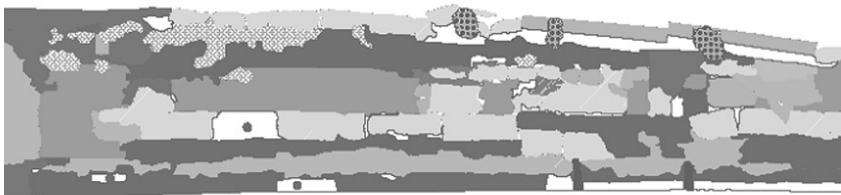
Figure 4: Survey of the different types of materials.

Solid bricks of ancient manufacture were used in the past to fill voids left by missing stones. In the terminal part of the left embankment the masonry is finished with blocks of Baveno pink granite. The right embankment shows similar features, even if there is a later external part made of concrete.

On the contrary the bricks are badly damaged. A biological attack by mosses often covers the masonry part over the water flowing line, while roots of upper plants (ailanto) cause damage and material expulsion. Finally the whole surface, in the submerged part, is coated by whitish consistent sediment, very thick attributable to a diffused alga on masonry (Fig. 4, 5).

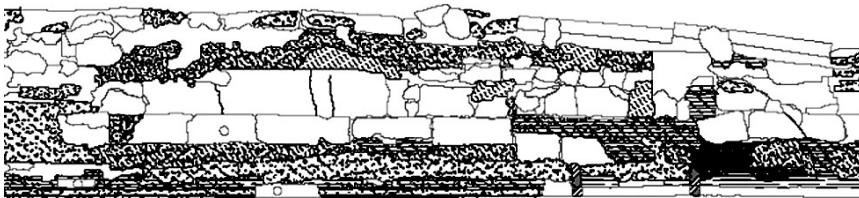
Figure 5: Survey of the stone decay.

exist (wooden piles, now decaying, can be surveyed only by marks) in other parts a brick masonry plate was found with different dimensions. This brick masonry show now deep gaps due to the water flowing action as well as to the canal cleaning operations along the times. The decay pathologies survey showed in addition the lack or deep erosion of mortar joints, as well as lack and gaps of the "ceppo" blocks; nevertheless the remaining blocks do not show decay phenomena due to the high porosity of the ceppo.

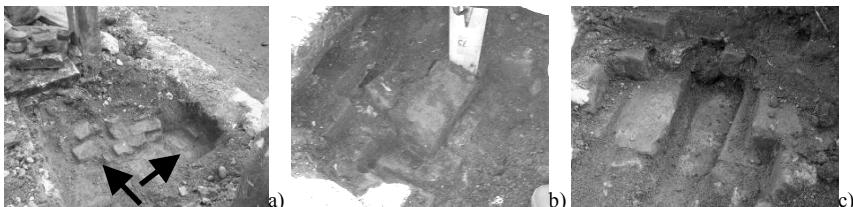
The first ditch T1 showed at first the presence of a solid masonry brick-wall behind the stone blocks. By removing some more material behind this wall, another leaf emerged built with a different technique and with different bricks. The sequence of pictures in Fig. 6a,b,c shows the good technique and consistency of the first wall behind the "ceppo". A second ditch T2 was dug on the left bank (Fig. 7a) and also in this case a solid brick wall was found behind the stones, while the second leaf behind is less homogeneous, and rather similar to a filling. The bricks belonging to the two masonries also appear to be different; nevertheless the presence of some concrete cover does not allow to make hypothesis on the materials, perhaps belonging to a late reconstruction.

Figure 6: a,b,c: Ditch T1: the sequence shows two masonry leaves, one behind the other.

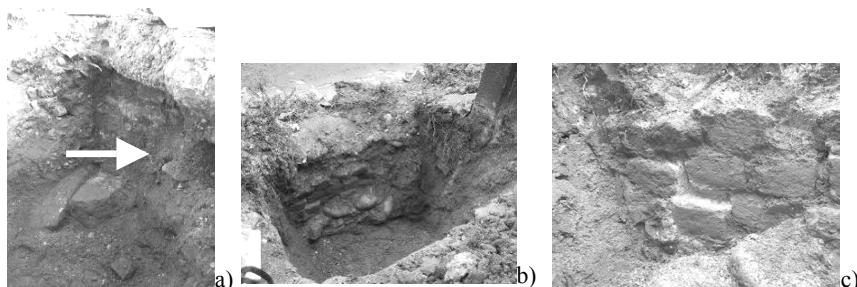
The third excavation (T3) was made on the left bank; also in this case the masonry behind the "ceppo" appears to be very solid and made partially with

bricks, partially with river stone pebbles (Fig. 7b). No other brickwork was found behind but only compacted soil (Fig. 7b). After the inspection of the left bank it was decided also to prepared a ditch T4 on the right bank. Also in this case a brick-wall was found, but with much less consistency than the others and signs of deep damages to the bricks and to the mortars (Fig. 7c).

Figure 7: a,b,c: Ditch T2, T3 and T4; only for T2 the presence of two leaves was found.

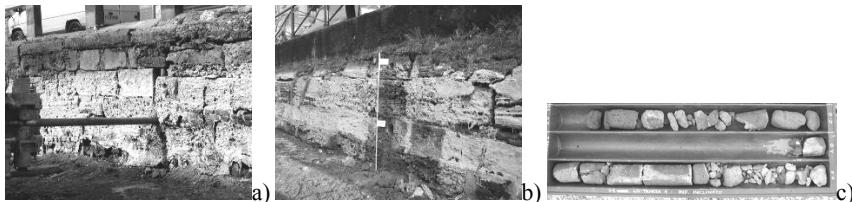
1,300mm (Fig. 8a,b). As it can be seen from Fig. 8c the obtained cores are nearly completely damaged, due to the stresses and the washing out caused by the coring operation. Therefore, in order to detect the section of the wall a videocamera (Fig. 8a) was used and cored section was registered and could be drawn. In the hole at first the “ceppo” can be seen, then a clear mall void between the stone and the brick wall and at 1000mm a filling made with soil.

Figure 8: a,b: Coring at two different heights of the walls (450 and 1500mm) from the canal bed, c) one of the cores.

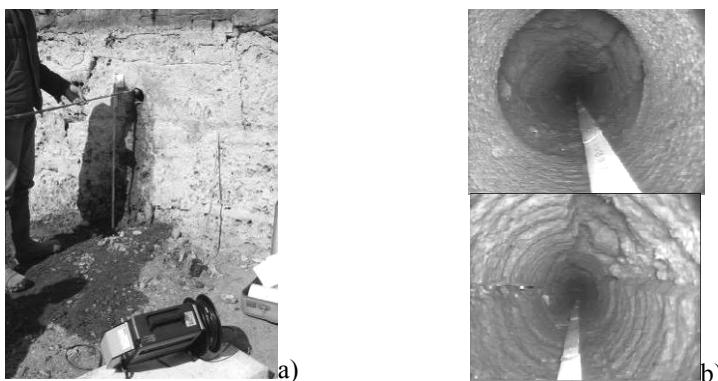
All the cores drilled showed a consistent wall up to 700- 800mm (Fig. 9a,b). Then a sort of rubble material with pieces of bricks or stones and mortar and finally soil. These observations confirm what was found by digging even more in depth.

Figure 9: a,b: Videoendoscopy of the cored areas. Details of the holes.

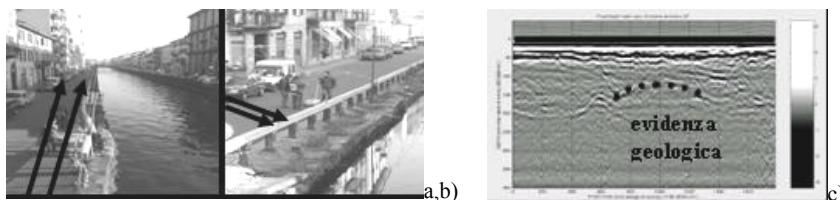
Two measurement campaigns were carried out. The first one along the street working on six profiles parallel to the canal bank for a length of 1,200 meters and 27 profiles normal to the bank at a distance of 1m for 105m (Fig. 10a,b). The test was carried out in order to control the depth of the embankment wall. Unfortunately these measurements were not so easy to interpret, due to the presence of numerous reflectors under the street level. The presence of several installations as electricity, water, telephone supplies and the lack of maps from the municipality to detect their position suggested to avoid using the results of this inspection. The only important information was the detection of a large geological evidence which could be found also by drilling cores as a bank of silty sand and mud 1300mm large at a depth of 8m (Fig.10c).

Figure 10: a,b: Profile directions, c) radargram of the soil section; a geological structure is present at 1300mm depth and 8m long.

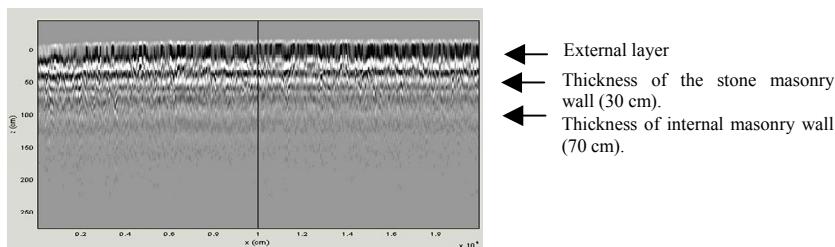
The second campaign was carried out on the wall of the embankment from the side of the canal, once it was fried. The measurements were carried out on the left and on the right bank, along the “ceppo” surface, at 800 and 1,500mm from the canal bed. A 500MHz and a 250 MHz antenna were used along an extension of 1,220m. By comparing the radargrams it was found that the 500 MHz antenna allowed to reach the right depth. The elaboration of the data clearly indicates that the depth of the masonry is around 700mm on both the bank sides while the depth of the “ceppo” is 300mm (Fig. 11). It was also possible to find positions where the two walls were detached.

Figure 11: Radargram showing the wall thickness and the two wall leaves.
