Vulnerability of Machu Picchu citadel 100 years after its scientific discovery

Abstract

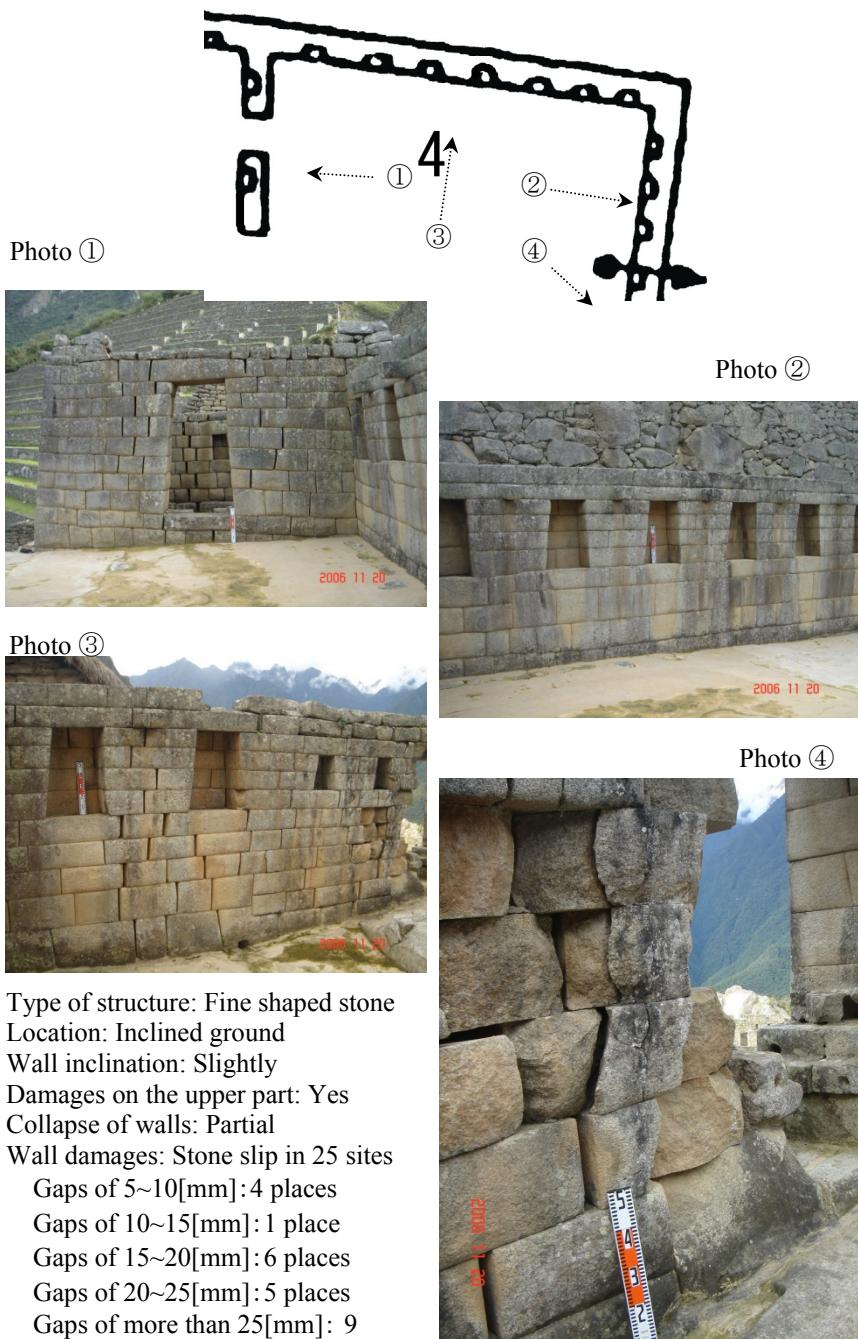
Figure 1: Damage evaluation at building no 2-4.

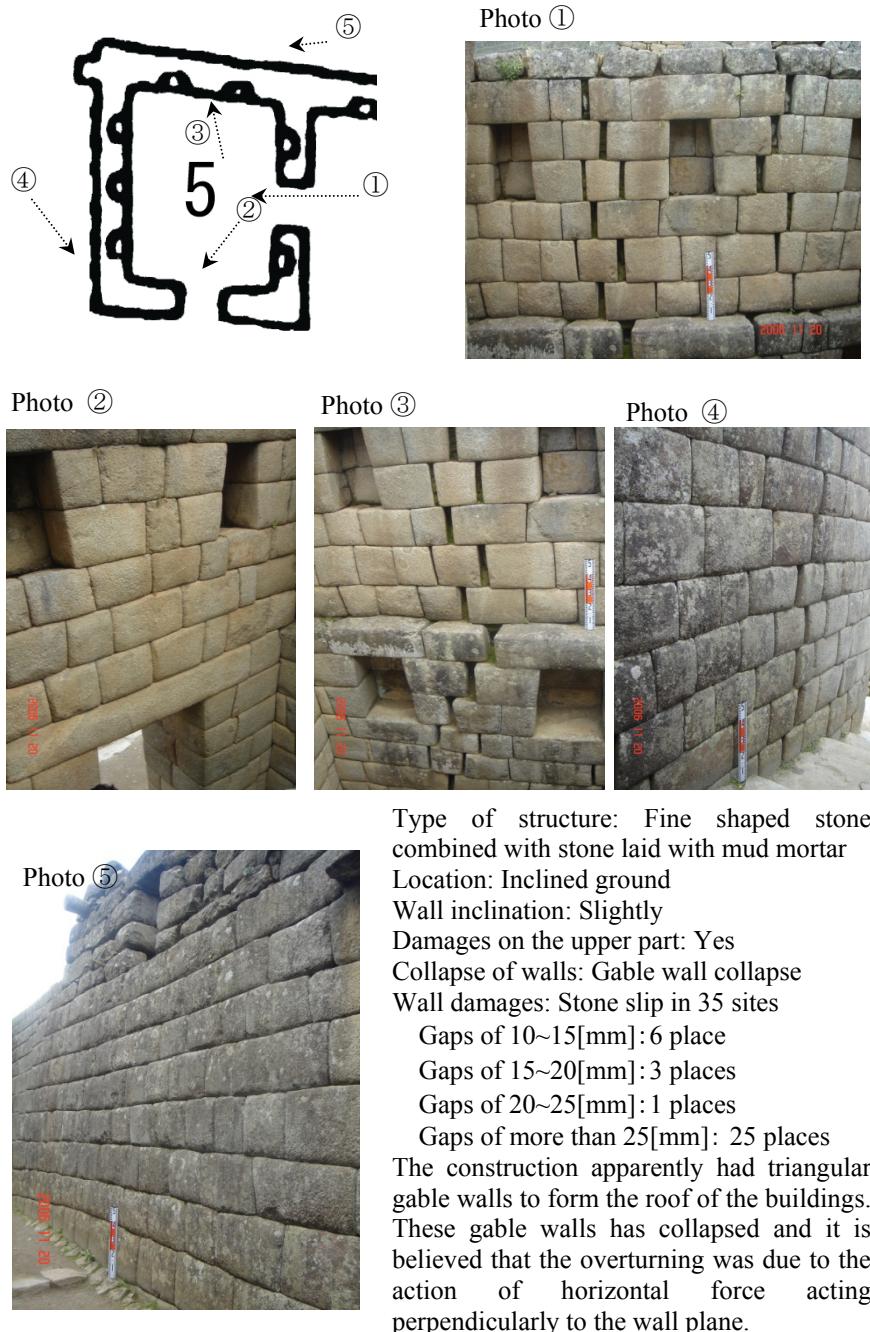
Figure 2: Damage evaluation at building no 2-5.

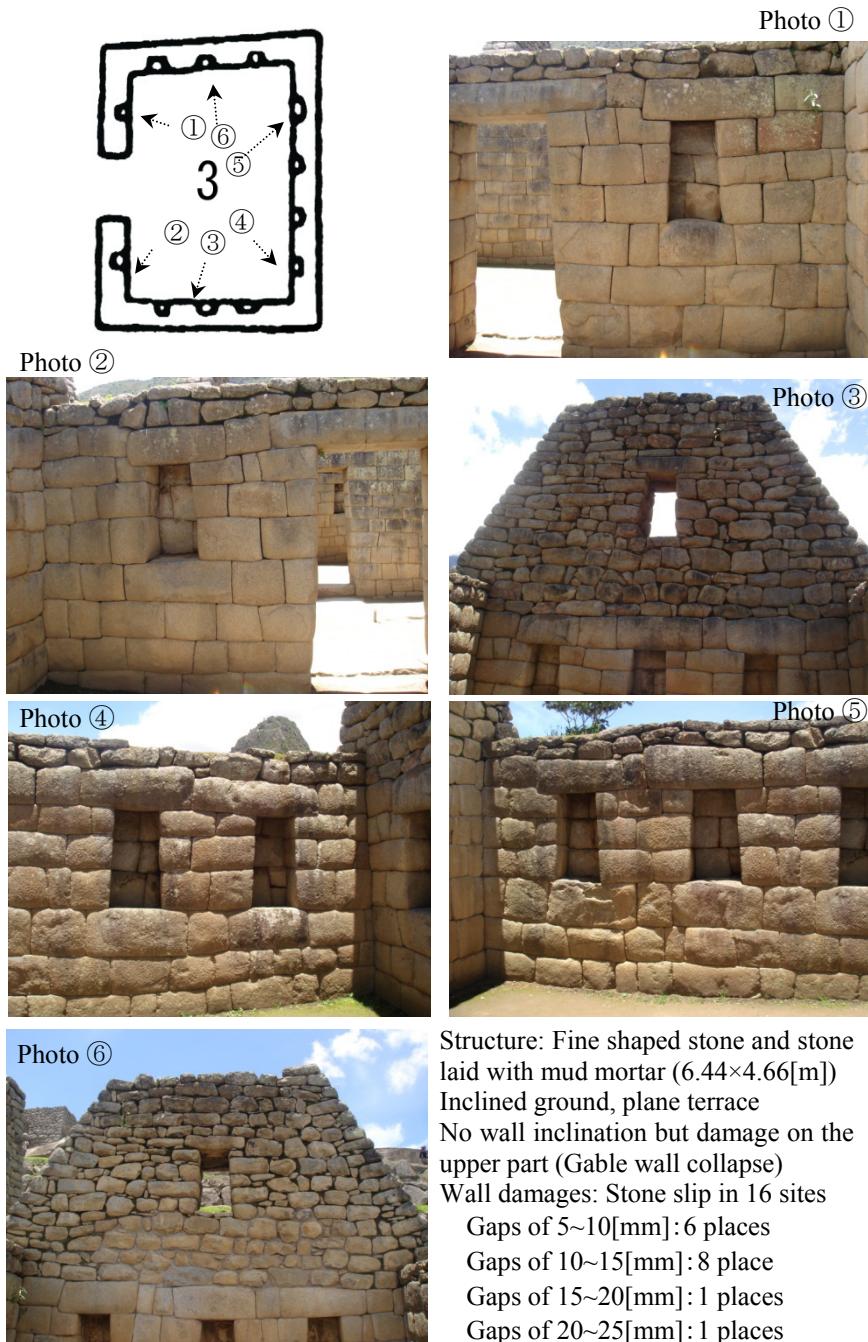
Figure 3: Damage evaluation at building no 3-3.

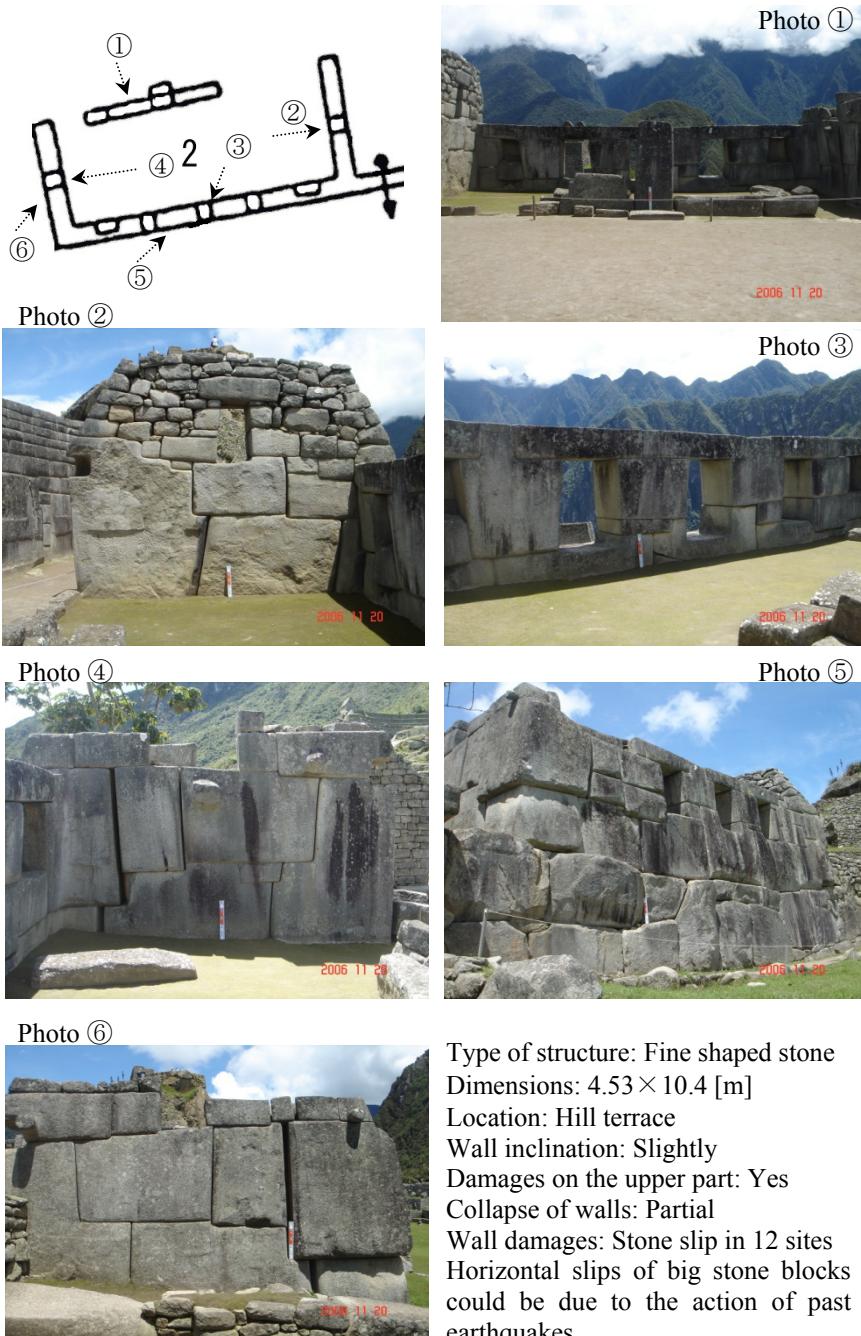
Figure 4: Damage evaluation at building no 4-2 (temple of the 3 windows).

The Main Temple and the Temple of the Three Windows are located in the Sacred Plaza sector which is a terrace. Details of the Temple of the Three Windows and Main Temple are presented in Figures 4 and 5. The Main Temple shows damage of displacements between stone blocks of the north wall due to the settlement of the east wall. In the case of the Temple of the Three Windows, relative horizontal displacements of stone blocks can be observed.

Finally, it is important to remark that the horizontal sliding between stone blocks in the Temple of the Three Windows could be the consequence of strong seismic forces of past earthquakes.

The particular horizontal sliding between stone blocks at one wall corner of the Temple of the Three Windows (Building No 4-2, Photo ⑥) could be the consequence of strong seismic forces of past earthquakes.

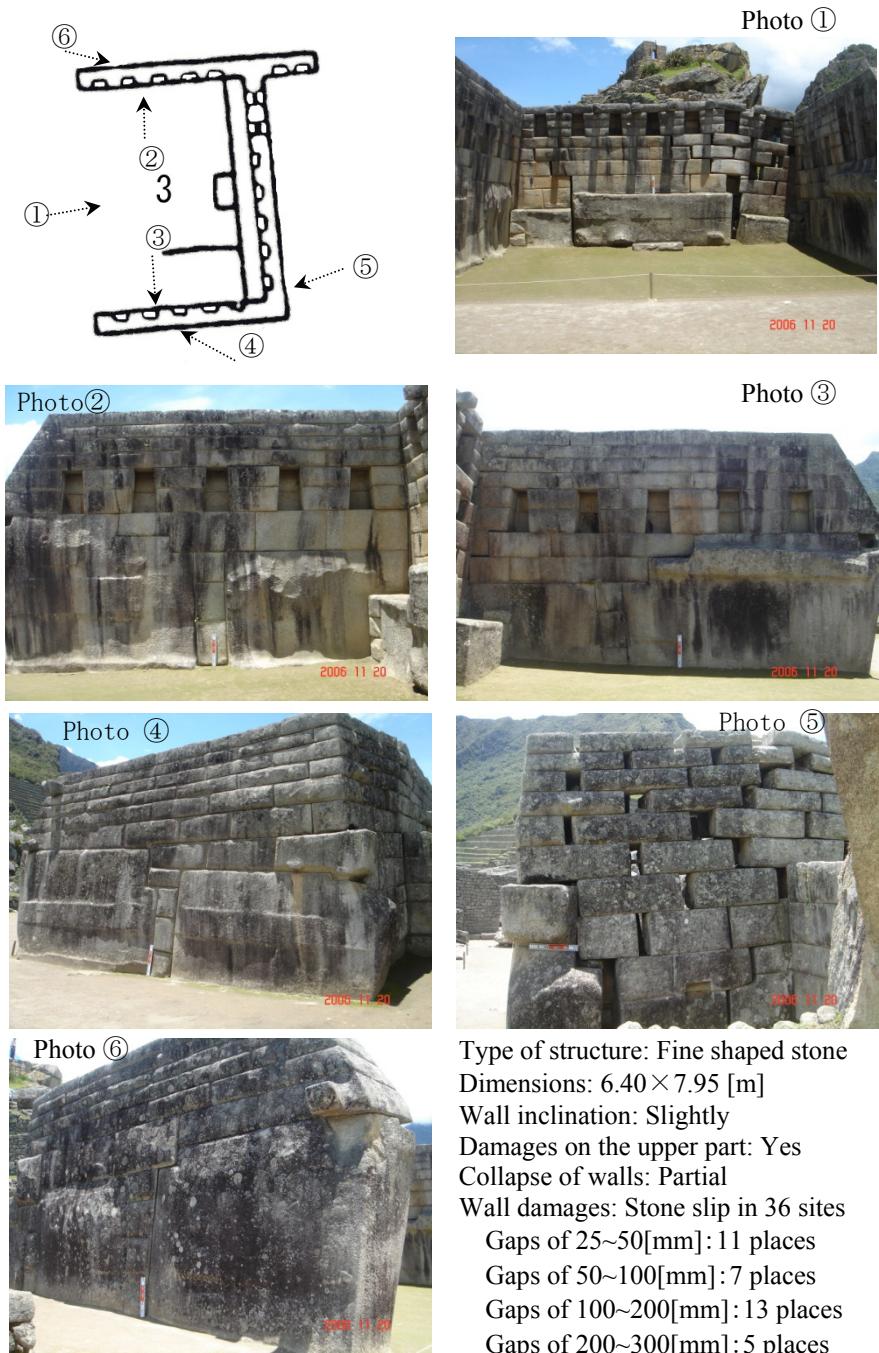
Figure 5: Damage evaluation at building no 4-3 (main temple).

Figure 6 shows the H/V spectral ratio obtained from microtremor measurements at the ground of Sacred Plaza. A predominant frequency of 23.7 Hz was estimated, which would mean that depth of the bedrock is shallow. Usually, the natural frequency of the ground ranges between 1 Hz for soft soil deposits and 10 Hz for hard soil deposits. Therefore, the estimated predominant frequency of 23.7 Hz indicates that the thickness for soft soil layer would be very thin (around 1 m) and that the bedrock would be close to the ground surface. In consequence, these buildings would be founded directly on the bedrock. Therefore the apparent soil settlement failure observed Figure 5 would correspond to a failure or rupture of the underlying rock.

The evaluation of the settlement observed in the Main Temple (Building No 4-3) conduces to think that it is probably due to the fracture of the subjacent bedrock in which the building is founded. Apparently, the bedrock is very shallow and the fracture of this rock can be explained only by the action of large geodynamic forces.

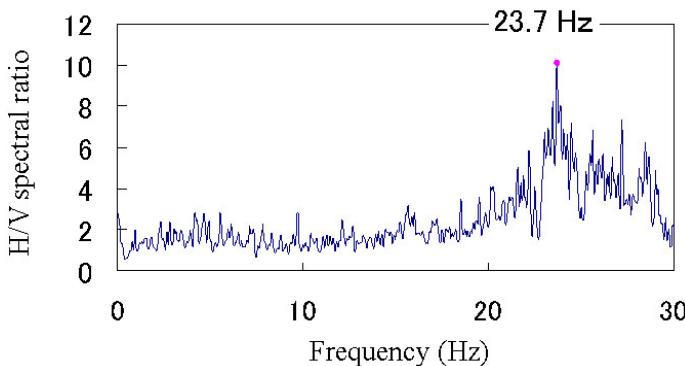
Figure 6: H/V spectral ratio at the ground of sacred plaza.

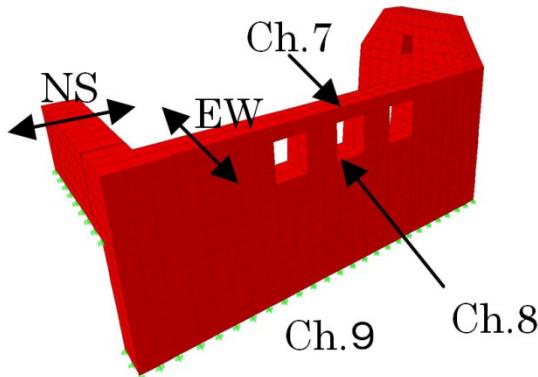
In the case of the Temple of the Three Windows, two horizontal components in NS direction and EW direction were measured, separately. Two sensors were located at the ground near building; one at the external ground (Ch. 9) and another sensor at the inner ground (Ch. 6) of the building. Also, one sensor was located at the central window (Ch. 8) and another sensor at the top of the building (just above the central window) (Ch 7). Figure 7 displays the locations of observation points.

Figure 7: Micro vibration measurements at the temple of three windows.

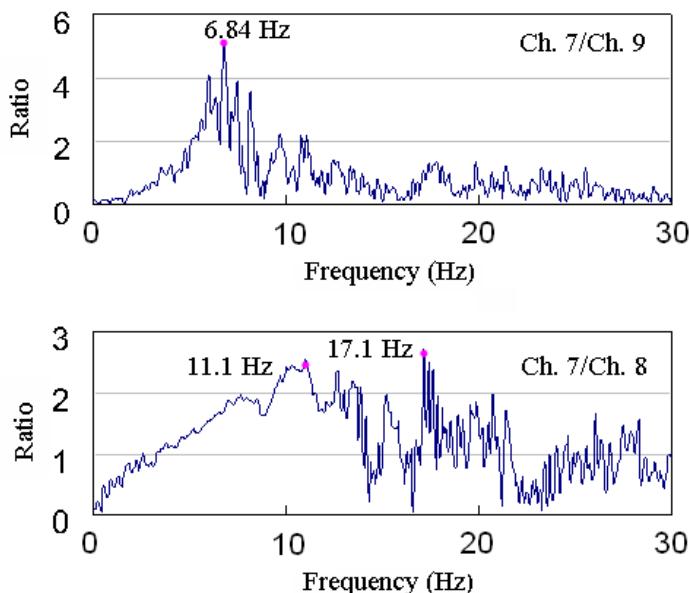
To estimate the dynamic characteristics of the Temple of the Three Windows, the transfer functions between Ch. 9 and Ch. 7 and between Ch. 8 and Ch. 7 were computed, which results along the EW direction are shown in Figure 8. According to these results, the predominant frequencies of the west wall is 6.84 Hz when considering the transfer function from the external ground surface to the top of the wall (Ch. 7/Ch. 9). When the transfer function from the inner

Figure 8: H/V spectral ratio in the temple of the three windows (EW direction).

ground surface to the top of the wall is considered, the predominant frequency is 17.1 Hz (Ch. 7/Ch. 8).

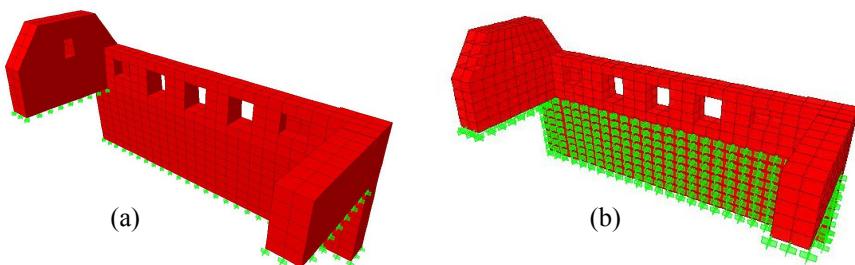
Since the ground levels of the external side and the inner side of the Temple of the Three Windows are different, two models were considered in the FEM analysis. The first model assumes that the east wall does not have contact with the inner ground, as shown in Figure 9(a). The second model considers that the wall is restrained by the inner ground, as shown in Figure 9(b). The walls were modeled using solid elements, and the elastic linear analysis was applied to compare the results with those obtained by micro vibrations. The appropriate value of the modulus of elasticity was determined by inverse analysis of the values of predominant frequencies estimated from transfer functions of micro vibration measurements. As equivalent elastic modulus a value of 1.3 kN/mm² was obtained, which gives good agreements between proper frequencies from FEM and predominant frequencies from micro vibration measurements. Table 1 shows the comparison of both results.

Figure 9: FEM models considered for the temple of the three windows.

The equivalent modulus of elasticity obtained for the polygonal shaped stone masonry, which is the case of the Temple of the Three Windows, is between the equivalent modulus of 0.9 kN/mm² (for roughly shape stone masonry) and the equivalent modulus of 1.8 kN/mm² (for rectangular shaped stone masonry). The smaller value for roughly shaped masonry can be explained due that mud mortar is used. Larger equivalent elastic modulus for polygonal stone masonry could be expected, but according to the results, larger equivalent elastic modulus for rectangular fine shaped stone masonry was obtained.
