BUILT HERITAGE IN THE 2020 EARTHQUAKES IN ZAGREB AND PETRINJA, CROATIA: EXPERIENCE AND CONSEQUENCES

JOSIP GALIĆ, DAVOR ANDRIĆ, LUCIJA STEPINAC & HRVOJE VUKIĆ

Department of Architectural Technology and Building Science, University of Zagreb, Croatia

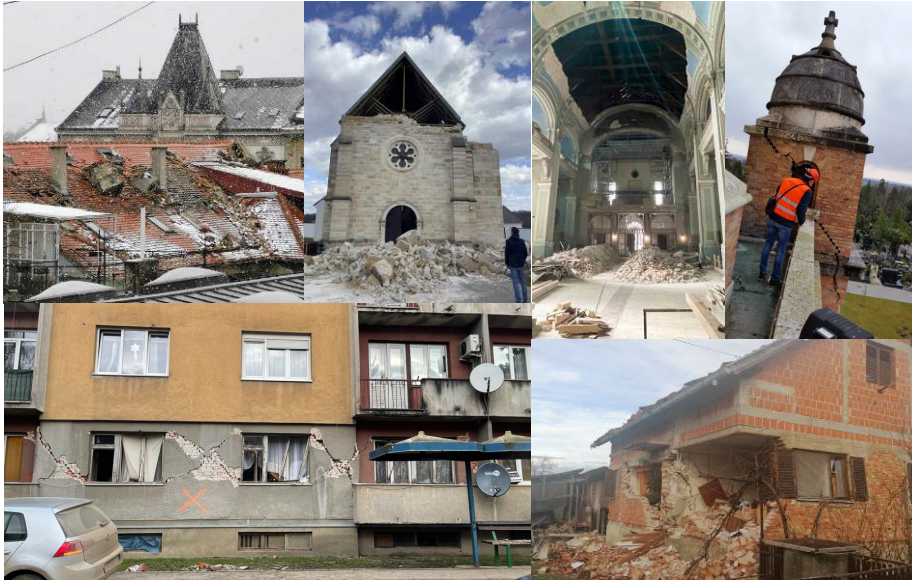
Several main deficiencies and reasons for damage and collapses of masonry buildings were noted. First one was the extremely poor quality of construction materials and thus low lateral resistance of load-bearing walls. Shear strength is not realistically higher than $f_{v0} = 0.10$ MPa. Second one is that the structural integrity of the buildings was insufficient, causing local failures, separation, and collapse of structural elements. Generally, the connections between the ceiling structure and the walls do not exist or is extremely weak – acting only through friction. The walls are usually not held transversally by other walls (out of plane problems), and the connection of longitudinal and transversal walls is exclusively done by a masonry connection which is inadequate due to its weak properties. The only additional connection is sometimes made by the built-in ties that were often found to be damaged. The roofs of the buildings were mostly dilapidated, and their structures were not properly connected with the masonry structure. Thirdly, inadequate load-bearing wall layout and inappropriate geometry is often the issue – which in most cases manifests in openings that are too large, buildings that have too many storeys, and systems with one-way ceilings that leave lateral walls unladen by the weight of the ceilings further increasing the number of cases of damage.

Masonry structures sustained several characteristic types of damage (Fig. 2). These include damage and collapse of unsupported protrusions like chimneys, gables, facades, towers and alike. Further, damage to brick vaults and wooden ceilings were often present as

well as separation, cracking and collapse of the walls. Common damage to masonry was in form of slipping or diagonal tensile/shear failure.

Figure 2: Damage to masonry structures. (Source: Authors.)

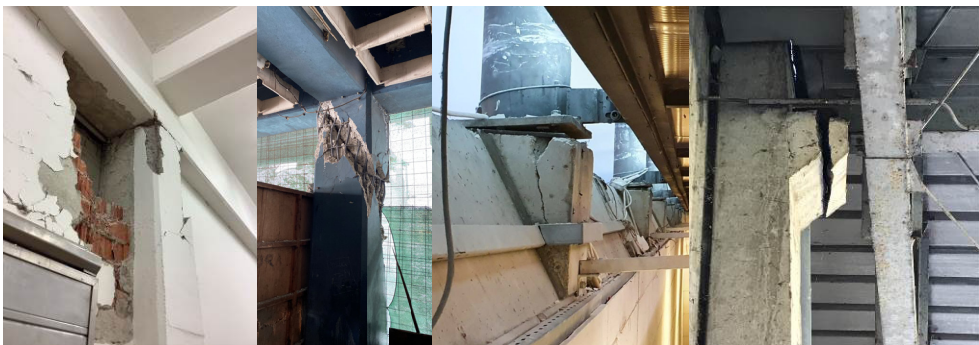
Damage to concrete structures (Fig. 3) was less spread, but still there were some reoccurring types of damage that they have sustained. Concerning the reinforced concrete frame structures, damage manifested mostly as partition and infill walls failing due to the flexibility of the frames and their horizontal displacements. Typical column damage was caused by sparsely spaced or missing reinforcement ties. Damage to the joints of steel and concrete girders on concrete columns and walls was also observed.

Figure 3: Damage to RC structures. (Source: [10] and authors.)
