# The repair of english ancient monuments: two case studies

I. Hume

*Conservation Engineering Branch, English  
Heritage, UK*

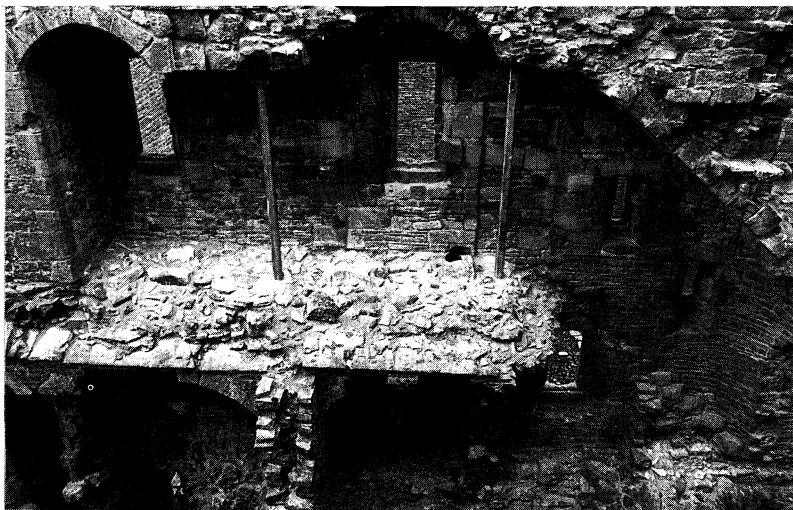
Additional supporting works. As discussed earlier a number of areas have, over the years, become poorly supported. The additional supporting works thought necessary at Castle Bolton, apart from numbers of small stainless steel dowels and brackets to fix loose masonry back locally, consists of some vertical square

Figure 2: New posts supporting massive overhangs. tube supports constructed from cold formed stainless steel. These have been installed to support major

overhangs of potentially unstable masonry.

As there was no clear detailed evidence for what supported these areas previously the stainless steel posts are intended as a clear statement of 20th century intervention. Figure 2 shows two of these new posts.

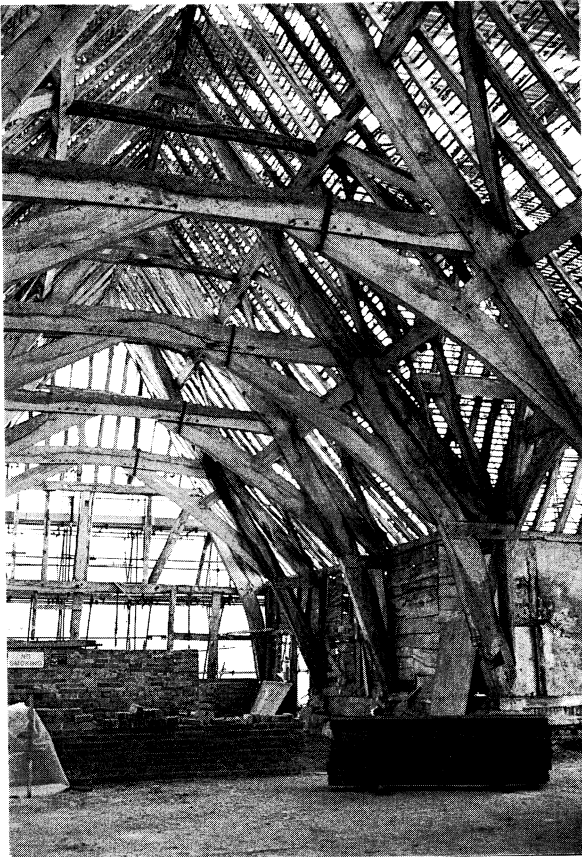
Figure  
4.

Leigh  
Court  
Barn.
