# Investigation and stabilisation of Chester city walls

G.A. Clifton

*Gifford and Partners Ltd, Consulting Engineers,  
Chester, UK*

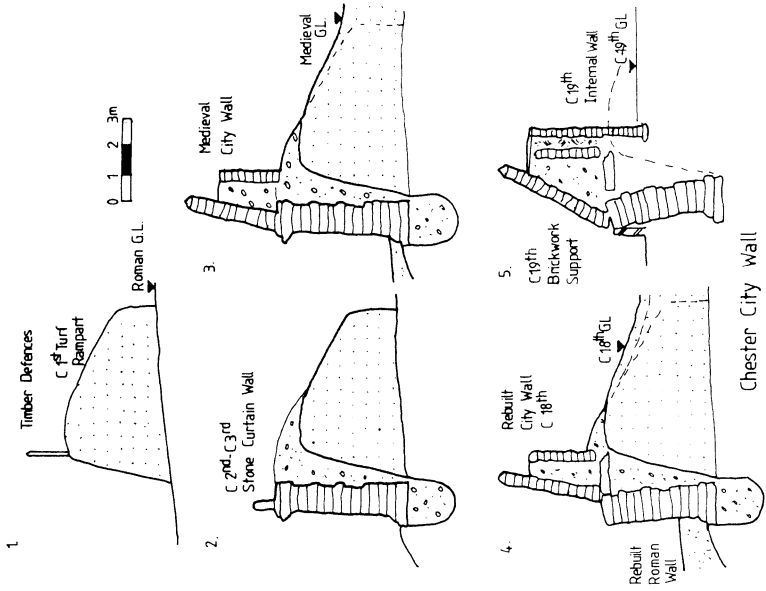
Fig 2

The detailed records allowed a "structural history" of the wall to be proposed. This is illustrated in condensed form in Figure 2.

The turf rampart remains a significant element in the city wall, though much buried and modified. The Roman masonry of the external leaf similarly survives to much of its original height though again buried and partially rebuilt. The medieval wall was perched on top of these remains and further patched and built upon during the Victorian period. The wall can be seen to be a collection of disparate elements only poorly tied together, but acting as a fascinating record of Chester's history.

Chester City Wall  
Evolution of North Wall

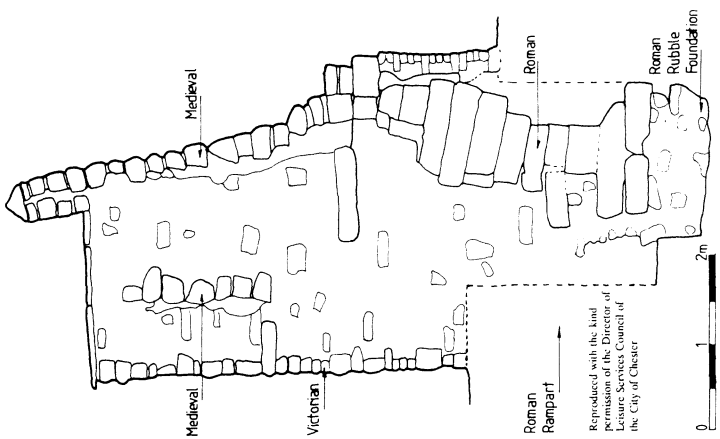
Fig 1

6. Detailed archaeological recording was carried out on all materials found and samples taken for analysis, which was not only for its engineering properties, but for environmental conditions e.g pollen analysis. Figure 1 shows a typical example of a recorded cross section.

Chester City Wall  
Section Through North Wall
