Scagliola or stucco marble: restoration of the altars in the church of Lichtenfels, Bavaria

C. Reithmeir

3 The restoration of the stucco marble altars in the church of Lichtenfels

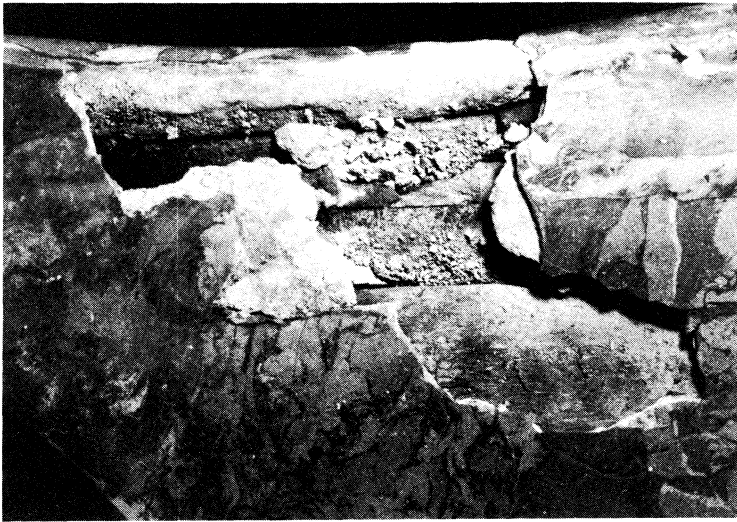
Damages: The most interesting object concerning the condition and the restoration itself is the main altar in the choir. Therefore, the following explanations will only refer to this altar. The object shows a wide range of damages which appear normally on stucco marble. They have partly external causes, such as mechanical stress or changes in the statics of the construction.

The basic construction of the altar consists of wooden laths and a layer of plaster above. Thus, the two basic materials are wood for the ground and mineral mortars for the plaster and the stucco marble layers. Both are reacting differently on moisture and mechanical influences. In addition, stucco marble is a very hard and brittle material, unable to compensate mechanical movements. The consequences are structural damages. In the church of Lichtenfels, we had to deal with cavities between the stucco marble layer and the plaster, cracks of different dimensions, partial detachments of the stucco marble and the plaster from the ground, as well as missing parts in the stucco marble layer. Fortunately, problems caused by any kind of moisture did not exist. Water or moisture normally results in aggravating damages and in the degradation of the substance, mainly because of its content of soluble salts. In the case of stucco marble, the influence of water also leads to the dissolution of the bonds between gypsum and glue, since glue is soluble in water. This may cause degradation of the substance and porosity of the surface.

Figure 2: Church of Lichtenfels, missing and loose parts in the stucco marble layer and the plaster

Other measurements: Beside the above mentioned measurements, interventions concerning the structural damages were performed. Cavities were filled with liquid gypsum. The filling was limited to cavities of large size or expansion. Loose parts of the stucco marble layer were fixed with liquid gypsum, a material which corresponds to the original material. Cracks were only closed where necessary. This means that cracks of large size were filled with a mortar similar to the stucco marble paste. The surface was also polished up to three times in order to close the pores. The purpose of the filling was to avoid the further penetration of dust and soot. Small cracks were left in its present state. The

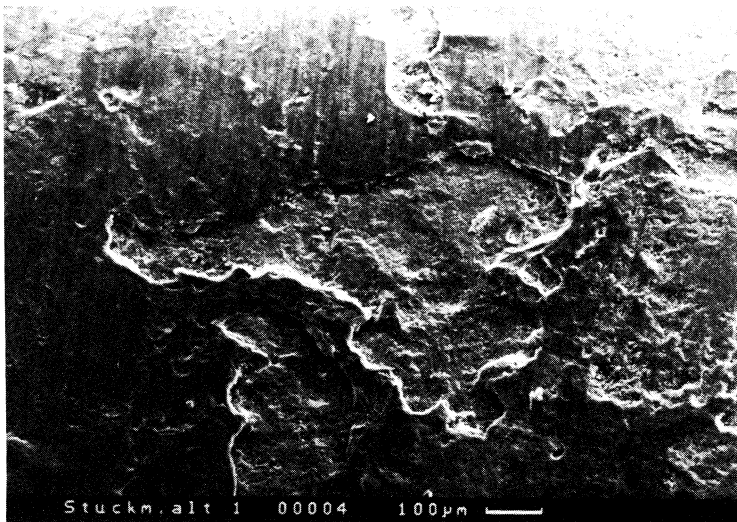
The whole surface of the stucco marble possessed coatings of different materials, consisting partly of shellac, but mainly consisting of varnishes on the basis of synthetic resins. The purpose of the additional and not original coatings was probably the creation of brilliancy on the old and porous surface. The consequences were a change of the original character with a brownish shade and a blunt and greasy lustre, as well as the partial degradation of the substance due to the coatings of synthetic resins.

In the 19th century the whole surface of the stucco marble was overpainted with white oil-color, because the baroque appearance with its bright and contrasting colors did not correspond to the taste of classicism. In the following restoration which took place in about 1920 or 1930, the oil-paint was removed with very aggressive corrosives that were possibly neutralized with hydrochloric acid. The effect was a degraded and extremely porous surface without any brightness or brilliancy. Another long-term consequence was the intense pollution of the surface with dust and soot settled in the open pores.

Figure 3: Church of Lichtenfels, degraded stucco marble surface (photograph by electron microscope)

Treatment of the surface: The most complex problem was the treatment of the stucco marble surface. The decision for the preservation concept with "smooth" interventions was taken in agreement with the Superintendence of Historic Monuments and the Rectory of the Church. The main reason for this decision was the lack of data concerning the original surface of the stucco marble in the church of Lichtenfels. Neither the material itself, nor the archival sources gave any hints. Therefore, in this case, a minimal intervention was the best restoration concept in the opinion of the experts involved in the restoration. The consequence was that the surface had not to be restored and the polishing

The first step was the polishing of the whole stucco marble surface with a very fine abrasive paper in order to remove remaining residues of dirt and coatings, as well as the removal of unevenesses. Then, the so-called stucco was laid on and polished after hardening. This process was performed only one time and not, as usual, two or three times. At last, the surface was impregnated with diluted glue which was polished after drying with a smooth cotton rag. A final treatment with natural wax did not take place.
