The collapse and proposed restoration of a prehistoric megalithic structure

A. Torpiano

Institute for Masonry and Construction Research, University of Malta, Malta

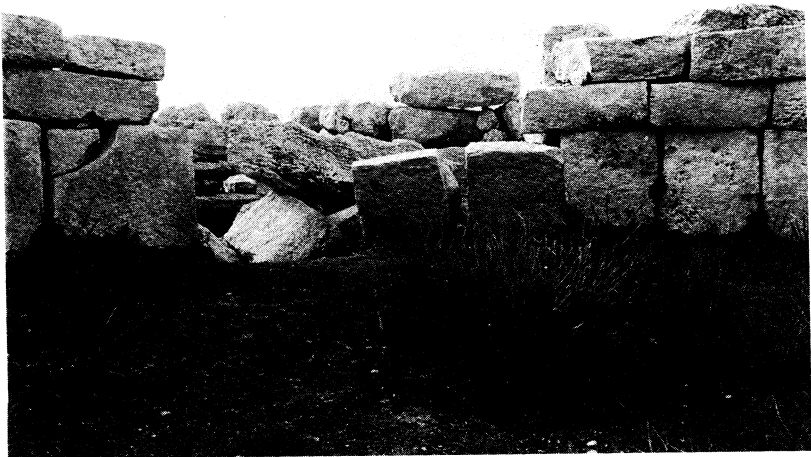
During the night of the 4 April 1995, part of the wall between the Middle and Lower Temple, collapsed. The direct cause of the collapse was attributed to the storm that occurred during the night, however it can also be seen that other factors, particularly the changes in structural configuration that had occurred as a result of the normal weathering mechanisms, as well as, what appear to be defects in the construction of the original temple, have to be considered.

On the other hand, the exceptional intensity of rain, coupled with a particular water drainage pattern, within the walls of the Middle temple, probably led to a saturation of the soil, both contained within the inner and outer skins of the wall, as well as retaining, or supporting, the base of the inner skin of the Middle temple. A complete saturation of 2m of soil, which is approximately the height of the top level of the soil infill with respect to the floor level of the Lower Temple, could have achieved a side thrust of up to 10 kN.

Plate 2. Collapsed wall from first apse of Middle Temple

The problem that now needs to be confronted is to establish the degree of intervention that is necessary to protect the monument from further damage. The collapsed blocks will be removed during the coming summer, and a partial reconstruction of the inner wall of the Middle Temple will be attempted. However, it seems that it will be necessary to consider a more dramatic intervention so as to protect the whole temple from the ravages of rain, salt spray and sun.

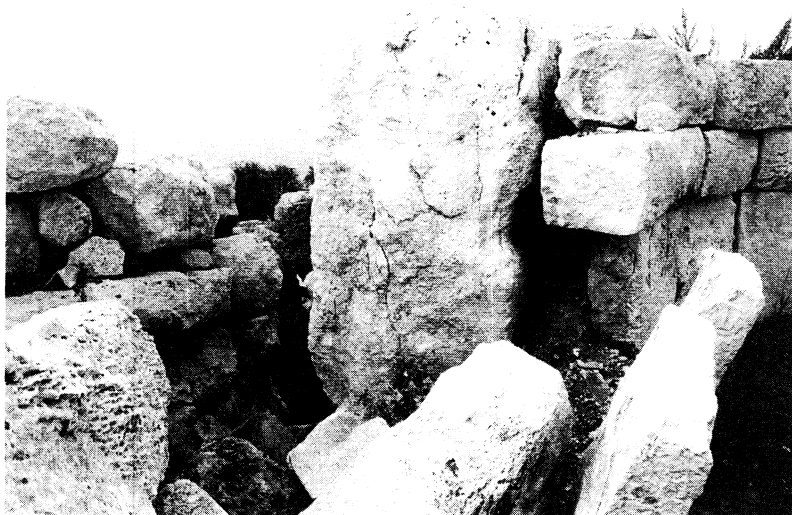
Plate 3. Close-up of the collapsed section

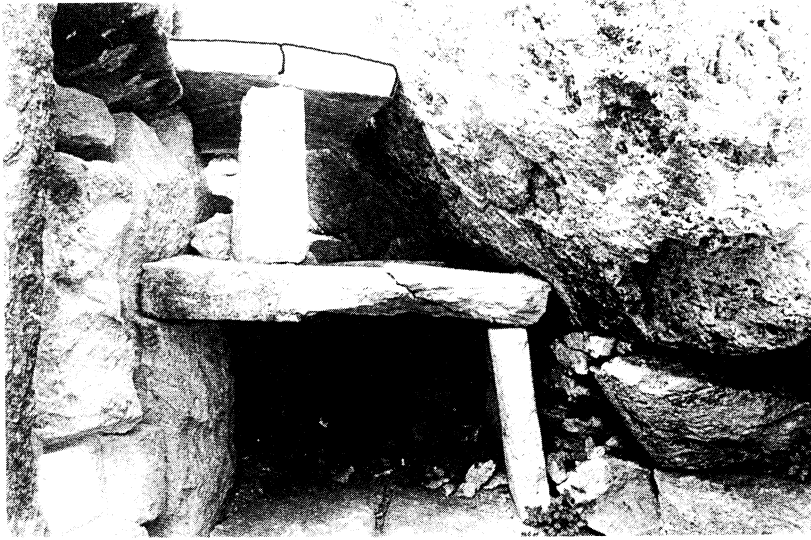
Plate 4. Double-table structure propping a massive megalith - 1987

Another curious feature is the table-structure that appears in Plate 4. The structure is recorded in the excavation of 1910²; archaeological evidence¹ suggests, however, that, although the horizontal slabs are supported in grooves formed into the megaliths of the Lower temple, it probably was inserted at a later stage.

The construction of the Middle Temple seems to have been less carefully done than that of the older one, to the extent that the stability of the megalith which is common to the external perimeters of both temples was probably in doubt at a very early point. The table structure, intentionally or otherwise, seems to have supported the weight of the precariously balanced megalith until years of weakening, coupled by the saturation of the soil during the storm, proved too much. Plate 1, which dates back to the sixties, already shows the cracks in the table structure as it is being pinched over the pillar supports by the adjacent boulder.

The collapse of this structure is considered as having led to the collapse of the inner wall of the Middle Temple. The upper corbelled courses of the Lower Temple were also displaced by the impact with the larger blocks as they fell. These important courses have not been brought down, in this incident, but, given that the contact between the vertical faces of adjacent blocks has been completely lost, thus destroying the original compression ring, and given the substantial displacement that has occurred, the stability of this portion must be considered precarious at best.
