Masonry investigation of the Nott Memorial

D.T. Biggs

Ryan-Biggs Associates, 291 River Street, Troy, NY 12180, USA

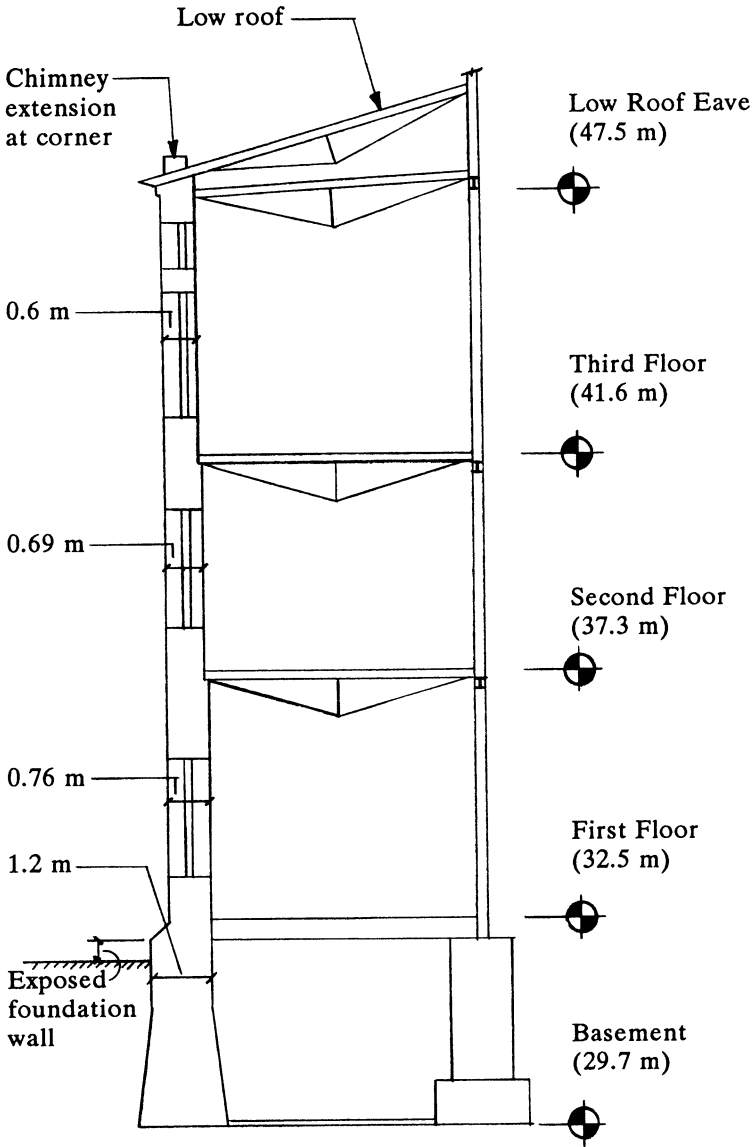
Figure 2: Section through Exterior Wall

The 16 exterior walls, each approximately 5.2 m, rise 16.2 m to the eave of the roof. The wall thickness varies from 1.2 m at the basement and 0.6 m at the roof. See Figures 1 and 2.

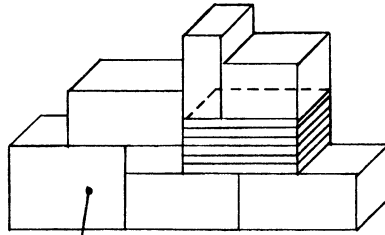
Figure 3: Bedding Plane Orientations

The majority of the facing stone is bluestone which is a sedimentary stone commonly called "shale". It has clearly defined bedding layers. Figure 3 shows the three possible orientations; all three were used in this building. The most serious deterioration occurred with the bedding planes vertical and parallel to the exterior face; spalling of the surface occurred. The other two bedding orientations showed deterioration at the edges of the stones along the bedding plane.

Many of the bluestones were sounded. Many with bedding planes vertical and parallel to the wall sounded "hollow" indicating the stone was delaminated and spalling.

The facing stones of granite and sandstone are in overall good condition. However, isolated sandstones need crack repairs. The bluestone condition is generally acceptable. Many stones have been damaged by the hard repointing mortar of previous repointing; spalled and cracked stones need to be replaced.

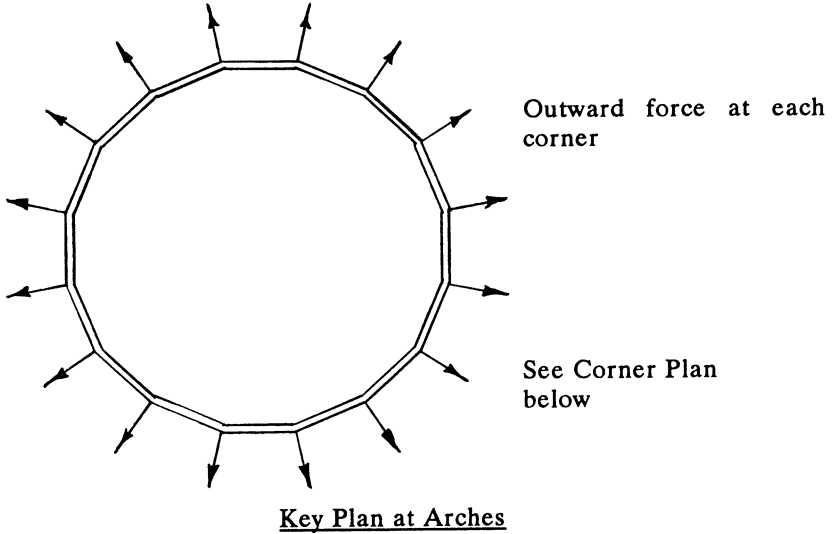
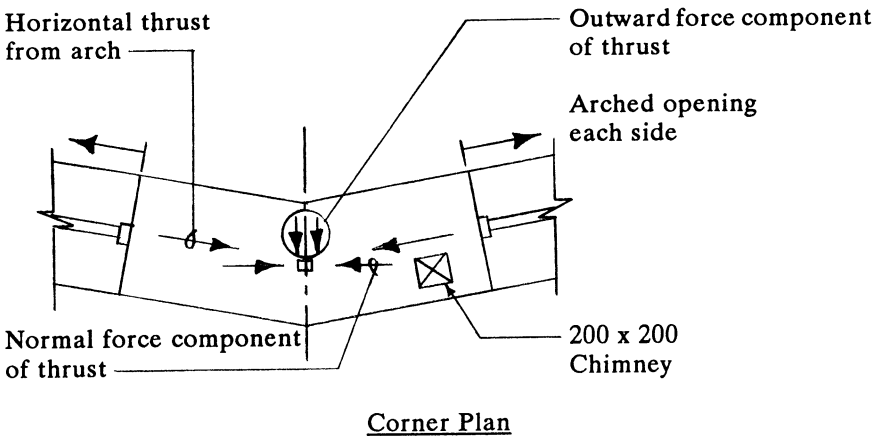
Figure 4: Horizontal Forces from Arches

Due to the unique, 16-sided configuration of the building, the arched openings create some unusual stresses. Figure 4 shows the horizontal thrust

of the arches resolve into normal and outward components. The normal components are offsetting but add to the overall compression of the vertical loads. The total compression increases to approximately 1380 kPa.

The outward component produces a hoop stress, which is taken by the masonry in tension, of approximately 172 kPa.

The highly stressed area is the point where the failure initiated.

The major structural problem is the high stresses in the corners which caused the cracking and the spreading of the building. To reduce the stresses, it was necessary to strengthen the 16 corners and redistribute the loads. This entailed filling the chimneys with a reinforced grout and patching the interior openings created during an earlier renovation. In addition, the outward forces from the arches were to be restrained by a reinforced concrete tension ring placed along the interior of the building and anchored to the reinforced corners.
