# **Rehabilitation at Hondarribia Castle, in Hondarribia, Guipuzcoa.**

A. Abasolo

#### **4. The 1990 rehabilitation project**

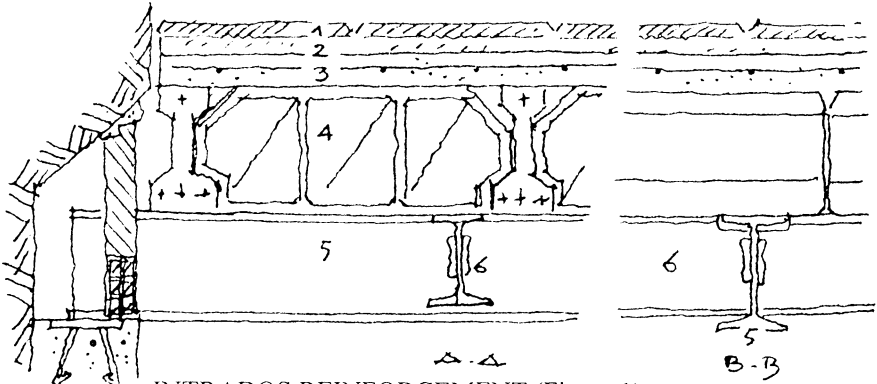
INTRADOS REINFORCEMENT (Figure 1)

Lack of compression layer and losses (not widespread) of covering on lower face with presence of corrosion in prestressed cables.

- Concrete of joists: very rich in cement with presence of carbonatation, particularly severe in areas of support and gutter pipes.
- Mortars: made of lime with carbonated Portland base (harder) with low presence of "strignite" (expansive element), therefore not dangerous.

- Profiles: A.37 steel, weldable with oxidations and up to 10.5% loss of thicknesses.
- Reinforcements: AH.1770, and depassivation in certain cases.

The joist used was the same for the three existing spans therefore it was deflection-tested by assimilating it to a double “T” of equal section, determining prestressed strains, deformations and stresses, an extreme resisting moment of  $M_u = 1.134 \text{ m. T}$  being obtained.

Note that  $S$  was well below the minimum of  $1.60$  prescribed in the Instruction.

What has been described so far meant that it was necessary to take immediate action, and the reason a collapse did not occur, (As  $S$  was below even  $1.00$ ), was due to the fact that fortunately, all the actions envisaged by the Instruction had not presented themselves simultaneously.

### 6.5.1. Strengthening of floors (see Illustration 1).

The solution found would consist in arranging cross joists (parallel to the floor direction) in IPN 330 profiles, supported by vaulted niches made in the walls every 5 metres and by a continuous longitudinal IPN 300 header beam which would prop up, in the centre, the floor joists.

Finally, in order to cover the negative resisting moment (very low, it should be said) in the central support area, it was necessary only to reinforce the new compression layer (8 cm. thick and  $15 \times 15 \text{ cm}^2$  mesh with diameter 10).

An epoxy solution applied to the upper wing of the joists ensured adhesion, preventing longitudinal shears.

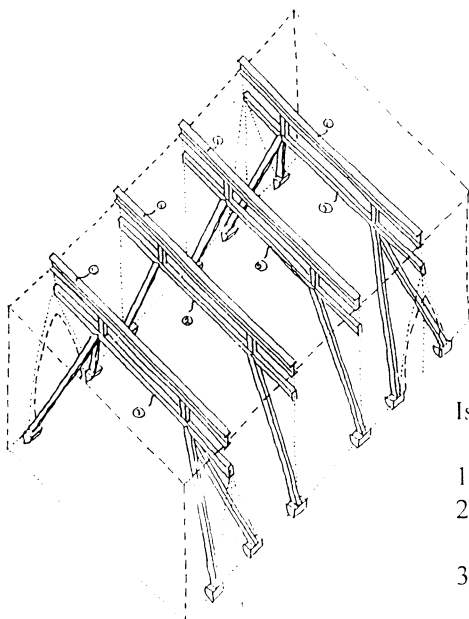
Isometric View (Figure 4)

Electrochemical corrosion (welts and craters) with loss of thicknesses.

The profile used was IPN 300, and once the section had been checked, as for the doubly-supported beam, for the existing conditions, a 340 calibre was seen to be necessary.

The problem detected (corrosions, losses of thickness and the insufficiency of sections) required urgent intervention, as above.

### **6.5.2. Reinforcement of main joists in the courtyard vestibule (see Illustration 2).**

1°.- Cleaning of profiles with descaling up to SA 2.5 (SIS), epoxy priming, rich in Zn and 25 micra chlororubber finish, all of this on the basis of the aggressive nature of the maritime climate.

2°.- The section insufficiency could be made up for by adding plates in order to reach the resistant model necessary but, as in the case of the floors, the solution opted for would involve reducing the span by dividing it, in this case, into three parts ( $1.30 + 3.00 + 1.30$  metres).

For this purpose, a permanent prop consisting of four varnished and multicoloured wooden porticos (one for each main joist) was made, fastened to the walls by means of short brackets and inserted footings.

A false ceiling (whose chamber housed the horizontal network for the disposal of waste from the bathrooms of the four new bedrooms) was crossed by the spindles which would determine the intermediate supports in each main joist.
