Restoration and seismic strengthening of Colorado Street Bridge

Sven E. Thomasen

Wiss, Janney, Elstner Associates, Inc., Emeryville, California, USA

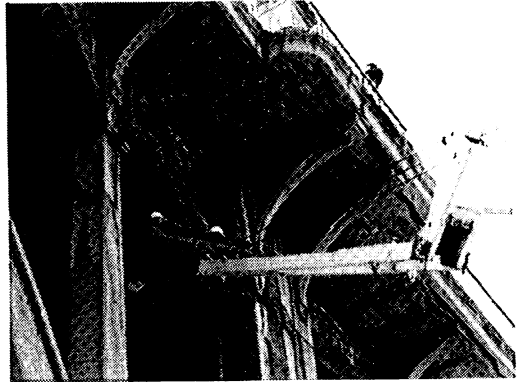
Figure 3: Field survey of bridge deck

Based on a document review of the bridge a close range inspection was conducted of all elements of the structure. The bridge deck was inspected visually and with a vehicle-mounted sound recording device to detect subsurface deterioration. Delaminations within the concrete slab at the level of the top reinforcing mat were recorded. The amount of delamination ranged from 33% to 93% of the surveyed deck area. The underside of the deck, spandrel columns, cross girders and high arch areas were surveyed from the bridge using a truck mounted “snooper vehicle” and from the ground using a high-lift crane (Fig. 3). The observed conditions, including delamination, concrete cracking, unusual displacements and performance of expansion joints were documented on design drawings. An assessment was also made of the soundness of the drainage system and of the operational capability of light standards and the ornamental bridge railing (Fig. 3).

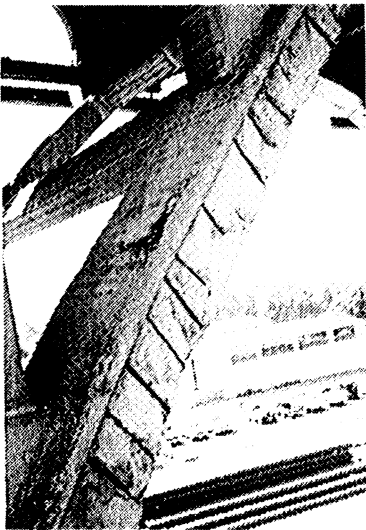
Figure 4: Exposed reinforcing

Deterioration was observed throughout the structure. The concrete exhibited extensive cracking and delamination. Exposed reinforcing bars had steel area loss from corrosion. The bridge deck showed severe cracking, softening of the concrete paste and residue of efflorescence. The deck expansion joints were no longer functioning and the drainage system was defective. Rain water leaking through deck joints unto the concrete surfaces of piers and arches had caused severe delamination of the concrete cover and had exposed large sections of the reinforcing bars to corrosion. In many bridge members substantial steel area loss had occurred (Fig. 4).

- The columns at the top of the arches were relatively stiff because of their short height and they attracted a disproportional amount of the seismic load. These columns were rebuilt with seismic hinges top and bottom.
- All exposed concrete was restored. Reinforcing steel bars, that had been exposed when the concrete cover spalled, were cleaned, coated with anti-corrosion paint and tied back to sound concrete, and the spalls were patched. The concrete for the restoration and for the replaced elements was carefully selected to match the warm color of the old bridge, and the original "form board" pattern was replicated by impressing the wet patches with pieces of lumber

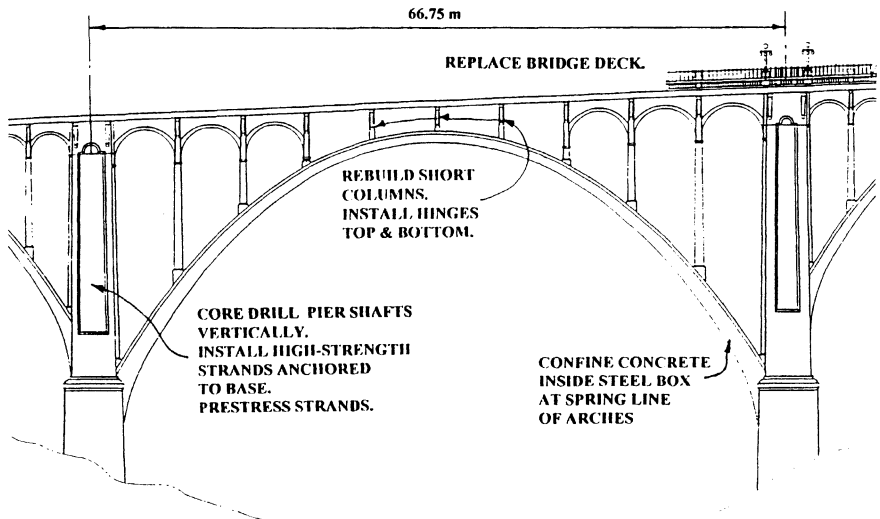
Figure 5: Rehabilitation and seismic strengthening

The condition assessment and the preliminary analysis of the Colorado Street bridge indicated that the deck and the under deck cross girders did not meet current requirements for highway traffic loads and the deck would have to be replaced. The analysis also indicated that extensive seismic strengthening of the arches and piers was required. For the seismic retrofit the length of the bridge precluded that the seismic forces could be resisted by the end abutments. Therefore, each of the 11 spans had to be designed, seismically, as a separate structure, and the seismic forces would have to be brought to the ground through the arches and the vertical piers.

For the longitudinal seismic forces the arches became the critical sections, while in the transverse direction the seismic forces could be resisted by both the piers and the arches with the stiffer piers taking most of the load. The analysis indicated the arches had to be reinforced at the spring line because of the low compressive strength of the concrete, the small amount of reinforcing steel and the absence of effective concrete confinement. It was also necessary to increase the strength of the tall piers. Finally, the columns at the very top of the arches were found to be relatively stiff because of their short height and they attracted a disproportional amount of the seismic load. To reduce the seismic load, these columns had to be rebuilt with hinges top and bottom (Fig. 5).

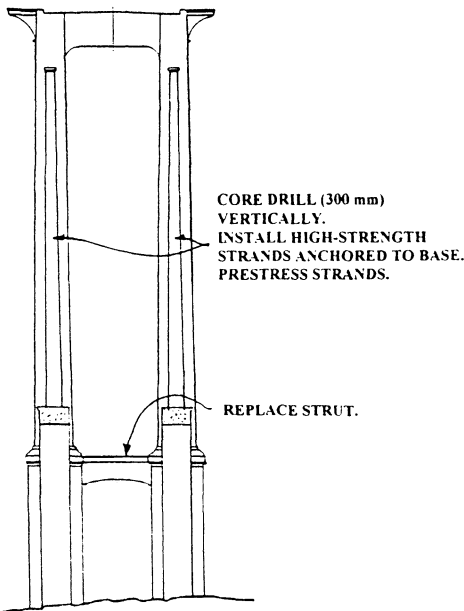
Figure 7: Strengthening of vertical piers

The piers are the main seismic resisting elements in the transverse direction of the bridge. The stiffness of the piers was increased by

replacing the strut between the two pier shafts with a heavier reinforced concrete section. To strengthen the pier shafts 300 mm holes were drilled from the very top of the shafts all the way down into the base. Prestressing steel rods were then placed in the holes and anchored to the foundation. The holes were grouted and the steel was stressed. The prestress in the steel rods will prevent them from buckling during a quake, thereby avoiding the need for installing steel ties, which would have required intervention to the surface of the piers (Fig. 7).
