St. Monica's Church earthquake damage repair

St. Monica's Church, a reinforced concrete frame, masonry infill structure dating from 1925, was severely damaged in the 1994 Northridge earthquake. The limestone cladding cracked and displaced, and parts of some walls collapsed. We evaluated the structure and facade, and designed repairs and seismic strengthening. The repairs included adding structural elements and rebuilding the stone cladding. The church reopened approximately 15 months after the earthquake.

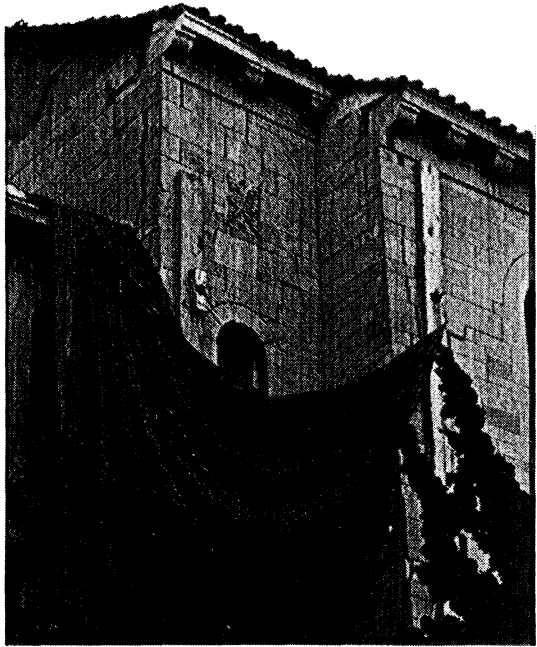
The tops of both the north and south gable end walls collapsed out-of-plane, leaving the attic space open to the exterior. (Fig. 3) At the north end, the stone had cracked and displaced away from both corner columns below the collapsed gable end wall.

Figure 3: Collapse of north gable end wall and cracking at adjacent corners.

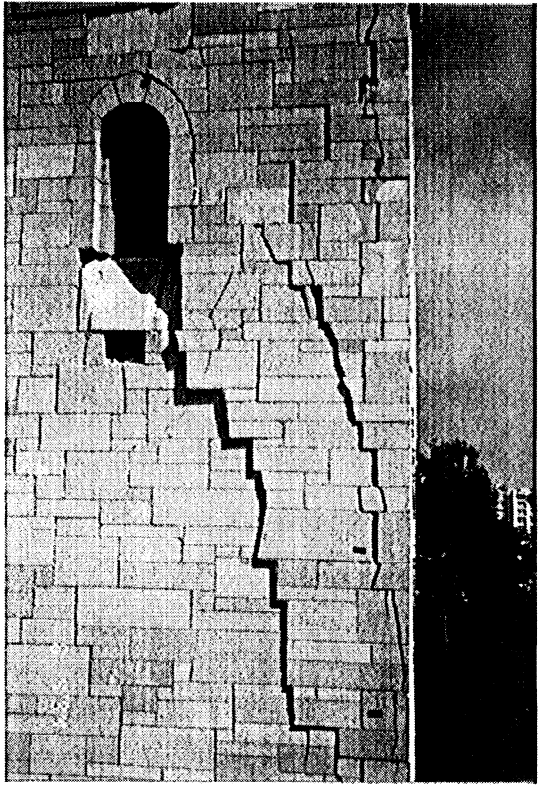
The tower also had extensive diagonal shear cracking and displacements. Joints between stones opened up to as much as 75 mm wide. (Fig. 4)

Figure 4: Severe cracking and displacement at tower
