# The Sultan Ahmet Mosque restoration works between 1988-1990

A. Güralp

## Abstract

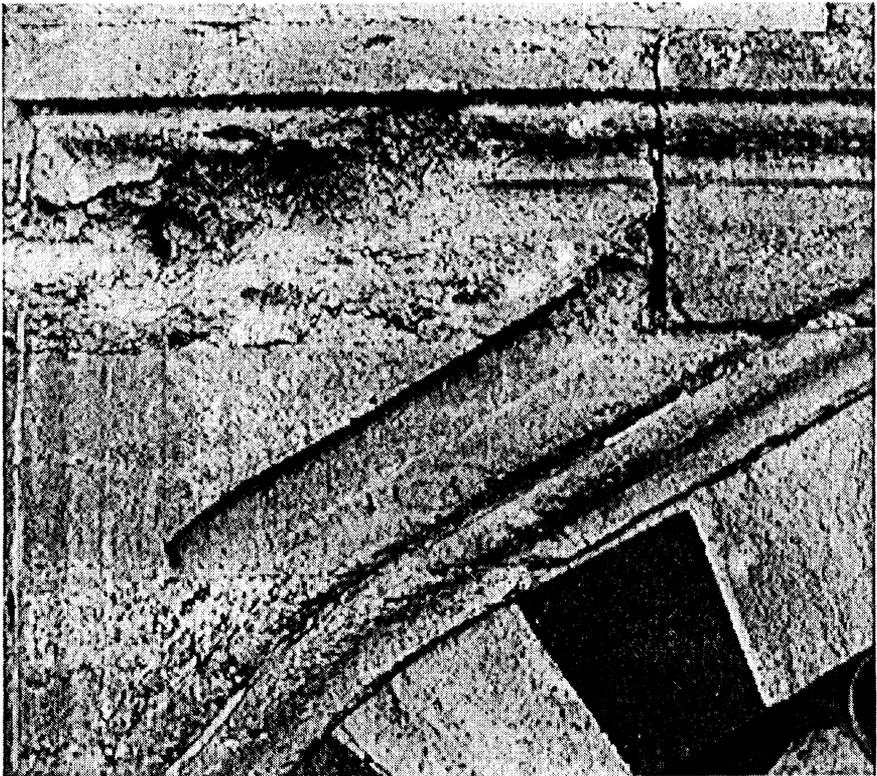
Figure 8

The calker - based stone had lost its supporting quality and loosened in many places due to weather conditions over time. These had to be replaced but it was not as easy as it seemed .

Nowadays cement mortar is used and although it is not a problem regarding resistance the cement has an acidic base and the stone will gradually wear away due to the acid seeping into its pores. The outer wall of the Sultan Ahmet Mosque is made of a stone, called the minaret stone which is a very tough calker type and is extracted from the Bakirköy region. However, winter conditions and water which enters through the cracks and freezes can ruin the stone .

The stone had to be removed and replaced without disturbing the static system of the structure. The most commonly used method is to wear away the stone and put a new one in its place which is what we did. Unfortunately I do not think this process was very successful because it will change the structure' supporting quality in time. Also, as a limestone-based mortar called khorasan

In my opinion, the most important point in replacing stone is that not enough tightening is obtained when stones are put into place. Tightening with wedges sometimes caused the stone or surrounding stones to crack presenting more work as the damage increased. It would cause no mortar to enter behind the stone leaving it empty which could present a hazardous condition. In such instances the use of a small compressed mortar pump would be useful.

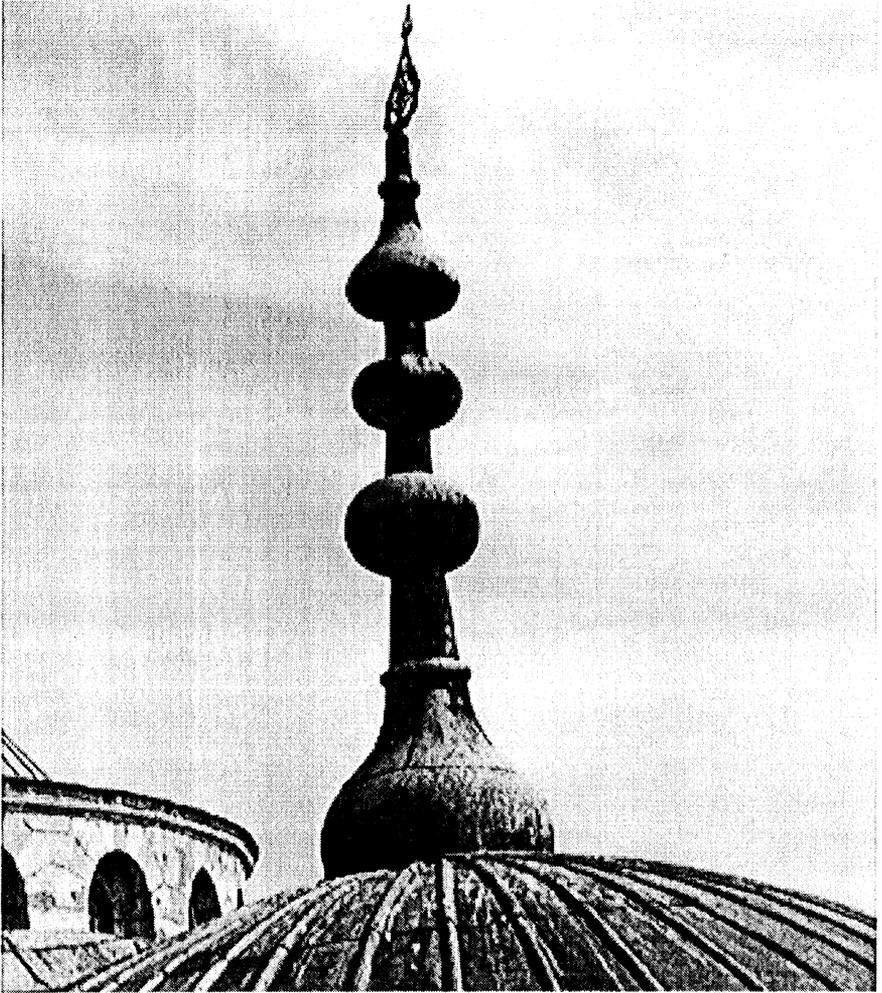
Figure 9

As it is known, lead plating is done by joining through interlocking. The lead should have a soft underneath while it is being pressed and hammered . Otherwise the lead can be torn through. As in the original, the underneath of the lead was plastered with a mortar consisting of clayey material and hay. One disadvantage of this is that in time pollen carried by birds and wind may take root and lift the lead causing water to enter the dome .

To prevent this, the dome should be insulated with an insulation mixture consisting of polyurethane foam or a perlite-limestone mixture. As perlite contains acidic based silica it does not allow plants to take root thus preventing such damage. When the dome is not insulated properly the air accumulating at the top of the dome will cause humidity which in turn will immediately destroy the decorative work. It is also important to sufficiently insulate against water where the cupola sits on the dome. The brass cupola had corroded over the years, therefore it was repaired by coating it with gold surfacing and welding with brass. As the sections called the apple and pear were very heavy we decided that only a heavy duty helicopter could lift them, so the idea to have them brought down was abandoned. Instead ,only necessary repairs and maintenance work were carried out.
