# On problems with saving of sacral buildings situated on coal mining terrains

Z. Pająk, J. Kubica, W. Starosolski

*Department of Building Structures, Silesian University of Technology,  
PL-44-100 Gliwice, ul. Akademicka 5, Poland*

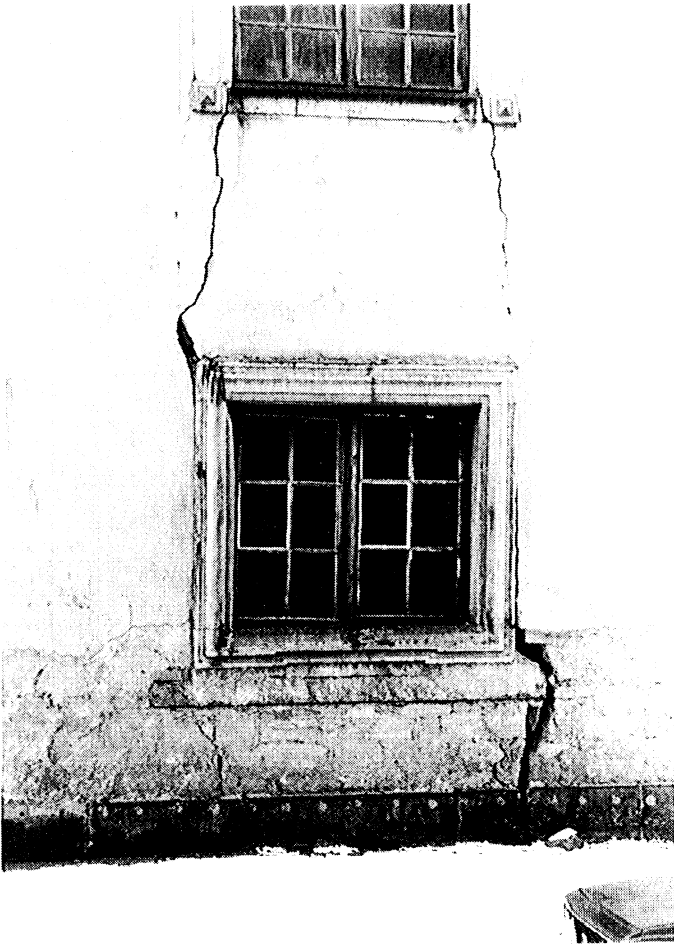
Main damages of the load bearing elements are concerned the external walls of the building. There are vertical cracks running across the whole high of the building. These cracks have the maximal width up to a few or even more than 10 centimetres (Fig.3) and they occurred rather regularly. The similar width of these cracks in the lower and upper part of walls was observed. In cornice area these cracks are not disappeared, on the contrary, sometimes they are expanded and damaged the cornice.

Figure 3: View of the width crack at lower part of the external wall.

Moreover, also in the underground part of the external load bearing walls, the cracks have a similar width like in the other parts of the walls. Directions and configuration of the cracks on the both longitudinal, external walls are also very similar to each other. All lintels in the external walls are damaged, sometimes very seriously.

Analysis of the available historical sources was permitted to state, those vertical cracks of the longitudinal external walls were first observed before about 100 years. First information about the appearance of this type cracks dated back to the year 1888. The fracture with the maximal width was registered both the north and south external wall of the main nave of the church in the area of the first row of windows – counted from the bell tower. Practically, this fracture is “cutting” across the building into the two pieces. According to the historical sources from 1938, the width of the cracks on the level of foundation was between 15 and 20 millimetres, but on the level of cornice – about 10 mm wider. In 1997 the fracture on the level of foundation has 20 to 20 mm width.

Most seriously damages of the longitudinal load bearing walls have rather regular character of vertical cracks. The most width fractures are in junction of main body of church with the tower. This fracture is entailed irregular vertical displacement of lower windows lintel beam and deformation of the window opening. In effect of them the lintels are also damaged. This type of failure suggested the occurrence of unequally settlements both parts of the building. In mentioned above, historical sources the different reasons of damages observed are presented.

Analysis made by authors with connection with performed calculations (based on the investigations of the soil parameters), permitted to define three following, main reasons of damages:

- irregular settlement – as a result of variations in the groundwater level;
- modification of construction of the church and raise a additional part of the bell tower;

- proximate influences of ground deformations – as a result of long and intensive coal mining.

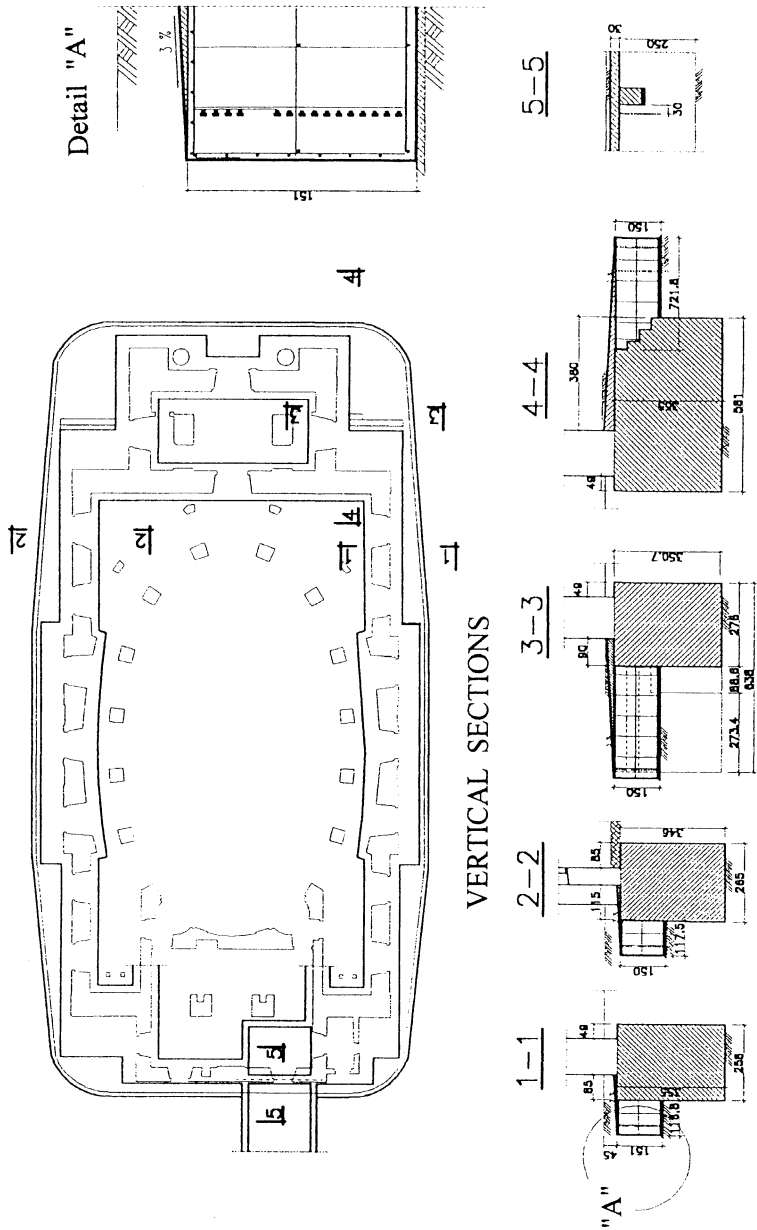
Figure 3: Construction of the RC band around the upper part of the foundation walls.

- performance of the reinforced concrete band around the building in the upper part of the foundation masonry walls (see Fig.3) in order to integration both parts (main body and the tower) of the church. It was made an assumption that RC band will take all additionally tensile forces produced by further horizontal ground displacements;

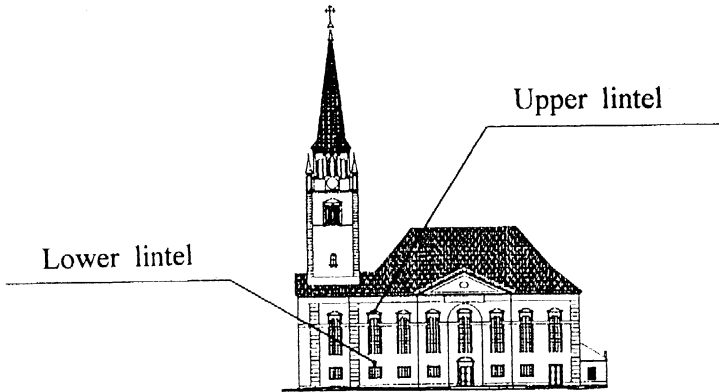
UPPER LINTEL

Figure 4: Method of damaged lintels strengthening.

- repair and strengthening of damaged lintels by performance of the reinforced concrete lintel beams and arches – like shown on Fig.4;
- repair of damaged walls using well known standard-methods [4,5] by removing and replacing shaded and cracked bricks and blocks with new and filling the cracks an appropriate (commonly 1:1:6) mortar mix, well rammed in, and repointing the surface. When the cracks were large, additionally the expansion bolts of modified mortar fixings should used;
