Preservation criteria applied to the case study of a 19th century fortress

C. Mileto, F. Vegas, V. Cristini & J. R. Ruiz-Checa *Universitat Politècnica de València, Spain*

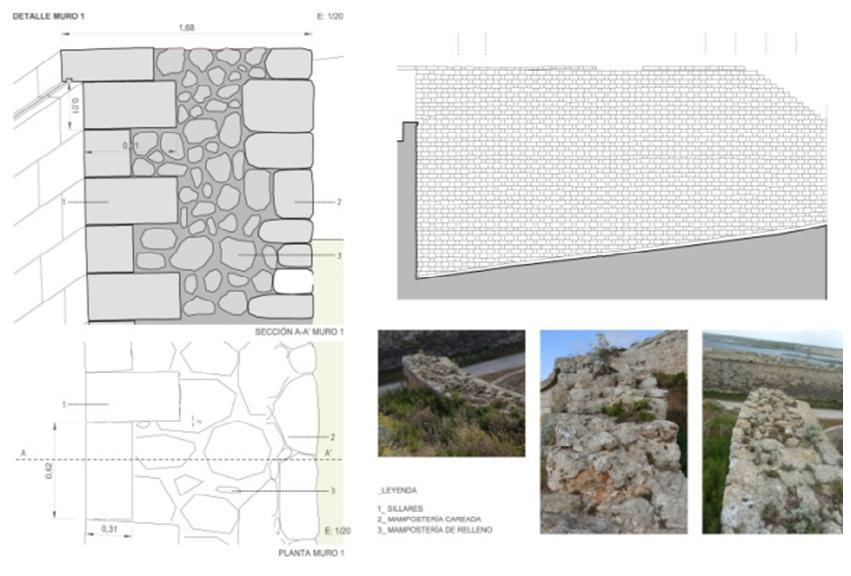
Figure 2: Constructive details, Recess 5 (authors).

Historically, what is known as Recess 5 consisted in a pincers-shaped defensive element with a redoubt at the incoming angle (Figure 2). The straight retaining wall of the pincers connecting the outgoing angle of the Princess Tower and the Recess 5 stretched for a length of 390 m, closing the landward defence [3]. This series of works — consisting of the straight section, the Recess 5 and its redoubt — began in 1850 and would carry on until 1860, and integrate a perfect example of a polygonal landward defence, in keeping with the fortification theories of the time [4, 5].

The Recess 5, being a section of the defensive wall of the fortress which acts as a retaining wall, was in a terrible condition, due to earth pressures. The section under study had a length of 30 m and a height of 15.07 m at the highest point. Prior to the intervention, the Recess 5 showed significant degradation, erosion and pulverization of many of the blocks of stone that formed the retaining wall. In addition to this, the entire wall was visibly collapsed; even some of the capstones were missing.

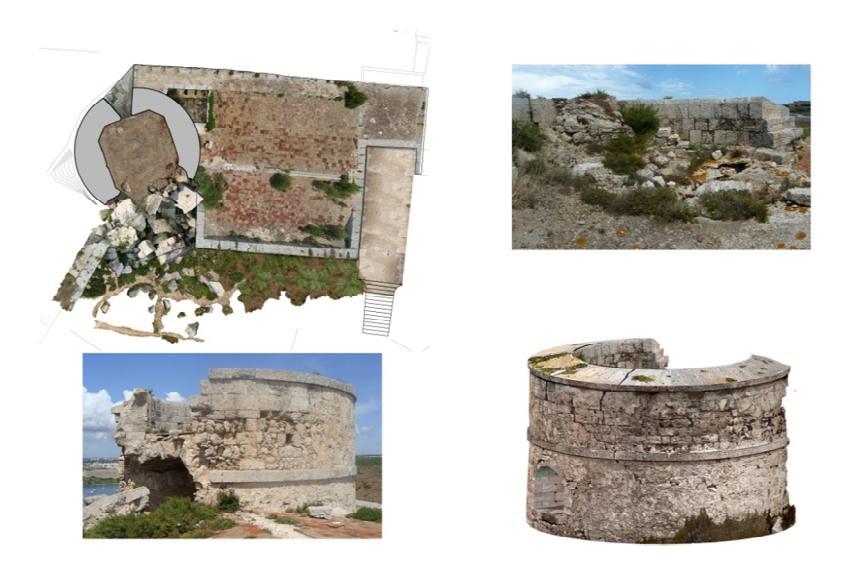
Figure 3: The Princess Tower, details (authors).

On the other hand, prior to the intervention, the Princess Tower presented a delicate state of preservation, being partially demolished on the inside due to an explosion caused by a lightning strike in 1958, when it was used as a gunpowder magazine. Neither the access nor the tower's stairway were preserved, but the embrasure facing north (towards the sea) remained standing. The tower had a circular plan and a slightly truncated cone-shaped morphology, with an upper radius of 5.06 m and a maximum height of 8.26 m, with a total floor area of 80.41 m². Its morphological characteristics were completed by the presence of a barbette on the upper rampart, usually for two or three heavy guns (32- and 36-pounder bronze naval cannons with rotating carriage). Its base was reinforced to resist ground attacks, and the door was risen above the ground level, covered by a vertical fire provided by a simple machicolation above it. The tower base typically housed warehouses and water tanks. The first level, vaulted and artillery-proof, featured loopholes and vertical vents.

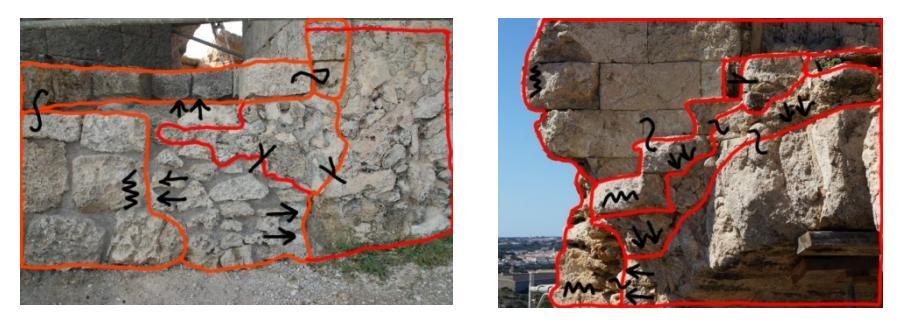
Figure 4: The Princess Tower, stratigraphic details (authors).

The third period corresponds to the construction and addition of the guardhouse, possibly in the late nineteenth century (Figure 4). In this case, the structure is built with autonomous and different construction techniques from those employed for the tower: regular blocks of reduced size and lime mortar with dense aggregate of metamorphic origin [7].
