Experimental investigation on a non-seismic precast RC beam-column exterior joint under quasi-static lateral cyclic loading

K. D. Ghani & N. H. Hamid

Faculty of Civil Engineering, Universiti Teknologi MARA, Malaysia

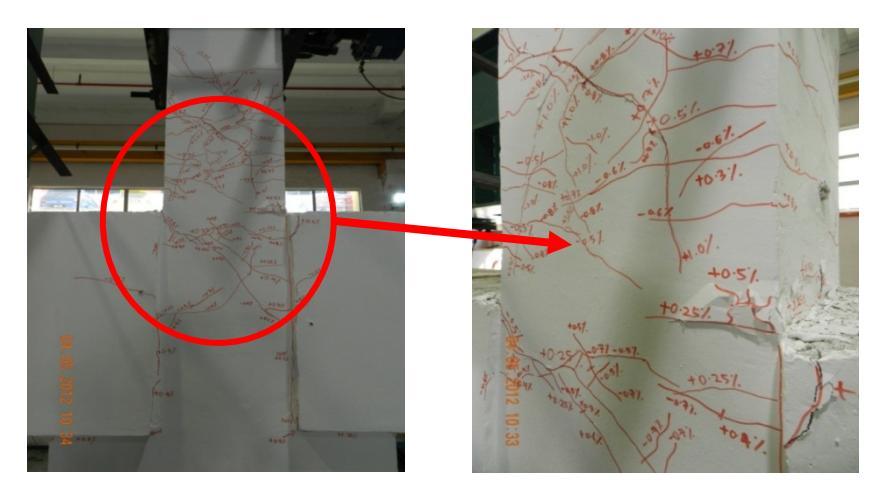
The response of specimen was remained elastic starting from $\pm 0.01\%$ until $\pm 0.5\%$ with successive cycles. At $\pm 0.5\%$ drift, hairline cracks below the corbel supporting Beam One and Beam Two were observed during experimental work. Within inelastic region, larger cracks were occurred at the cast-in-place area of the joint. Gap opening between surface of corbel and beam during loading and unloading of actuator leads to shear cracks which can be obviously seen at the upper part of the column. Figure 6 shows the front view of the sub-assemblage beam-column exterior joint where most diagonal crack occurred at the cast-in-place area. At $\pm 1.0\%$ drift (final drift), more severe cracks and damages occurred above the joint. However, cracks were also observed at the cast-in-place area (monolithic) which is detected as weak area of the exterior beam-column joint. The situation is known as 'captive column', due to strong beam-weak column under soft storey mechanism. After thorough inspection on the specimen, severe

Figure 6: Shear and diagonal cracks were observed above the joint.

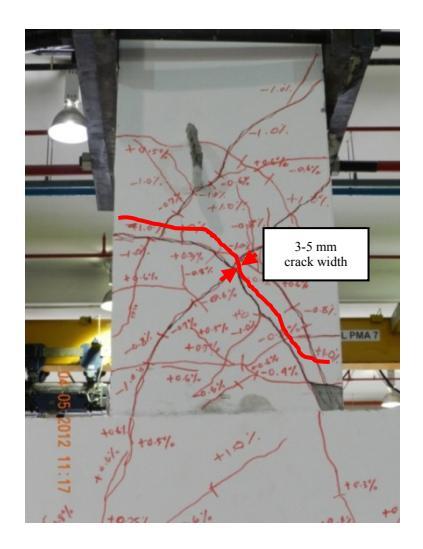
diagonal cracks were observed especially at the upper part of column near the joint. Figure 7 demonstrates that the diagonal cracks between 3mm to 5mm width when measured using Vernier Caliper. Major shear cracks were also observed at the lower part of column which located at bottom of corbel as shown in Figure 8. The damage was due to poor detailing at the beam-column joint and insufficient reinforcement bar in the column. The wide spacing of mild steel link inside the column measured as 190 mm centre-to-centre was unable to cater larger load, especially lateral loading from earthquake. Although the minimum percentage of reinforcement required by BS8110 (which is 0.4% [11]) was met, however, this joint is not designed for lateral loading.

Figure 7: Diagonal crack width measured 3–5mm.

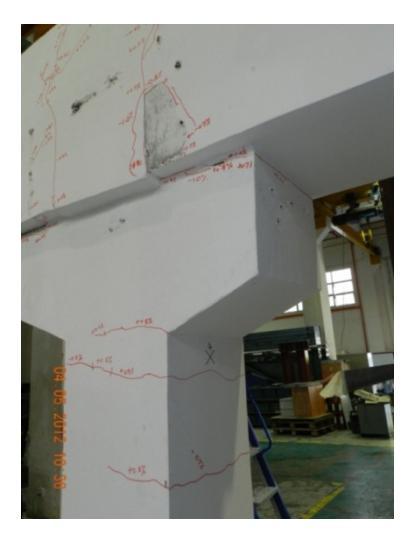
Figure 8 Cracks at bottom of column and near corbels.
