Assessment of current conditions of the Bílina River in the Czech Republic

M. Neruda¹, D. Kramer² & I. Tikhonova²

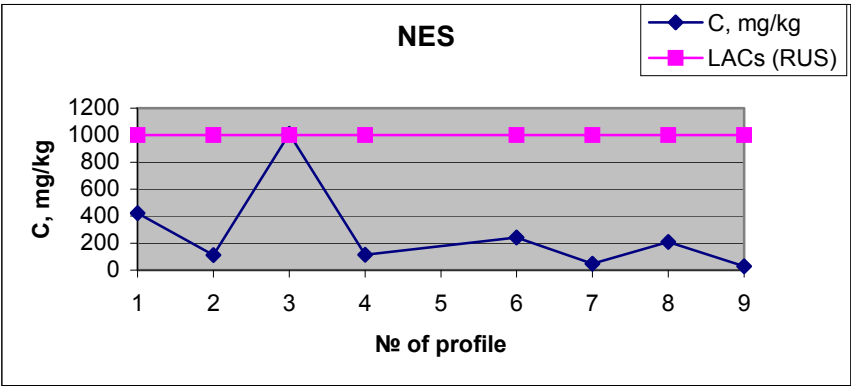
Figure 1: Changes of NES concentration in bottom sediments in the Bilina River.

As shown in table 3, concentrations of NES in water do not exceed Russian LAC_w and concentrations of NES in the bottom sediments exceed Russian LAC_s only in the third profile with concentrations in other profiles being significantly lower. High concentration of NES in the bottom sediments in third profile can be explained by the impact of the Ždírnický potok stream that flows through the urban part of Ústí nad Labem.

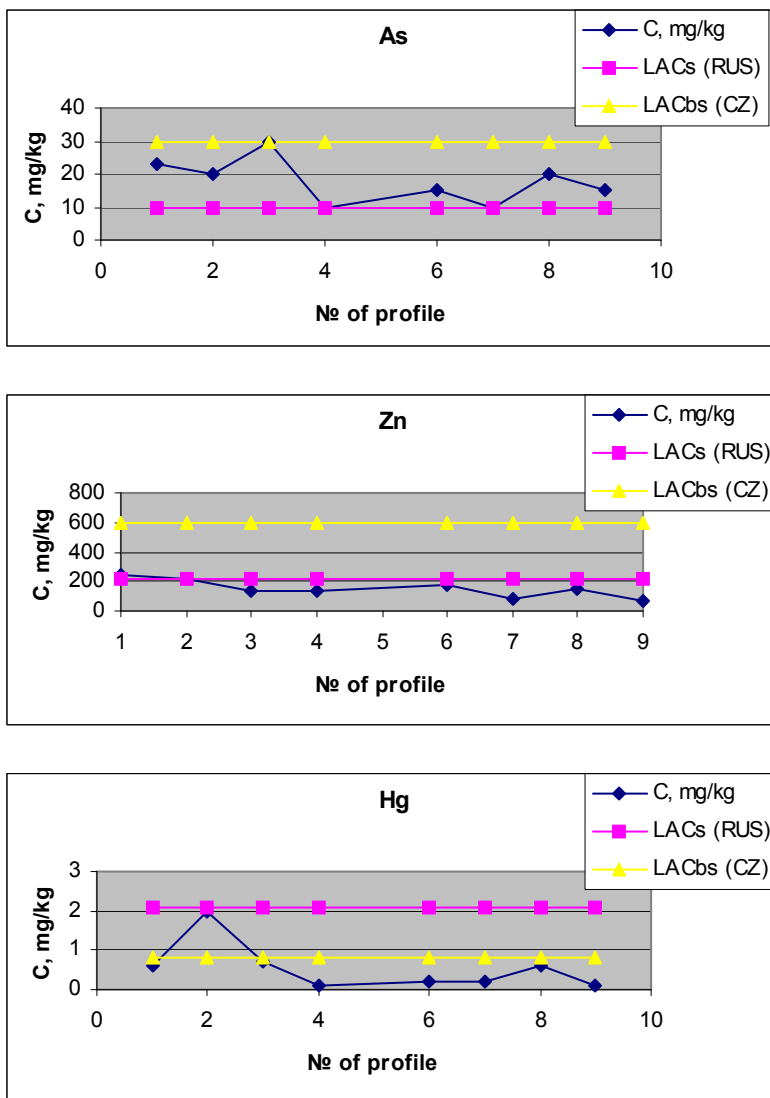
Figure 2: Changes of As, Zn and Hg concentrations in bottom sediments in the Bilina River.

From table 4 it can be seen that the Bilina River contains very slight concentrations of heavy metals in water with most of them being under the measuring limit. There is no concentration that exceeds either Russian LAC_w or Czech LAC_w . As far as bottom sediments are concerned (table 5), we also say that they are mostly clean but there are several concentrations that exceed Russian LAC_s and the concentration of Hg in profile 2 exceeds Czech LAC_{bs} . Concentration of As is higher than Russian LACs in six out of eight profiles and the possible explanation for this fact is the stability of compounds containing As. A high concentration of Hg in profile 2 could occur because of the closeness of the train station and its facilities to the profile. A slight excess of Zn concentration in profile 1 compared to Russian LAC_s can be explained by building works that occurred there at time of sampling.

According to danger indexes using Russian LAC_s (table 6) the most polluted profiles are profiles 1, 2 and 3 that can be explained by the impact of the Ždírnický potok stream in profile 3 and flowing in an industrial part of Ústí nad Labem for profiles 1 and 2. The most dangerous substances are As, Zn and V; with As being the most dangerous substance by far. The least dangerous are profile 4 and Pb as a substance. When we used Czech LAC_{bs} for calculating danger indexes (table 7) the most polluted profiles were profiles 2, 3 and 8. Lower danger index of profile 1 can be explained by the difference in legislative norms for Zn. Profile 8 is situated in an urban part of Most Town which explains the relatively high danger index. Most dangerous substances are Hg, As and V. Substitution of Zn with Hg is also explained by the difference in legislative norms for these substances. The least dangerous profile is profile 4 and the least dangerous substance is Zn.

After evaluating the results obtained we can say that Bílina River's water is clean in terms of NES and heavy metal concentration and bottom sediments are only slightly polluted with As, Zn and Hg. We consider the Bílina River as a good example of a river self-purifying and we hope that this article will also improve the river's image in the eyes of the community.
