Tests on a polyvinyl chloride pipe from an existing water distribution system

B. Kowalska¹, A. Rudawska² & D. Kowalski¹

¹Department of Water Supply and Sewage Disposal, Lublin University of Technology, Poland ²Department of Production Engineering, Lublin University of Technology, Poland

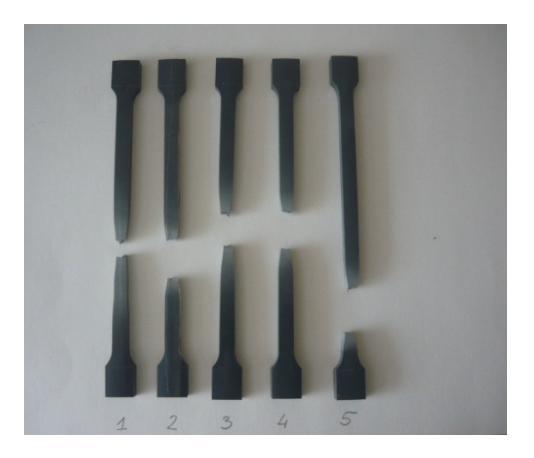
The test results presented in Table 1 indicate that basic strength parameters of the analysed PVC-U pipe were not subjected to substantial change as compared with literature or new pipe data. Polyvinyl chloride pipes tend to manifest increase in strength values when in contact with chlorinated water, as it is hardened and strengthened through the acquisition of additional chlorine atoms into the pipe material structure. Operating water distribution networks are disinfected with chlorine compounds on a regular basis, which could be the factor influencing their excellent results after 40 years of service; e.g. elongation at break values exceeded manufacturer specifications, however, were smaller than the values obtained in new pipe tensile strength tests. Available literature suggests that the range given by the manufacturer refers to unplasticised polyvinyl chloride in general, rather than a particular pipe. Decrease in elongation following years of service of PVC-U pipes is probably a result of its brittleness gradually increasing in time. In the case of Young's modulus, which describes stiffness of materials, obtained values were slightly discrepant, yet comparable to those acquired in new pipe strength tests. The differences might result from different failure points, as evidenced in Fig. 2.

Figure 2: Test samples after tensile testing to failure.

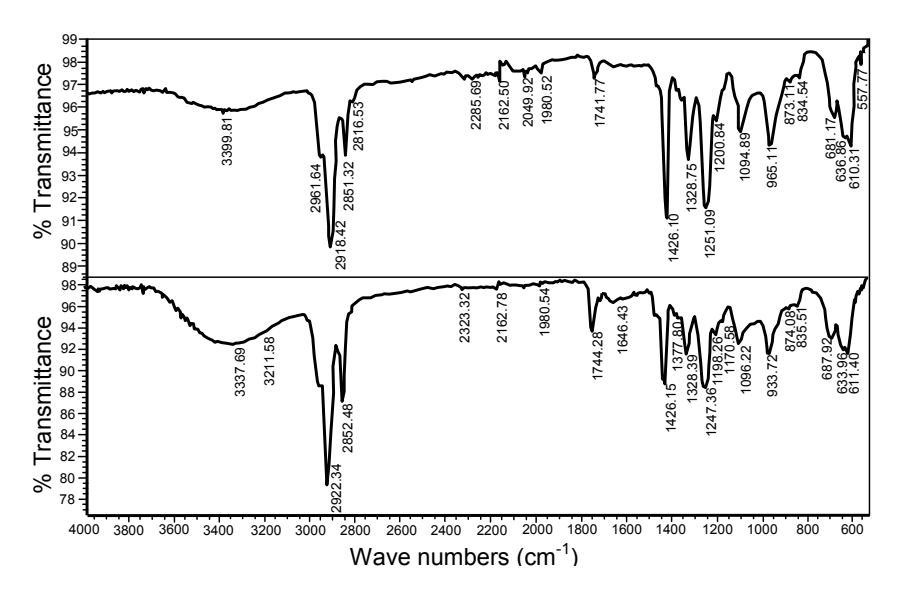
The analyses allowed us to observe differences in the spectrum between the inner and outer layer of the polymer (Fig. 3). Degradation is predominantly connected with the outer polymer layer and conformational changes in its chain structure. The peak was observed at 1750 cm⁻¹ (C=O stretching vibration) and 1640 cm⁻¹ (C=C stretching vibration). The peak presence suggests degradation of polymer and the creation of new bonds as a result of oxidation. What can also be observed is the decrease in peak intensity, which is characteristic of deformation vibrations of CH₂ groups in the wavelength of 1300–1450 cm⁻¹. Peak intensity decrease in the area of 1430 cm⁻¹ and 1330 cm⁻¹ could be indicative of polymer chain degradation (mer degradation or branching).

Figure 3: IR spectrum of PVC sample extracted from pipe. Comparison of outer (bottom spectrum) and inner (upper spectrum) layer.

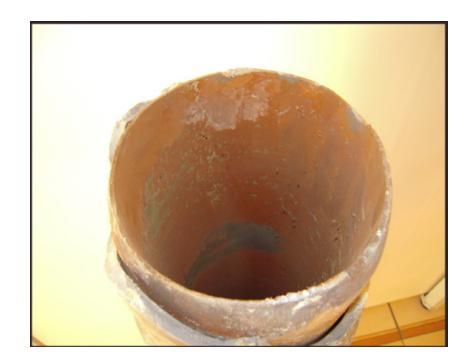
The next stage of research consisted of analysing sediment on the inside pipe wall in the aspect of structure and chemical composition. Figure 4 shows a thin layer of sediment loosely attached to the pipe material.

The form and morphology of major mineral components and chemical composition analysis of the sediment was conducted with Quanta 200 FEG Scanning Electron Microscope (SEM). Microscope analysis of the sediment evidenced that it mainly consists of calcium carbonate ($CaCO_3$) and oxides and hydroxides of iron and manganese, together with the mineral form of sodium chloride – halite (NaCl).

Figure 4: Inside wall of U-PVC pipe sample with sediment.

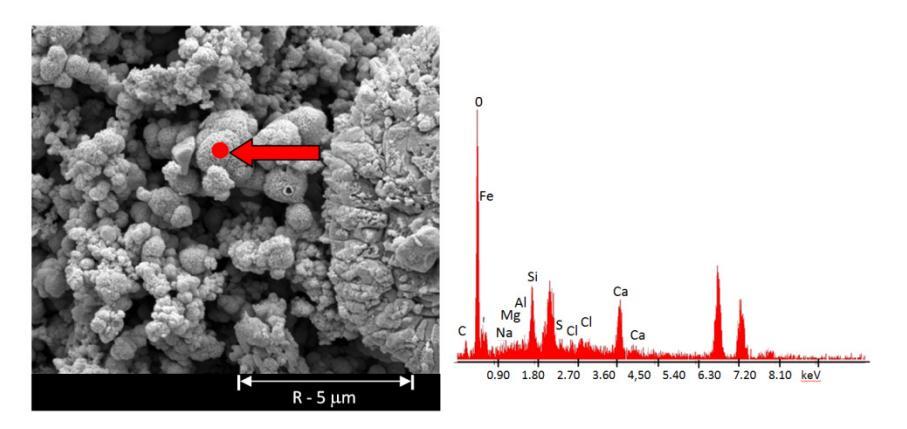
Figure 5: Sediment microstructure – CaCO₃ marked in red.

Figure 5 shows a selected fragment of sediment microstructure with its chemical composition. The visible forms are "skein-like" (the red dot) composed of $CaCO_3$, on the surface of which there are oxides of iron and quartz.
