RECORDING AND ANALYZING THE PATHOLOGY IN OTTOMAN MOSQUES

M. LOUKMA & M. STEFANIDOU

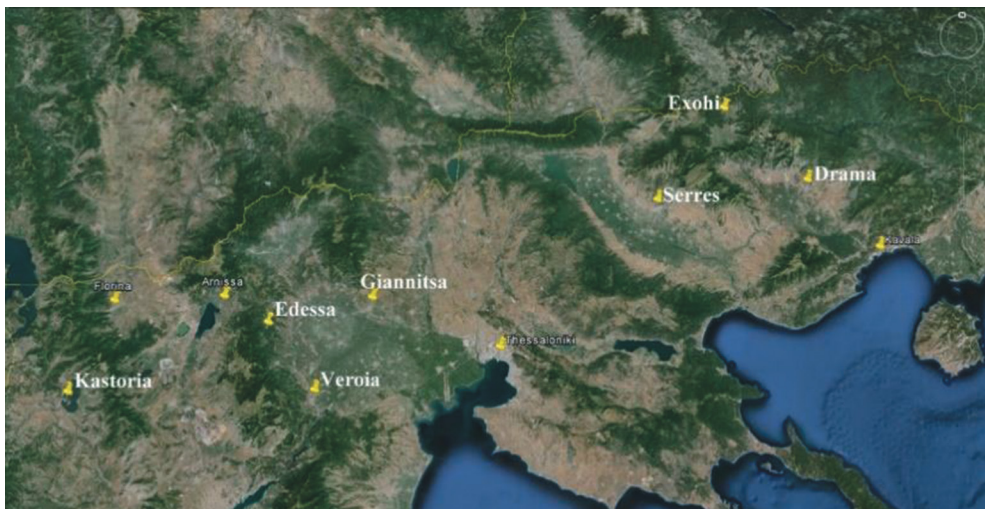
Figure 1: Map of Northern Greece with the cities where the studied Ottoman mosques are located.

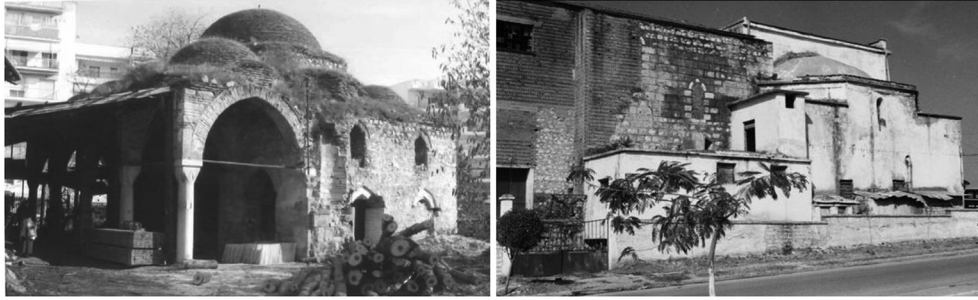
Figure 3: (a) Moustafa Bey mosque as a carpentry and (b) Iskender Bey mosque as a cotton gin.

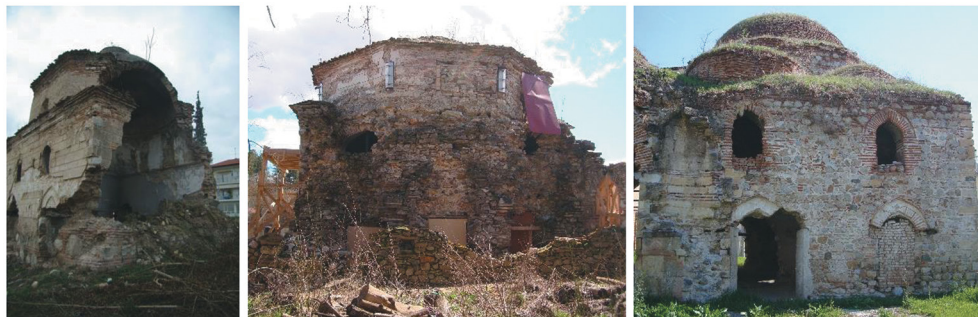
Figure 4: Present state of mosques: (a) Ahmet Bey mosque, (b) mosque in Exochi and (c) Moustafa Bey mosque.

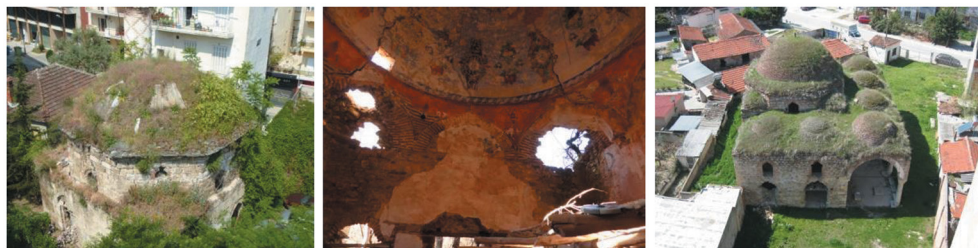
Figure 5: (a) View of the Orta mosque, (b) part of the dome inside the mosque at Exochi and (c) view of Moustafa mosque.

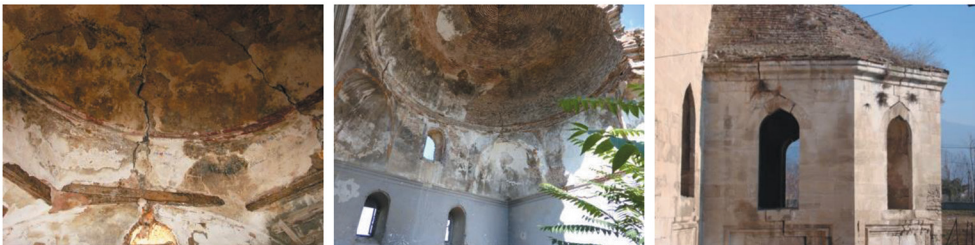
Figure 7: Cracking in the three monuments: (a) Orta mosque, (b) Ahmet Bey mosque and (c) Mehmet Bey mosque.

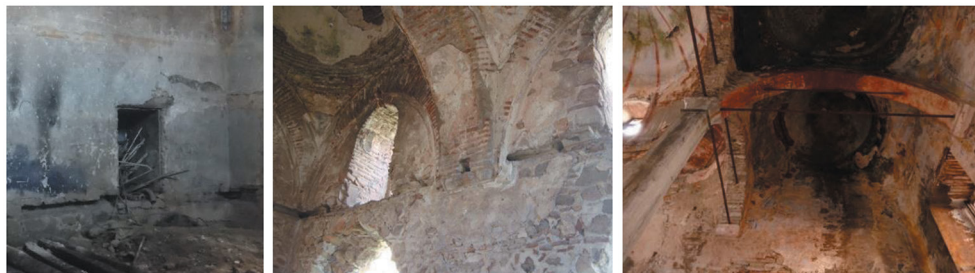
Figure 8: Loss of wooden tie-beam from (a) Coursoum mosque, (b) Moustafa Bey mosque and presence of metal tie-beam from (c) Arap mosque.

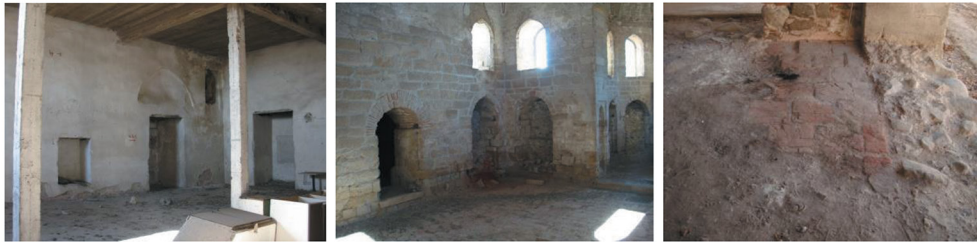
Figure 10: (a) Presence of concrete on the floor of Iskender Bey mosque, (b) the preserved floor of ceramic tiles at Mehmet Bey mosque and (c) part of preserved floor at Moustafa Bey mosque.

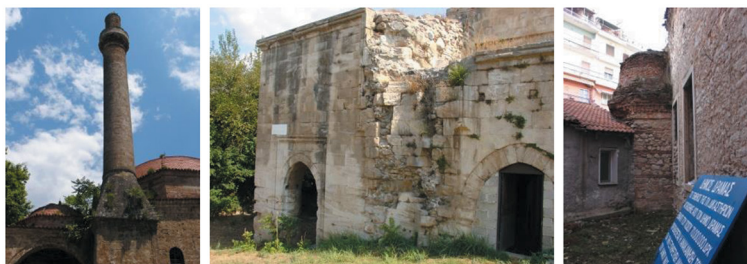
Figure 11: (a) View of the minaret of Geni mosque, (b) the demolished minaret of Mehmet Bey mosque and (c) part of the preserved minaret of Arap mosque.

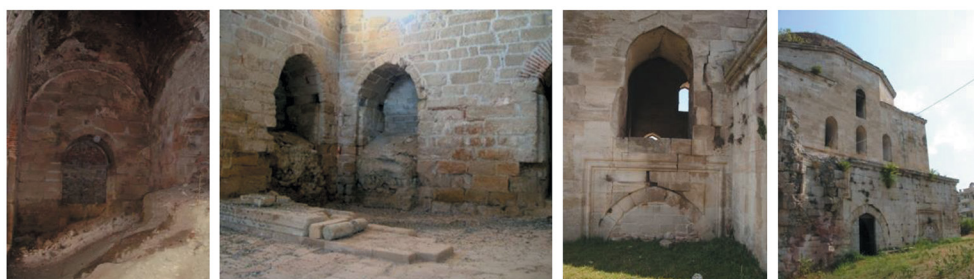
Figure 12: Views of Mehmet Bey mosque where the interior and exterior space is full of debris.

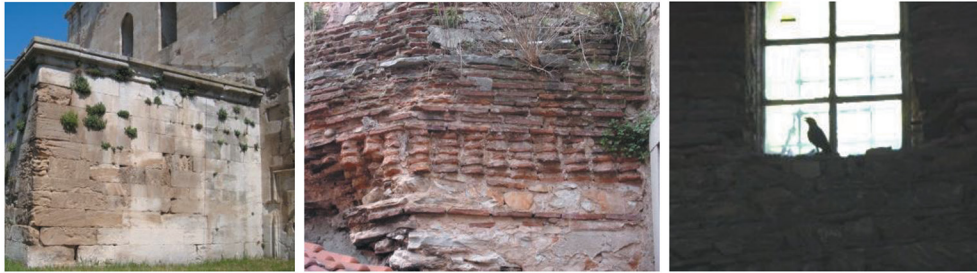
Figure 13: (a) Masonry of Mehmet Bey mosque, (b) brick wall of the minaret of Arap mosque and (c) the presence of birds.
