SEISMIC PERFORMANCE OF TRADITIONAL URBAN ARCHITECTURE IN MOROCCO

K. EL HARROUNI¹, H. KHARMICH¹ & A. LAMZAH²

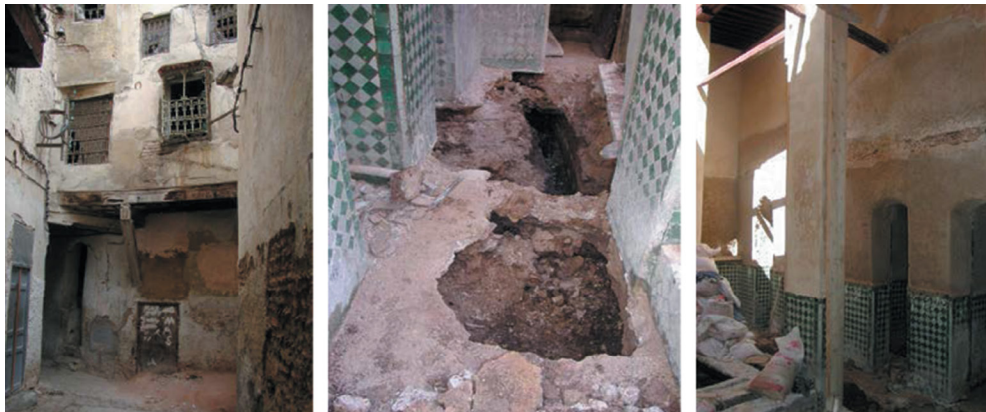
Figure 7: Degraded historic built environment: degradation of facades, walls and foundations (Hassouni [2]).

The major problems of traditional constructions (Fig. 7) are mainly due to the following factors:

- Overloading, overutilization and overdensification of the buildings
- Ground subsidence
- Aging of materials
- Deterioration and filling of the traditional evacuation pipes and overflow of used water
- Capillary increase of moisture in the walls
- Water sealing problems
- The collapse of a number of houses leading to many empty spaces which weaken the neighbouring buildings and make them more vulnerable to earthquakes and other hazards.

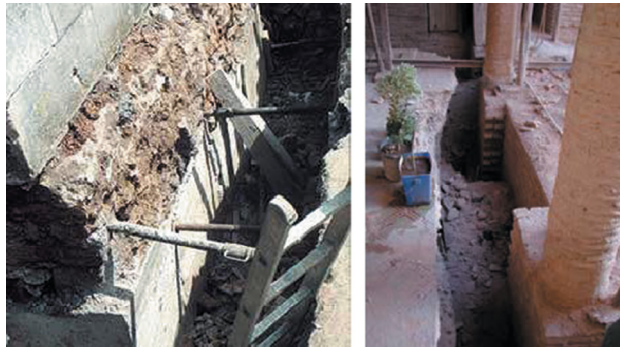
Figure 8: Underpinning work by rebuilding the foundation step by step or by using micropiles to strengthen the foundation with pressure cement grouting (Hassouni [2]).

Due to the large number of damaged buildings in some medinas (Fez, for example, Fig. 8–11), propping is adopted as a provisional solution to avoid the risk of collapse and to allow the sustenance of the walls and the floor and thus the recovery below the foundations, the repair of masonry, the replacement and the repair of the floors, etc. The following main steps are usually used in retrofitting of damaged buildings:

- Visual inspection and follow-up of the phenomenon
- Propping
- Foundation consolidation
- Repair of the walls and stitching
- Consolidation of the floors
- Repair of the ceilings

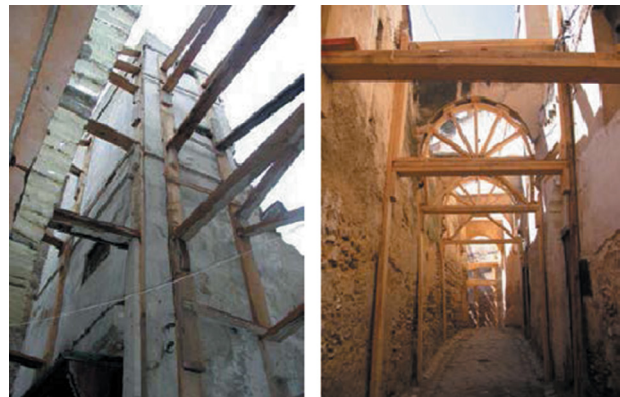
Figure 9: Example of propping of damaged buildings in Fez.

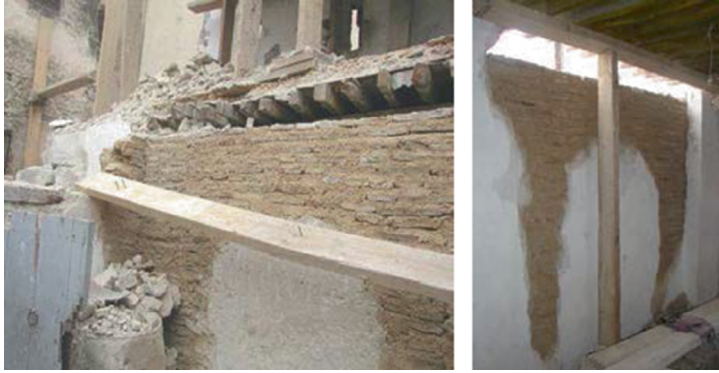
Figure 10: Repair of masonries, ‘restitching’ of fissures and re-establishing of the junction between the walls and the floors (Hassouni [2]).

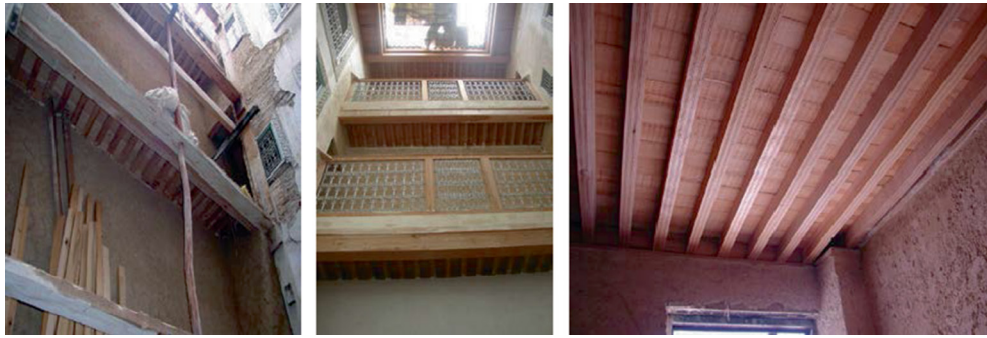
Figure 11: Reconstitution of the destroyed parts of the courtyard (Hassouni [2]).

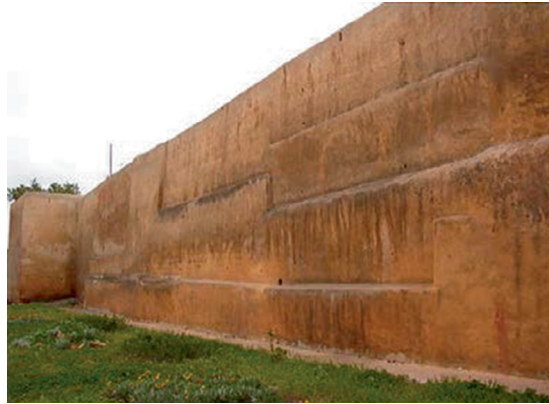
Figure 14: Example of anomalies – Sale medina rampart.

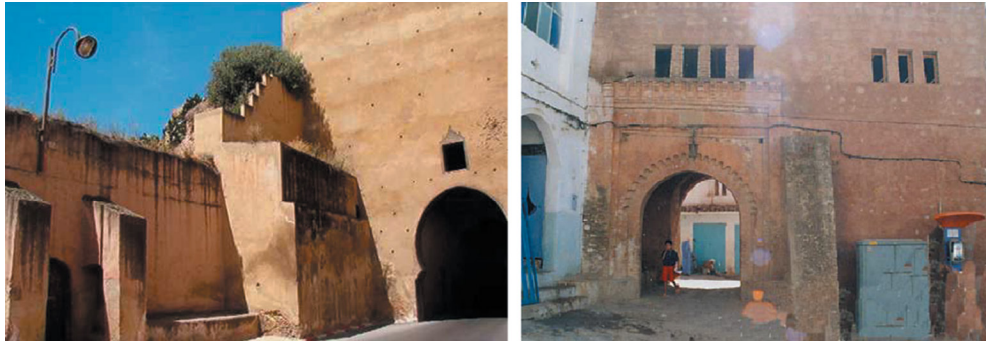
Figure 15: Use of buttress in Meknes medina rampart and Chefchaouen medina.

When a frontage wall or a great wall presents a cant, the response of the community to this problem is almost always the same: the use of a buttress (Fig. 15), a mass of masonry built against a wall to strengthen it. This system is a consolidating element to the existing structure and it is generally added to an older masonry building. Sometimes, the buttress is carried out during construction, a voluntary and premeditated act to reinforce this construction, generally at the corners of the structure. In earthquake-prone areas, the buttress frequently accompanies the stone frame and becomes an essential element to achieve building stability. Sometimes, the buttresses were used as both utilitarian and decorative forms. They can also be used as staircases, ensuring access to the dwelling, built to play the role of *confortement*, a judicious way to associate reinforcement technique with comfort.

The unreinforced masonry structures have very low stress levels and their stability, not strength, governs the safety; but the geometry changes may threaten the stability of the structure. For high-vaulted buildings, the arch will collapse and the buttress will remain standing in most cases. A masonry buttress will fracture at collapse, reducing its load capacity.

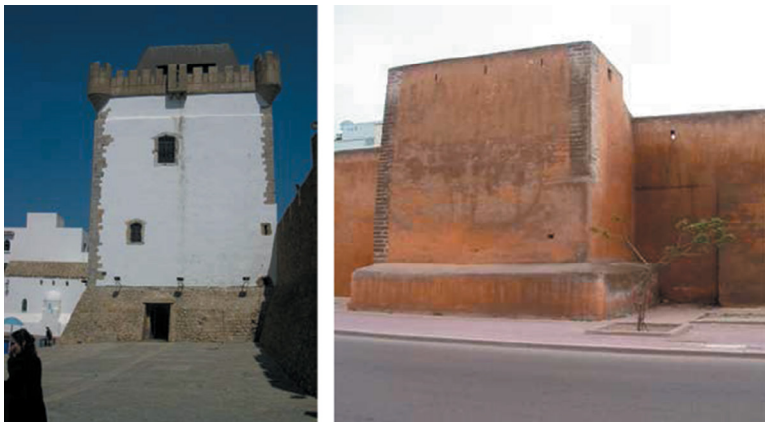
Figure 16: Al Kamra Tower in Asilah medina and Rampart in Sale medina.

The basement should be high to ensure a stable base on which a building is raised, a historic monument for example (Fig. 16). The vertical reinforcing chain made of cut stone is another means of reinforcement and consolidation of the building corners, which is generally used in colonial architecture and fortified architecture. These techniques, when used with a material other than the original masonry of the traditional building, decrease the seismic performance of the building. It also causes an aesthetic damage to the building because the new material stays visible and visually reduces the appearance of the building.

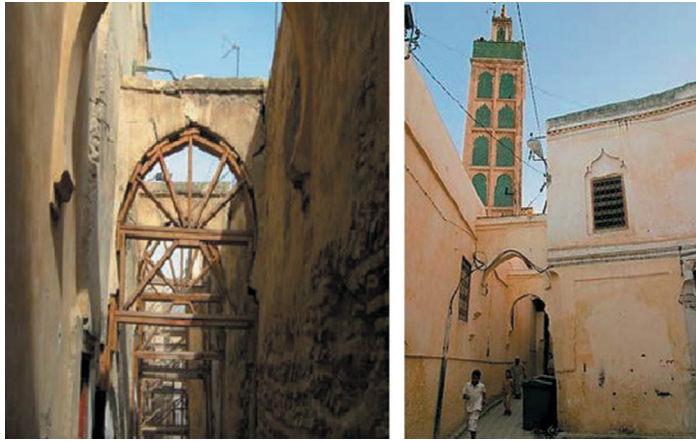
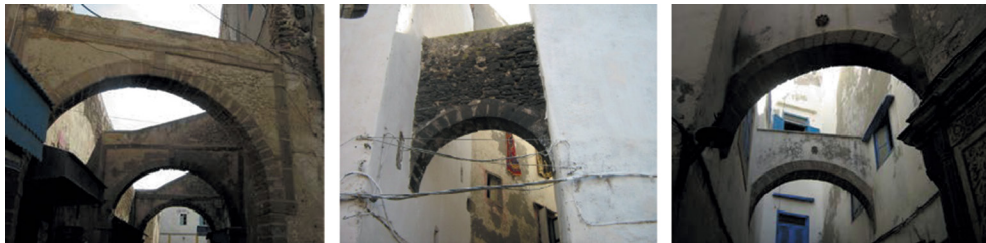
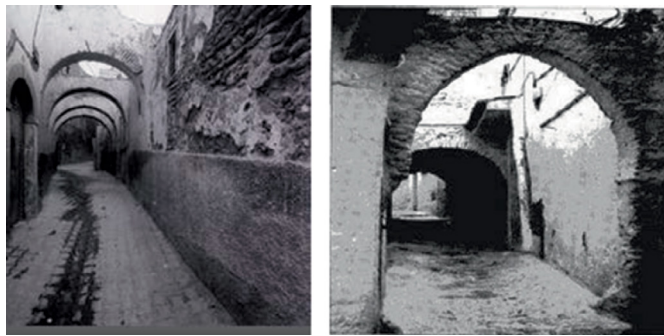
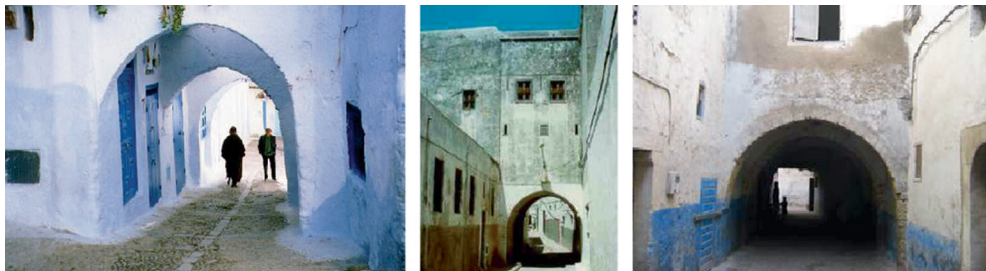
Figure 17: Contrasting arches in (a) Fez and Meknes medinas, (b) Essaouira medina and (c) Chefchaouen medina and Azzemour medina. (d) *Sabats* in Chefchaouen, Rabat and Essaouira medinas.

The urban structure of the medina is badly affected by the constraints of the site and is organized in an irregular network of narrow streets which are rarely rectilinear; these streets surround the blocks and separate them from each other, allowing them a dynamic behaviour during the earthquakes. These separating spaces play the role of an empty joint of separation. This urban morphology and building construction with narrow streets are probably a solution to reduce seismic damage and prevent the houses from collapsing.

The houses are semi-detached, overlapping and leaning against each other, thus forming a compact unit. Some streets are covered by galleries on top of which the houses extend, thus creating roofed passageways called the *sabats*. This extension is done on the top of the public space of the street, covering it forming a passageway, and constituting a physical link between the houses. (Abdessemed-Foufa [14]). These elements are realized either in vaults built out of stones or bricks with wooden incorporated logs. They constitute reinforcing elements by bracing the blocks and houses between each other. The houses form then a compact monolithic entity with a higher seismic resistance. Those are elements of reinforcement which determine the bracing of the blocks between themselves.

In addition, the urban framework of the medina is characterized by a certain number of arches built of stone or bricks, called *confortement* arches or contrasting arches whose relative flexibility and elasticity allow the transmission of the horizontal stresses to the ground. The buildings are not considered any more as isolated elements but as a compact dynamic block. This bracing is always present in the narrow streets of the medina and prevents the construction from collapsing (Fig. 17).

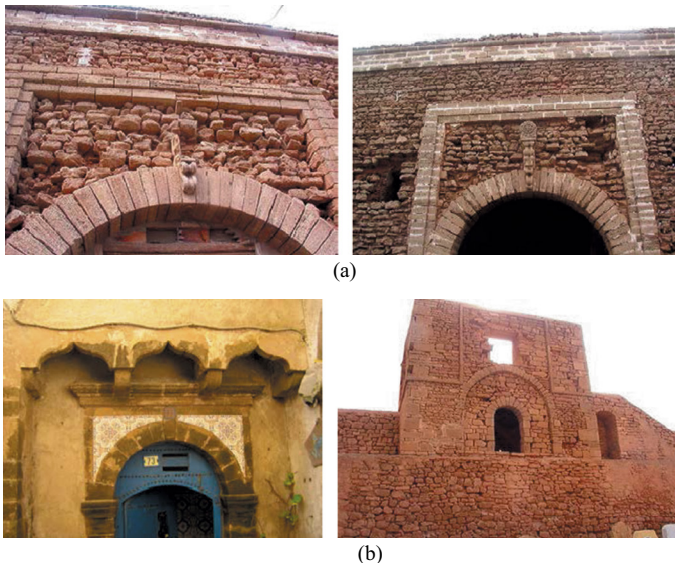
Figure 18: (a) Discharging arch and framed openings in Rabat *extra-muros*. (b) Framed openings in Essaouira medina and Sale medina.

A discharging arch or relieving arch is an arch over a door, window or other opening, designed to distribute the pressure of the wall above. An opening in a frontage constitutes a vulnerable point in the event of deformation of the frame. The cracks on the front walls are found in the contours of the openings where the stresses are most significant and in particular close to the re-entrant angles. The earthquake-resistant design codes recommend, for masonry structures, rigid reinforced concrete and steel or wood framings for the openings, which, in principle, must be connected to the links of the walls. The wooden framings must be effectively connected to the masonry. The openings in the medina, doors and windows are framed by wood and well connected to masonry. Cut stone arcs are also located at the top of these openings (Fig. 18).

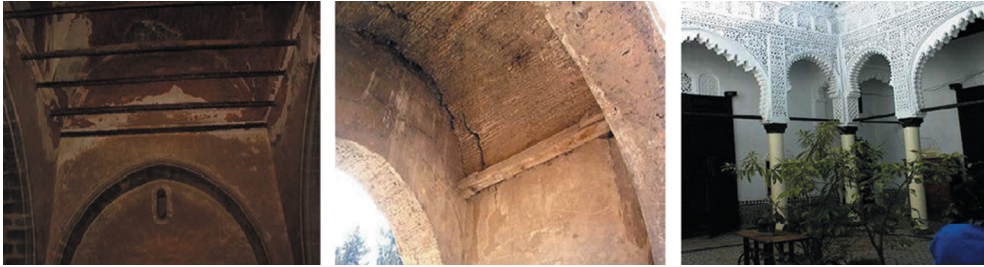
Figure 19: Use of bracing and wooden tie in Rabat, Meknes and Sale medinas.

As mentioned earlier, bracing is one of the most significant aspects of earthquake-resistant design. The monolithic design in traditional architecture is a basic principle. According to this principle the various parts of a structure stay connected (Fig. 19), which prevents the dissociation of their elements under earthquake loads. This structural technique is realized mainly by the bracing arc, which binds two different masonry entities and links them to each other. They are consolidated by a wooden beam system which connects the frontages of the galleries to those of the load-bearing walls to ensure the stability of the walls with those of the interior and avoid their opening and collapse. Their distribution is rather regular and is particularly observed in the traditional courtyard houses.
