KNOWING TO PRESERVE: THE BUILDING COGNITION PROCESS FOR THE CONSERVATION OF ST' ANNE CHARTERHOUSE, COVENTRY – UK

RAFAELA SIMONATO CITRON

Department of Architecture and Urbanism, IMED, Brazil

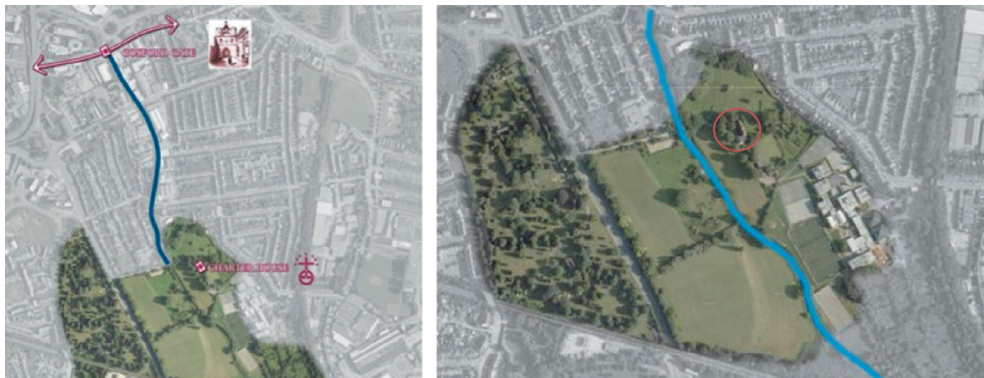
Figure 1: Location of The Charterhouse.

The Priory of St Anne, or The Charterhouse, is located in Coventry, England. Coventry is a metropolitan city in the province of West Midlands in England and is located 153 km north west of central London and 31 km east–south of Birmingham. Coventry was one of the most important cities in England during the Middle Ages thanks to its textile production booming. The Charterhouse is located next to the river Sherbourne, a few minutes' walk, along London Road, of the ancient walls of the medieval city (Fig. 1).

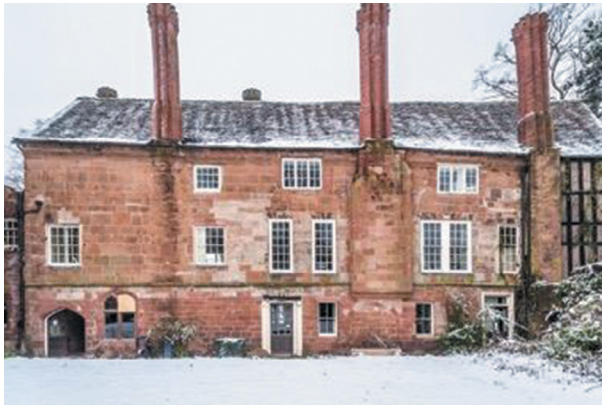
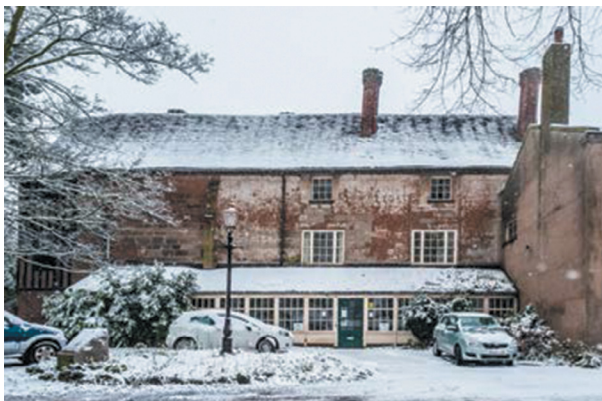
The remaining building is believed to be the Prior's accommodation, built in sandstone from the 15th century. A short extension on the left, which was added in the 16th century when the property became a private home, after the dissolution of the monasteries, is built with stone walls on the ground floor and timber framed above (Figs. 2 and 3).

Figure 2: The Charterhouse, east façade.

Figure 3: The Charterhouse, west façade.

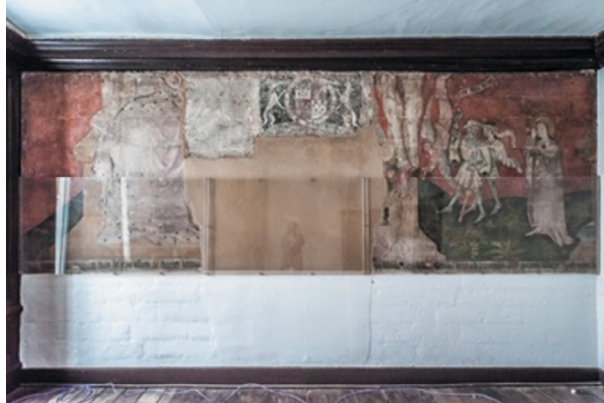
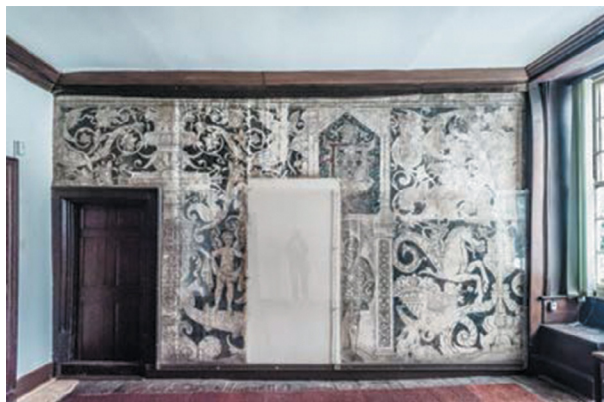
Some original features can be found in the building, including a stone fireplace, some original stone shelves and carved wooden beams. There is also ancient oak panelling, possibly from the 17th century, and doors and sash windows from the 18th century. Perhaps the most notable features are medieval wall paintings from the 16th and 17th centuries, depicting the crucifixion and important elements of the English Renaissance (Figs. 4 and 5).

Figure 4: The medieval painting.

Figure 5: The English Renaissance painting.

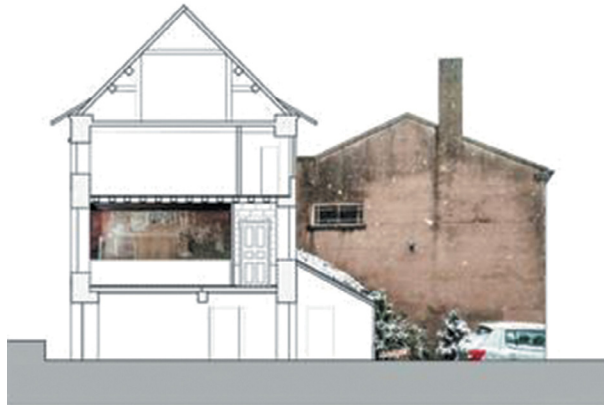
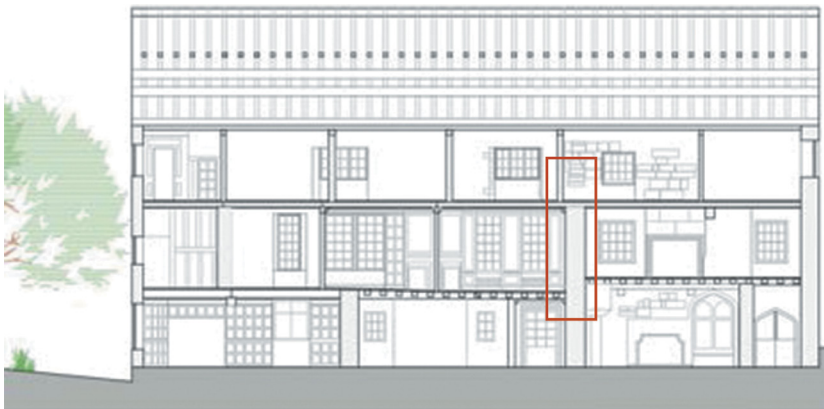
The information that we had prior to the survey was that the medieval painting of the crucifixion had been divided into two by the insertion of the second floor in the 16th century and the top part of the painting had been removed or covered, although no traces of the painting in the second floor have ever been found. The survey showed that it would never have been possible to find the top of the painting because the ancient masonry was destroyed and a new wall was built almost in the same place, which has caused the confusion (Figs. 6 and 7).

Figure 6: Section showing painting in the first floor.

Figure 7: Section showing that top part was demolished.

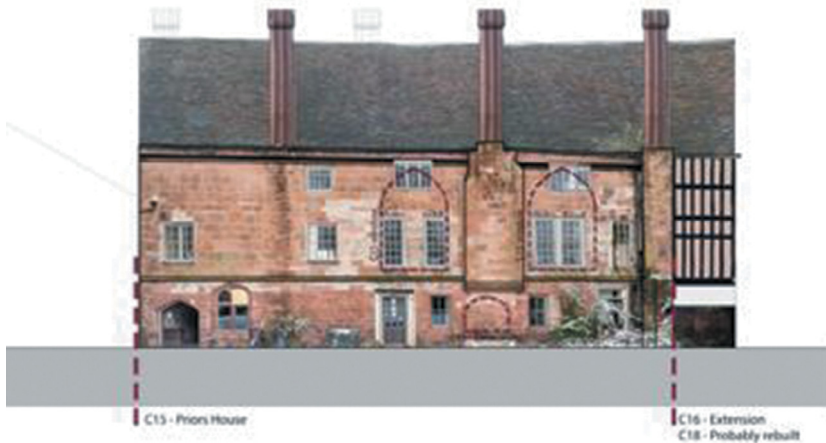
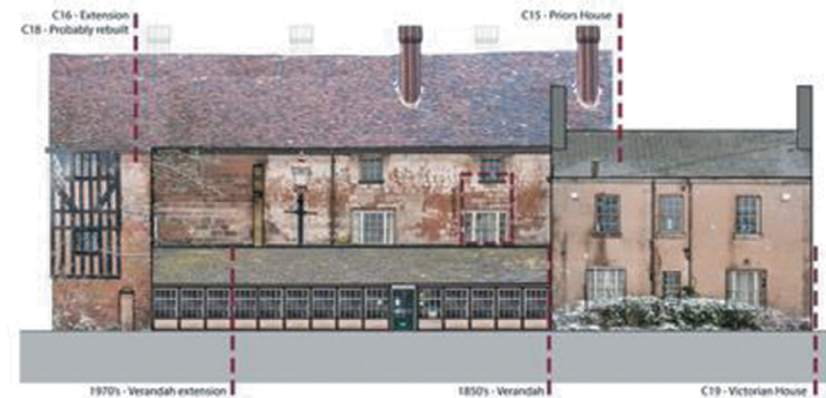
For the survey of the elevations, the use of photographs was crucial and gave the supporting documentation for the stratigraphic analysis, which will be shown next. Due to the difficulty of direct measurement, the elevations were produced with the photographic images, using the

Figure 8: Photo elevation and analysis of East elevation.

Figure 9: Photo elevation and analysis of West elevation.

image rectification method, a technique that allows you to reduce the geometric distortions to get correct dimensional information (Figs. 8 and 9).

With the architectural survey, it has been possible to recognize some of the changes that the building has gone through. Besides the demolition of an important wall painting, as mentioned previously, it became clear, while drawing the elevations, that two big medieval windows on the east façade have been closed off, probably after the dissolution, when the building became a private house.

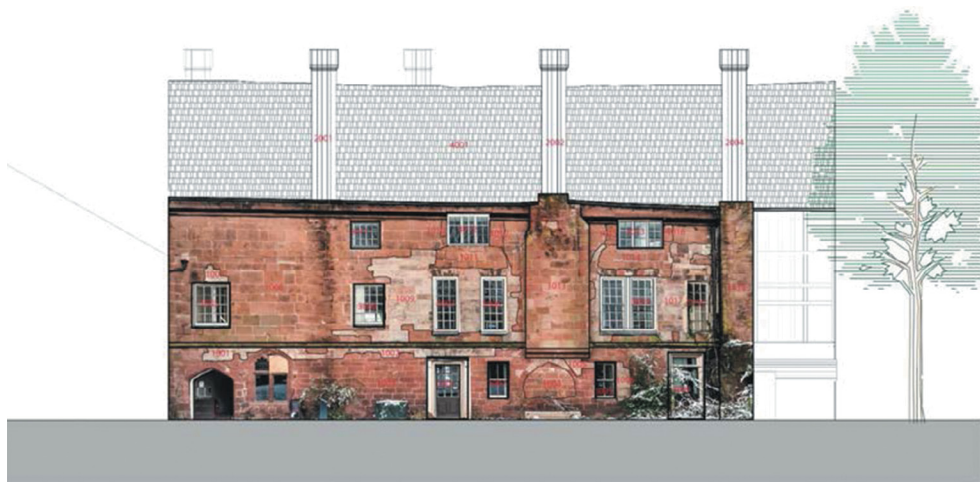
To recognize the different SUs, it has been taken in consideration the type of materials used in the facades. Three different types of stone have been identified, one grey and two red, one more regular than the other, and these three types of masonry were encountered all over the observed façade (east). Doors and windows have also been identified, along with the roof and architectural elements, such as the chimneys. The SUs recognized on site were then marked and numbers in the photo elevation. The masonry SUs are numbered from 1001 to 1018, the architectural elements from 2001 to 2004 and the openings from 3001 to 3013 (Fig. 10).

Figure 10: Stratigraphic analysis.

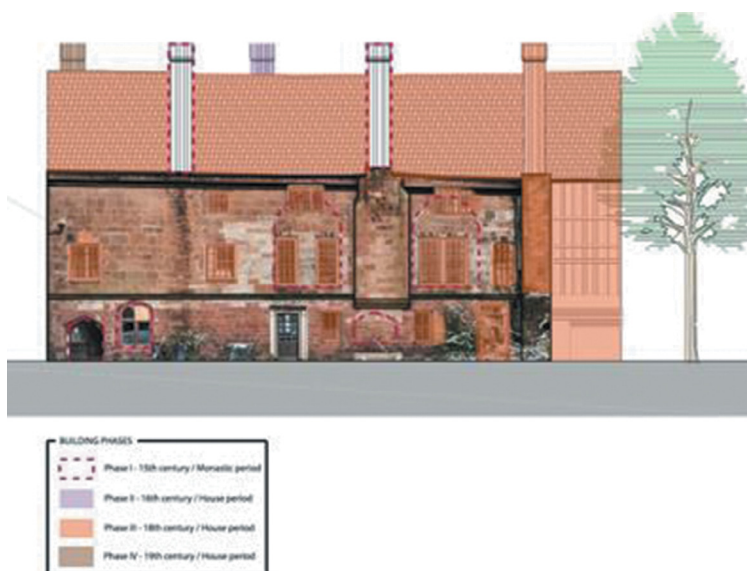
Figure 12: Chronology, east elevation.

Figure 13: Chronology, ground floor.

With all units arranged, a chronological sequence has been assigned and the units have become the evolutionary stages of the building modifications. Each of these stages, and supported by an adequate investigation of indirect sources, refers to a specific historical period (Figs. 12 and 13).

- Phase I – 15th century, monastic period
- Phase II – 16th century, house period
- Phase III – 18th century, house period
- Phase IV – 19th century, house period
- Phase V – 20th century, house period.

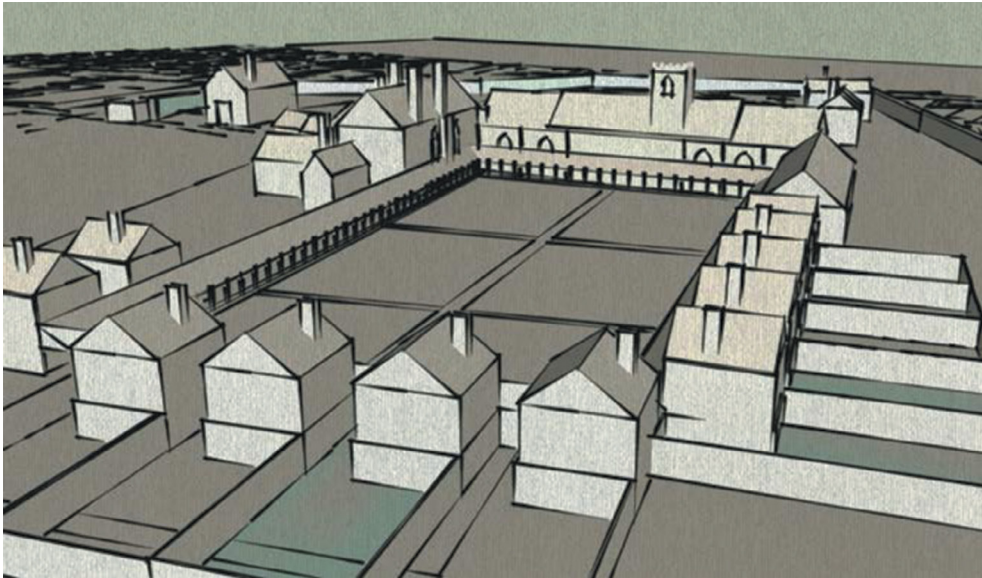
To help tell this story, the medieval monastery was reconstructed in a three-dimensional model, based on the research (Fig. 14). From the archaeological excavations, we knew with certainty the location of the church and the monks' cells and these, together with the standing building, were the starting point for the three-dimensional model. Although only five cells have been excavated, it is known from historical research (the research on indirect sources, which have not been covered in this article) that there were in total eleven, six to the east of the cloister, four to the south and two to the west of the cloister.

Figure 14: Three-dimensional reconstruction of The Charterhouse.

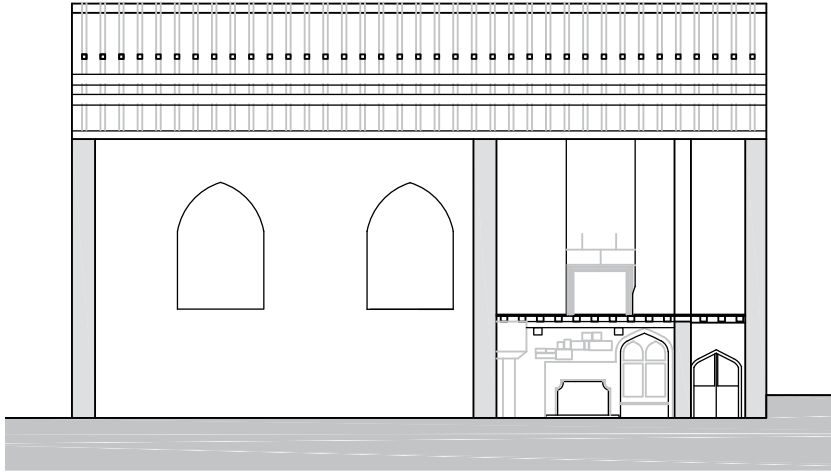
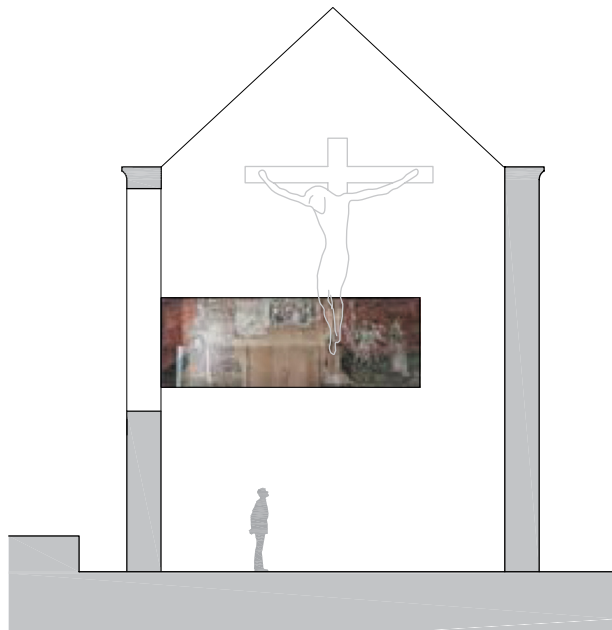
The north side of the building has always been thought of as the refectory on the ground floor due to the presence of lavatory in the east facade, where monks used to wash their hands before eating and entering the church, and the guest house on the first floor. However, the medieval painting of the crucifixion, today on the first floor, would most certainly be in the refectory, rather than in the guest house, as most Carthusian Monasteries had a crucifixion painting in the refectory. Besides, there are no traces of a staircase connecting the ground floor to the first, the only staircase is the one in the Prior's house, which had no internal connection with the refectory (there is currently a connection through an opening that cuts the

Figure 15: Assumed original longitudinal section.

Figure 16: Assumed original transversal section.

medieval painting and certainly this was not the case in the monastic period). This leads to a conclusion that there was actually no first floor and the refectory used to be a double-height room. Other evidence for this conclusion is that the paintings in the refectory were usually located at a height of 2–3 meters from the floor, for reasons of scale (to make it possible to be seen from the ideal angle) and also to re-table the god's importance (in the case of the crucifixion). Today, this is at only 1 meter from the floor where it is located (the first floor) (Figs. 15 and 16).

The refectory contained two openings on the east side and no windows on the west side, perhaps for the rule of not visual contact with the outside courtyard. The building is accessed from the east side through an opening to the north of the lavatory and the opening in the west would probably link the refectory to the kitchen.
