# NON-DESTRUCTIVE TESTING OF THE HISTORIC TIMBER ROOF STRUCTURES OF THE NATIONAL MUSEUM IN STOCKHOLM, SWEDEN

The National Museum in Stockholm is Sweden's leading museum of art and design. Behind the now closed doors of the National Museum and its construction coverings a renovation project is taking place, which began in 2014 and will be completed in 2018. The renovation project will create a modern museum, a brighter atmosphere for the arts and for its visitors. Part of the renovation project was to design and upgrade the timber roof structure for new loads according to Eurocode 5. As the roof structure was originally built in 1860, it was important to evaluate the condition and mechanical properties of the original load-bearing timber members. The roof structure, which is of main interest, comprises roof trusses and lantern structures.

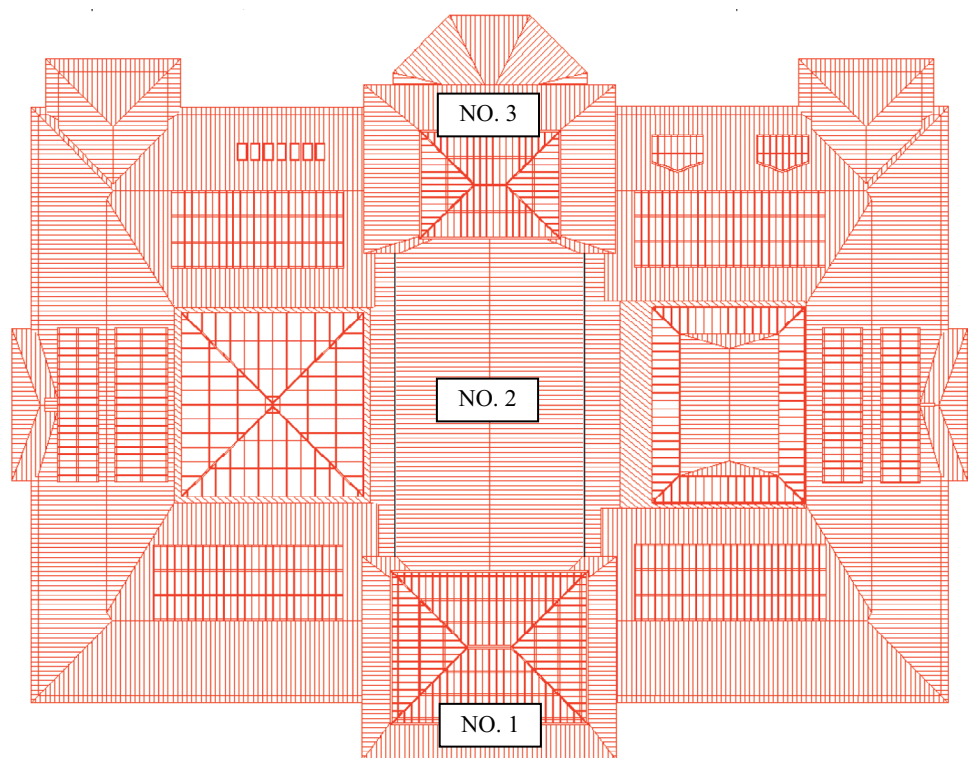
Figure 2: The overview of the National Museum roof structures.

For the structural assessment calculations of two lanterns roof structures a numerical 3D model was prepared based on a 3D-CAD model (Figs 1 and 2). The roof structure no. 1 is presented in Fig. 3, while the roof structure no. 3 is presented in Fig. 5. A 2D numerical

model for roof structure no. 2 was prepared based on 3D-CAD model (Figs 1, 2 and 4). In this chapter only these three types of roof structures are presented as the non-destructive testing of structural timber was performed only for those historical roof structures. Other roof structures (Figs 1 and 2) were strengthened and rebuilt without any further non-destructive testing of structural timber.

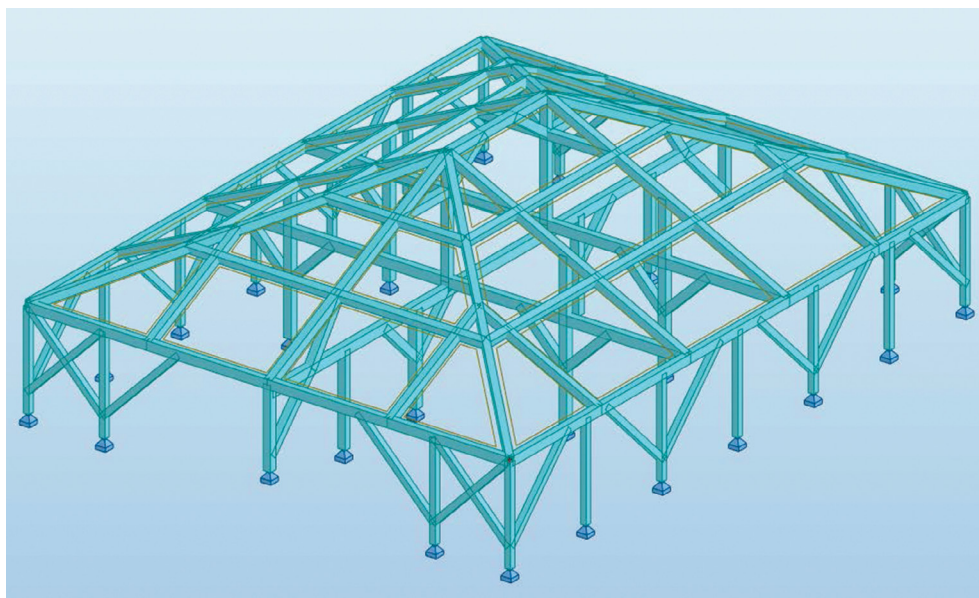
For the structural assessment calculations, the geometrical survey data were used to prepare numerical 2D and 3D models. Figures 9 and 10 present the 3D numerical model of roof structure type 1. The structural 3D modelling process did not focus on details (carpentry joints and connections) modelling. The structural analysis of roof types 1–3, with timber strength class assigned to C30, showed satisfactory results both in ULS and SLS designs. Only in roof type 1 four rafters and purlins were removed and exchanged with new glulam beams due to architectural design of new glass roof structure. Purlins in roof type 3 were also removed and exchanged with new glulam beams due to the same architectural design of glass roof structure. Roof structure type 2 was neither strengthened nor rebuilt from original design.

Figure 9: 3D numerical model

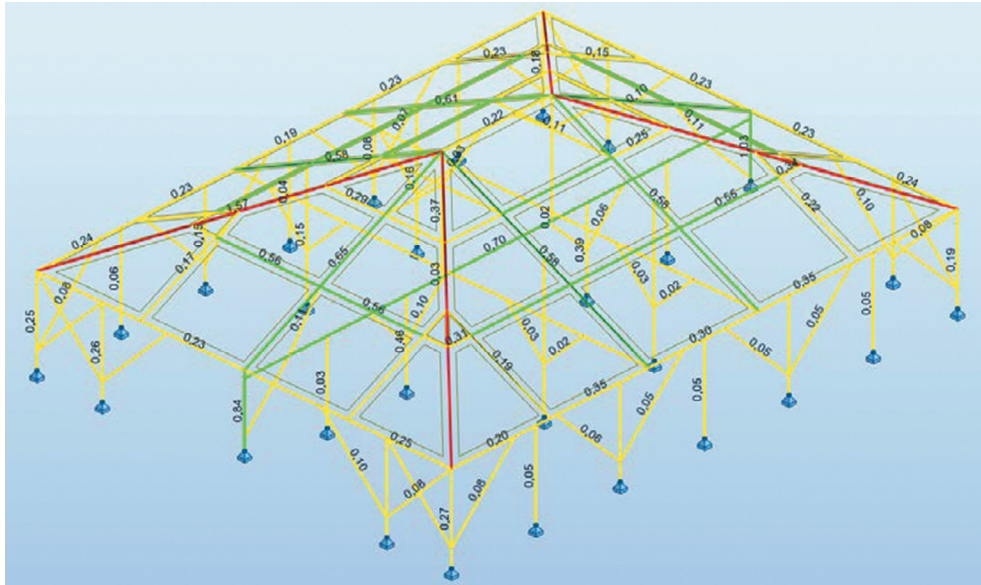
Figure 10: Results – utilization ration for roof structure type 1 – timber strength class C30.
