MANAGEMENT AND ASSESSMENT OF HERITAGE BUILDINGS IN THE CITY OF HAVANA THROUGH THE PRIORITIZATION OF EMERGENCY ACTIONS

Declared a World Heritage Site by UNESCO, in 1982, the Historical Center of Havana, occupying an area of 2.14 km², has 3,510 buildings, many of which now severely dilapidated. In fact, the Historical Center is in need of preferential action, due to the severity of the deterioration of its buildings. The situation is continually worsened following each hurricane season, and their accompanying tropical storms that have caused irreparable damage to buildings over the years. After a careful inspection of the heritage buildings of the Historical Center, it was possible to identify those in danger of imminent collapse and those with a useful life that could be prolonged through the implementation of the necessary emergency actions. In response to both challenges, a multi-criterion instrument based on the MIVES system was applied, with the purpose of prioritizing in an objective and justifiable way the necessary repairs and degrees of intervention. This instrument is based on requirements, criteria and indicators, all of which are selected, analysed and approved by a spec

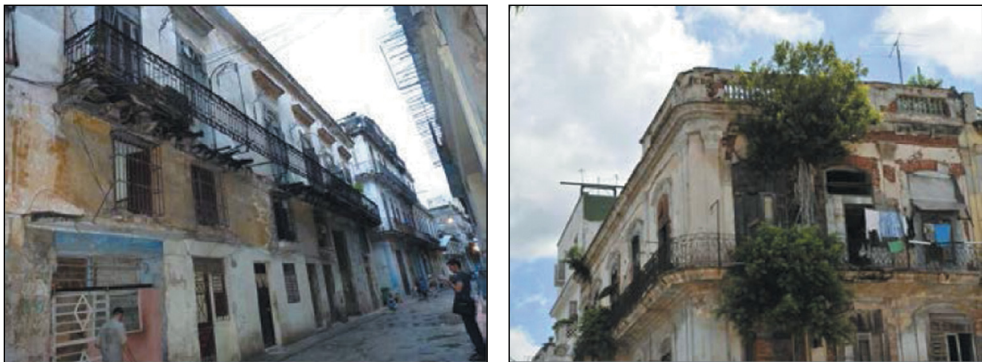
Figure 1: Dilapidated buildings in the Historical Center of Havana.

The built environment of the Historical Center is characterized, to a large extent, by poor housing conditions, a quantitative and qualitative deficit of services, overcrowding and the subsequent deterioration of buildings destined for residential use (Fig. 1). The structural condition and façades of the buildings present alarming warning signs: 44% have structural pathologies in the roof, 42% show cracks or collapses in walls and façades, 24% show signs of structural collapses or failure of supporting members, 51% have water leaks through the roof or flooring and 38% leaks in walls; etc. [1].

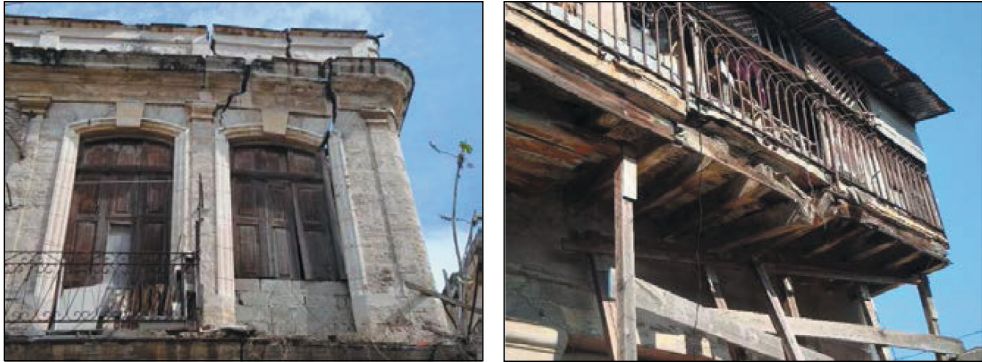
Figure 2: Need for emergency actions. A collapsing lintel (left) and balcony (right).

In all, 1,033 buildings were identified in the Historical Centre of Havana (out of the existing 3,510) in need of one or more emergency actions (representing 30% of the total) (Fig. 2). There were around 500 buildings (approximately 3,750 dwellings) in such a bad condition that it was not feasible to apply emergency actions, due to the degree of their deterioration, and around 200 buildings (1,300 houses approximately) that were in very poor condition. It was also found that around 1,700 buildings (approximately 14,350 dwellings) were in danger of some type of imminent collapse, placing the safety of their residents at risk, and/or with serious cracks that were deteriorating or could deteriorate their structures [3].
