APPLICATION OF THE HOLE-DRILLING METHOD FOR MEASURING STRESS IN TIMBER STRUCTURAL ELEMENTS SUBJECTED TO COMPRESSION PERPENDICULAR TO THE FIBRES

M. CRESPO DE ANTONIO, D. LUENGAS-CARREÑO & S. SÁNCHEZ-BEITIA

Higher Technical School of Architecture, University of the Basque Country (UPV/EHU), Spain.

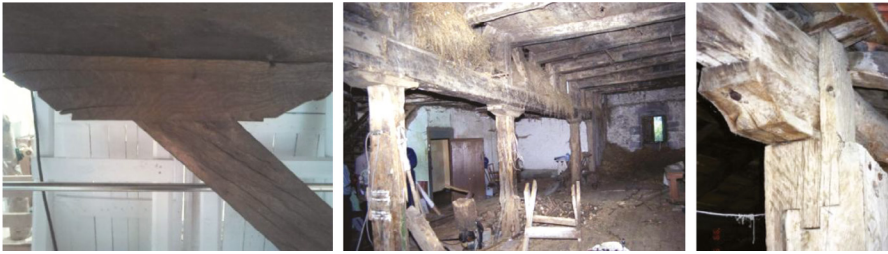
Figure 2: Examples of different ‘zapatas’ in existent structures of historical buildings in the Basque Country.

This work analyses the compression perpendicular to the grain, simulating the behaviour of ‘zapata’ structural elements (Fig. 2). In the Basque Country, as in other places, it is usual

to find this element in many ancient buildings, where it is used for distributing loads from a beam to a pier or other element. In this paper, we discuss the hole-drilling technique which is used to measure stress in those specific structural elements that are subjected to high stress and large deformation. These tests could serve to validate the hole-drilling technique on the in situ assessment of structural timber elements.

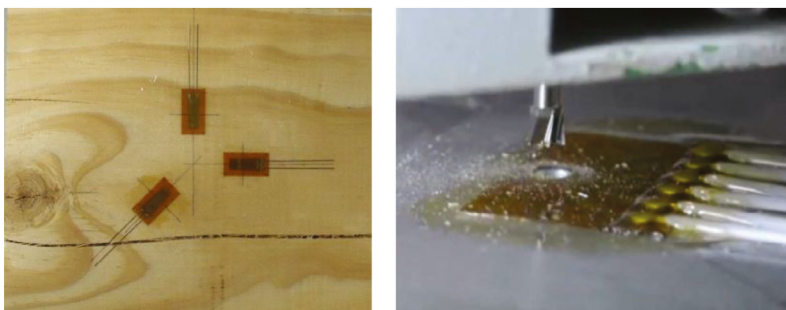
Figure 3: On the left, the individual strain gauges (HBM) forming a rosette, as developed by the authors, on a wood sample. On the right, a new technological device to be applied for drilling an isotropic material (Source: SINT Technology).

ASTM E837 standard establishes strain gauges position (three gauges rosette), hole diameter and depth of drilling for relating them with stress status, but it is only referred to isotropic materials [9]. There are many improved commercial devices to measure internal stress in technological isotropic materials (Fig. 3, right), but unfortunately, there is not one to measure

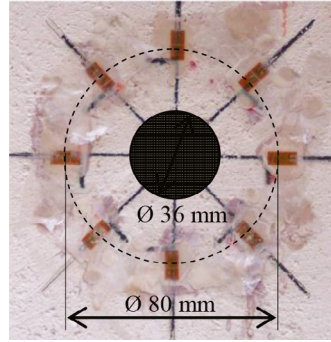
Figure 4: The eight-strain-gauge rosette glued to a stone pier.

structural stress yet. The rosette needs to be handmade using bigger single gauges. Due to the rosette and hole drilling having to be handmade, the scale should be increased to ease the process and to avoid errors. The authors of this paper were pioneers adapting the method for masonry structures in order to measure load stresses instead of manufacturing stresses [10–14]. There was no commercial rosette for this bigger scale and a rosette was designed using eight single strain gauges (Fig. 4).

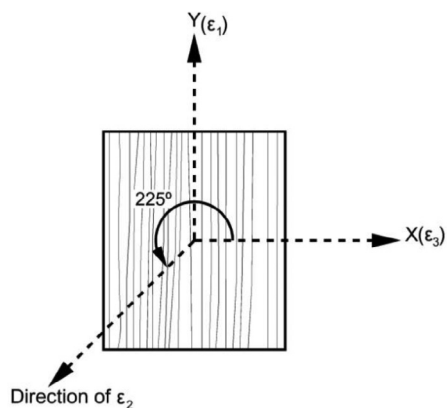
Figure 5: Plane reference system where direction of the grain coincides with the y axis. The lines model the direction of the grain.

In eqn (1) c_{ij} are dimensionless constants of compliance, relative to each wood species and structural piece. The value of the constants c_{12} and c_{32} is zero when X and Y directions of the rosette coincide with the main elastic directions of the material. σ_y , τ_{xy} and σ_x are the stresses in the x – y plane. ε_1 , ε_2 and ε_3 are the relaxed strains recorded by the rosette. E_x and E_y are the principal moduli of elasticity. The reference system shown in Fig. 5 has been applied in all the tests.

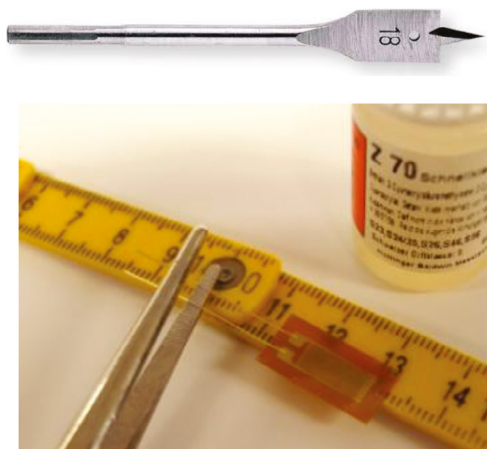
Figure 6: The boring tool (18 mm spade bit for wood) and one of the gauges used for the tests carried out on wooden samples.

Some compression tests were done in order to validate the application of the hole-drilling method on wooden structural elements as was shown in STREMAH 2015 [7]. According to the recommendations of the standard, but also to the available boring tool (18 mm) and commercial strain gauges size (10 mm in length) (Fig. 6), new dimensions for the experimental situation are 18 mm in hole diameter, 16 mm in depth of drill and 40 mm in rosette diameter (Fig. 7).

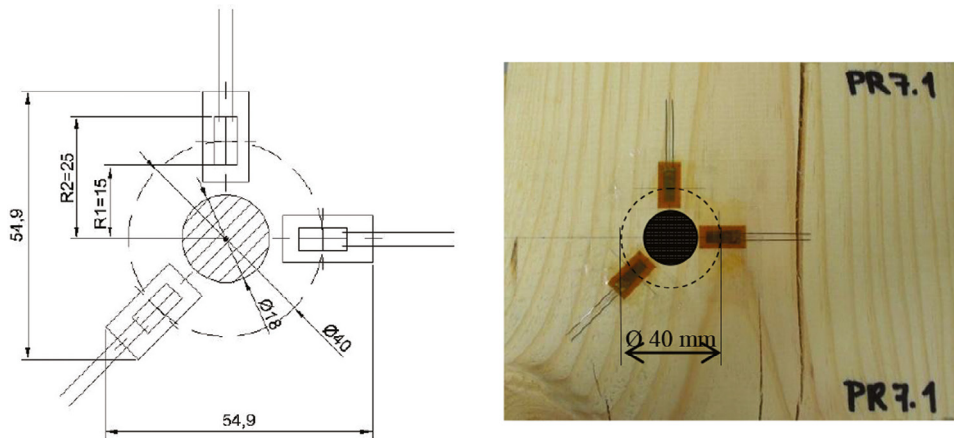
Figure 7: On the left, the device disposal scheme, measured in millimetres. On the right, a real sample with its rosette located avoiding a crack.

In this case, there is no commercial device developed to be applied to these kind of structural elements. Therefore, according to the ASTM E837 standard's recommendations, the rosette is composed in situ by the researcher using three individual strain gauges as shown in Fig. 7.

avoided when locating the rosette. When the rosette is glued onto the surface of the wood member, grain deviation, cracks and knots must be avoided. Registered strains around the hole could be wrong. Capturing the effect of defects or singularities of the whole sample is very interesting, but not if registering anomalous deformation due to the proximity of a fault. For example, a strain gauge should not be glued on a crack, or the drilling should not be performed where there is a knot. The technician must select the location of the rosette avoiding these singularities (Fig. 7, right).

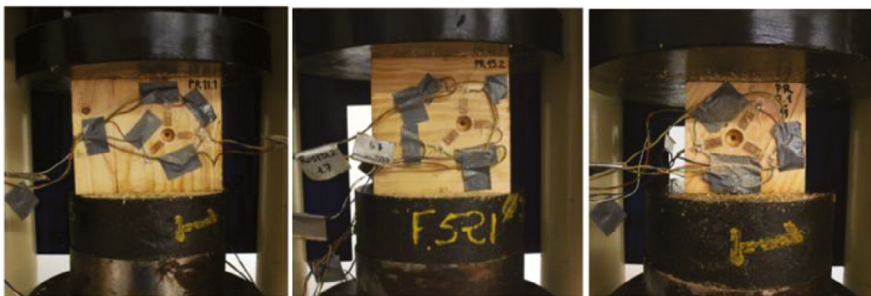
Figure 8: Real samples tested in the direction of the fibres (left), perpendicular-to-fibre direction (middle) and tilted to the vertical load direction (right).

Pinus radiata D. Don was the species selected for all the tests. It is a widely used wood in building timber structures in many zones of Europe. At the laboratory, three different tests were performed in order to complete the matrix of compliance under three types of compressive loads: compression parallel to the fibres, compression perpendicular to the fibres and tilted compression, on the special block (Fig. 8).

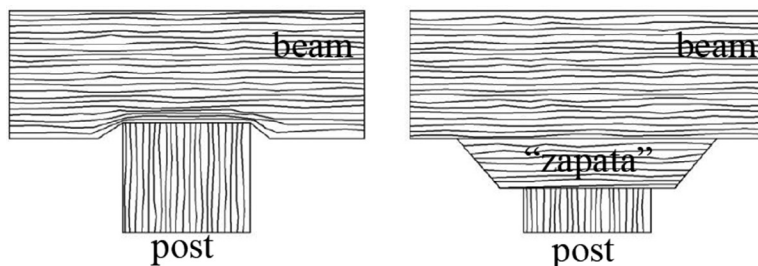
Figure 9: Details of joints between a post and a beam: On the left, a support without ‘zapata’, where the fibres of the beam are crushed, and on the right, a post supporting a beam, using a ‘zapata’ as a transition piece avoiding the crushing of the fibres of the beam.

The main objective of this paper is to measure stresses in compression perpendicular to the grain. That effect occurs in ‘zapata’ pieces. ‘Zapata’ means shoe in Spanish and it refers to a transitional horizontal element between a post and a beam, in order to avoid fibres flattening caused by punching (Fig. 9). Firstly, some verification tests were made at the laboratory, simulating stress in ‘zapatas’ in order to assure the applicability before testing a real structure.
