Earthquake resistant characteristics of traditional Khasi houses in Shillong, India

B. I. O. Dahunsi & A. K. Mittal

Structural Engineering Division, Central Building Research Institute, India

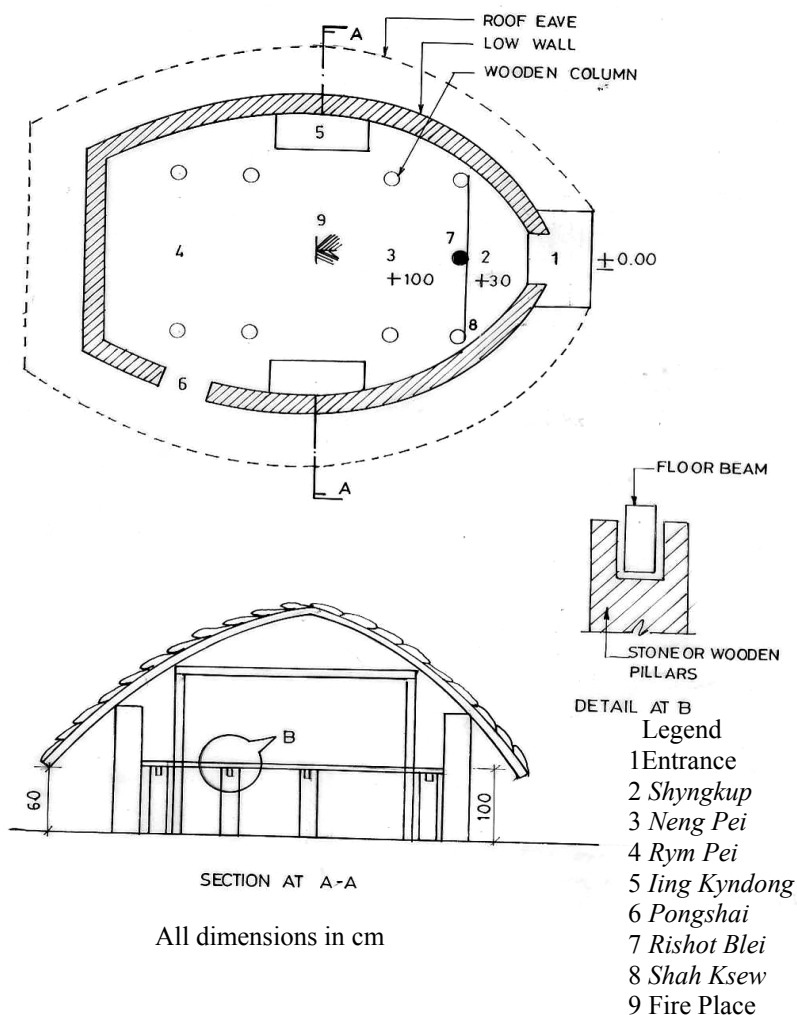
Figure 1: Layout of traditional Khasi house.

The first portion of the house is the entrance, which in most cases is roofed. From the entrance one move into the *Shyngkup* whose function is like a verandah and separates the main living areas from outside. The wall at the end of the *Shyngkup* known as *Shah Ksew* (first plank) is the last part of house where dogs and other domestic animals are allowed, beyond is strictly for human habitation. In the line of the *Shah Ksew*, about half way along the wall, is the *Rishot Blei*, a column that serves religious rather than structural functions (this column can be seen in the front part of the traditional houses as shown in Figure 1 and Figure 5). The outermost part of the living area, known as *Neng Pei* is according to Mawrie [3], the last part of the house that strangers may have access to. Beyond this, is the *Rympei*, which is the innermost part of the house and the private family area, where the family worships and also where the oral histories and traditions of the people are passed down through the generations. The sleeping areas are called *ling Kyndong*. Usually there is a small window-opening on one side of the building known as *Pongshai*.

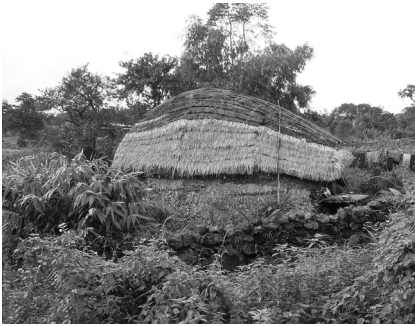
Figure 2: Side view of traditional Khasi house.

Basically the traditional Khasi houses of Shillong and adjoining areas are oval or egg-like shaped, somewhat resembling an overturned boat. Some natives related the similarity to egg as being linked to the traditional belief that egg is a source of life and that the eggshell offered protection for the content of the egg just as the traditional houses offer protection for its occupants. The layouts of the buildings are as show in Figure 1. The buildings are generally built on raised platforms. The roofs are of thatch while the walls may be from materials such as stone masonry with lime mortars, lime rendered mud walls or of thatch depending on prevailing weather conditions. Mud and stone walls are common in areas with heavy rainfalls, as thatch deteriorates quickly in such conditions. Figure 2 illustrates the side view of a typical grass walled and roofed traditional Khasi building while the front view is shown in Figure 3. An upgraded traditional house is shown in Figure 4. It has lime rendered mud walls and corrugated iron roofing sheets.

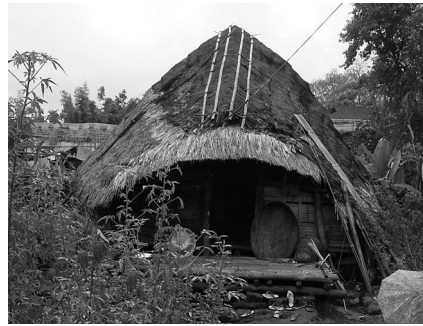
Figure 3: Front view of traditional Khasi house.

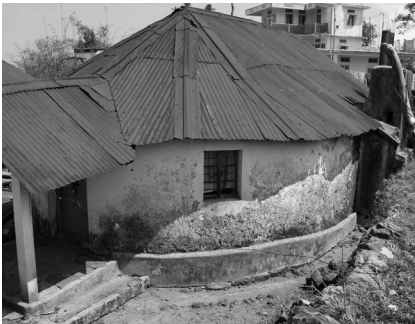
Figure 4: An upgraded traditional Khasi house.

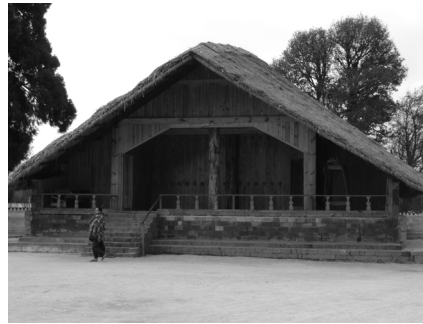
Figure 5: The *ling Sad*.

The traditional Khasi building system of the Shillong plateau was followed in the construction of the *ling Sad* (The building housing the queen mother; mother of the traditional Khasi chief and a custodian of the matrilineal culture of the people). The building though built with technical skills commensurate with modern building construction practices and professional supervision, replicates the methods, materials and structural forms used in traditional constructions (Figure 5). Hence, it was used in this present study in several instances to explain the structural form of the traditional Khasi construction system.

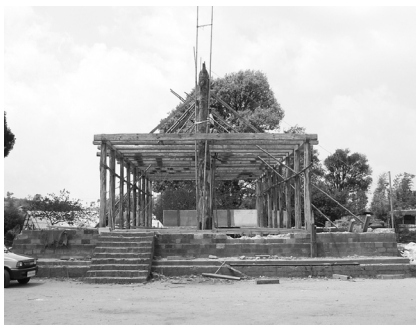
Figure 6: Structural framework of the *Ling Sad*.

ling Sad is as shown in Figures 6 and 7. Figure 7 also illustrates the floor support details of the construction. The wooden pillars in the *ling Sad* are however encased in limestone almost to plinth level to protect them from attacks by insects and deterioration from moisture absorption. The rafters (Figures 8–10), as in other parts of the construction are connected with a system of grooves and tongues, twigs and ropes and in some cases wooden studs. Nails are not used as the use of nails is a traditional taboo among the Khasi people. Other taboos of the people that are related to building construction include;

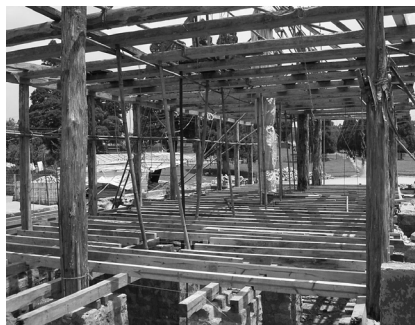
Figure 7: Beam and post system of the *Ling Sad* showing the floor support details.

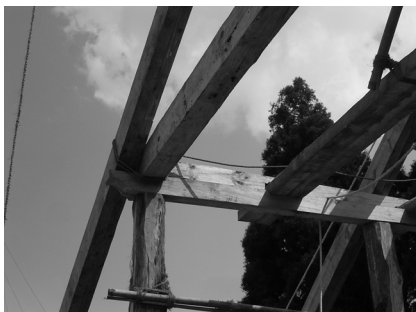
Figure 8: Rafter, beam and post joint detail of the *Ling Sad*.

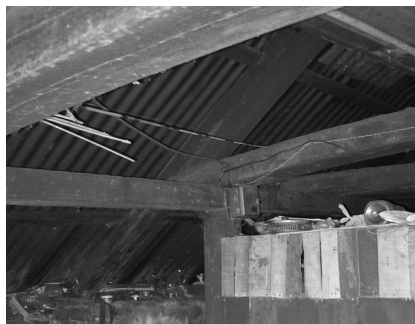
Figure 9: Rafter, beam and post junction of a traditional house.

It was observed that the middle portions of the main beams at the front, middle and back parts of the traditional constructions are slightly curved upwards (this can be seen in Figures 9 and 11). The beams towards the innermost parts of the house were more closely spaced than those at the front parts. The main living areas thus seemed better tied together.

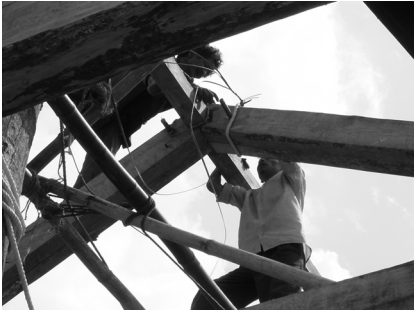
Figure 10: Framework for the ridge of the roof.

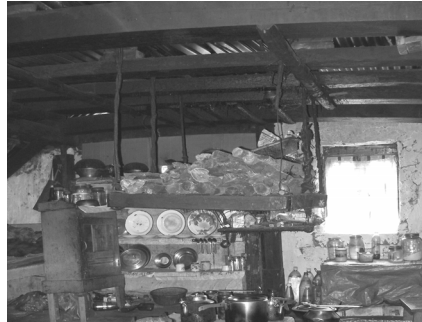
Figure 11: Closely spaced beams at inner parts of the Building.

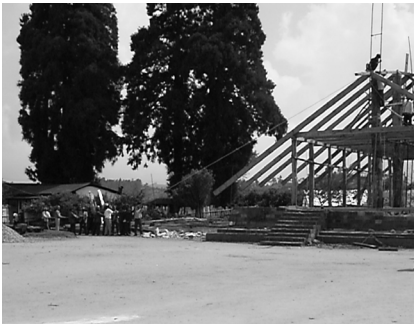
Figure 12: Roof rafters with eaves projecting well beyond main timber frameworks.

The rafters extend beyond the inner frameworks that serve as walls of the main living areas (Figure 12). The outer walls of the buildings are built close to the edge of the eaves and are usually less than one metre high. Figure 13 shows the outer walls, slightly beyond the inner wall of a traditional building. The main frames of the buildings are structurally independent of the walls and would be unaffected even if the walls fail as shown in Figure 12.

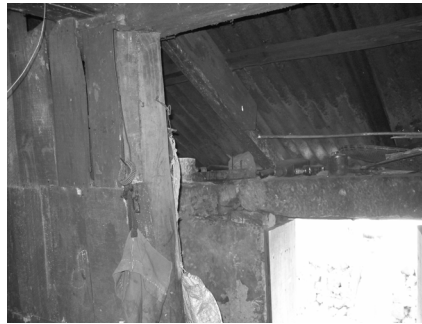
Figure 13: Roof rafters of traditional house are structurally supported by timber frame.

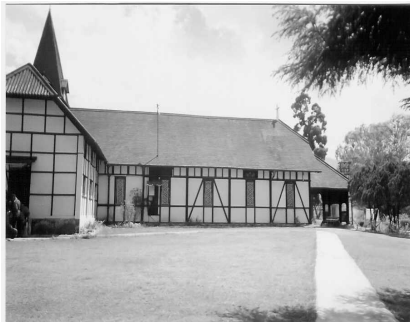
Figure 14: New All Saints church rebuilt after the 1897 earthquake.

The large scale destruction of houses during the 1897 earthquake, led to the adoption of a new type of building style as was the case in Portugal after the devastating earthquake of 1755 as reported by Gulkan and Langenbach [8]. It is normally referred to as the Assam type house. It is a timber framed structure and is at present the standard housing system in the North Eastern part of India although reinforced concrete structures are becoming popular. Some of the pre-1897 structures rebuilt with the Assam type construction include the chief commissioner's residency and the All Saints church (Figure 14). Some similarities can be found in the traditional buildings and the Assam type construction. The two types are on elevated short pillars of stone masonry or timber (Figure 15). They are both made up of timber frames. The Assam type

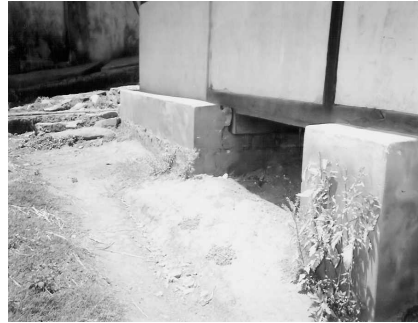
Figure 15: Base of typical Assam type house raised above the ground.
