Improving the shear resistance of adobe masonry for rebuilding and new construction purposes

W. Jäger & J. Braun

Structural Design, TU Dresden, Germany

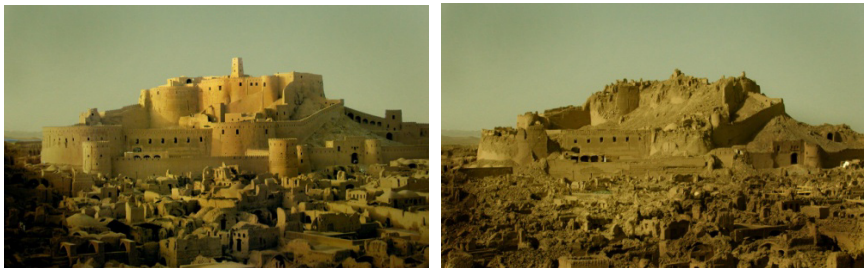
Figure 1: The historical Citadel in Bam before and after destruction.

Built before 500 BC and used until 1850 AD, the ancient citadel of Arg-e Bam (Iran) was the largest adobe building in the world. On December 26, 2003 a major earthquake struck Bam and the surrounding Kerman province with a magnitude of 6.3 on the Richter scale. The earthquake destroyed about 70 percent of the buildings in Bam city and more than 80 percent of the historical Citadel itself.

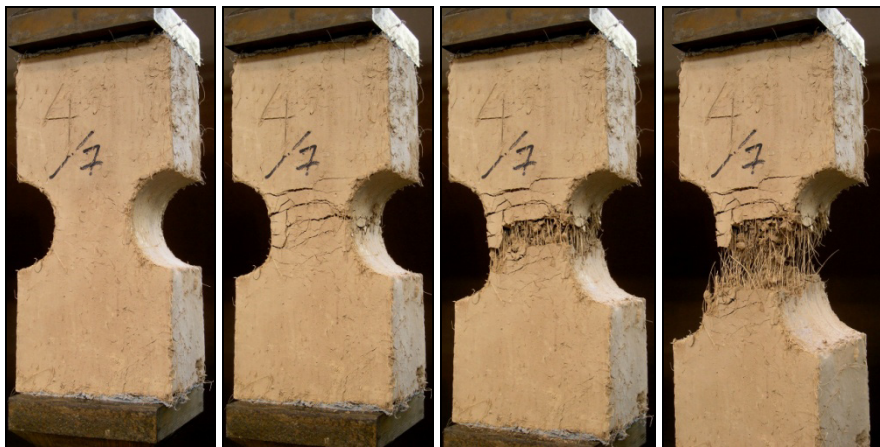
Figure 4: Failure process of reinforced clay bricks under tension.

While the test specimens without reinforcement show a sudden, brittle collapse, the fibre reinforcement of the bricks can continue to absorb tension load even after the failure of the clay itself (see Figure 4).

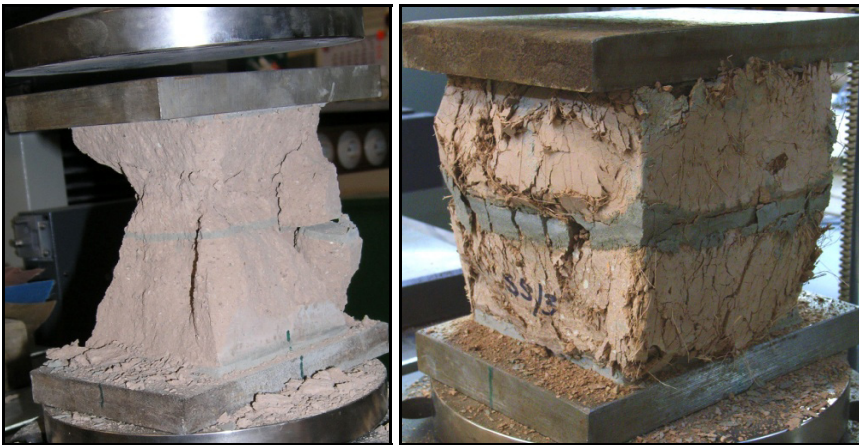
Figure 6: Failure process of unreinforced and reinforced clay bricks under compression.

Under compression the cross-section area of the unreinforced test specimens is reduced by cracks resulting from transverse tension, causing a brittle failure. In reinforced clay bricks cracks also occur due to transverse tension, but do not cause a reduction of the compression absorbing cross-section area, because the debris continues to be held in place by the fibres. Therefore the specimens maintain their shape during the test and display a ductile failure.

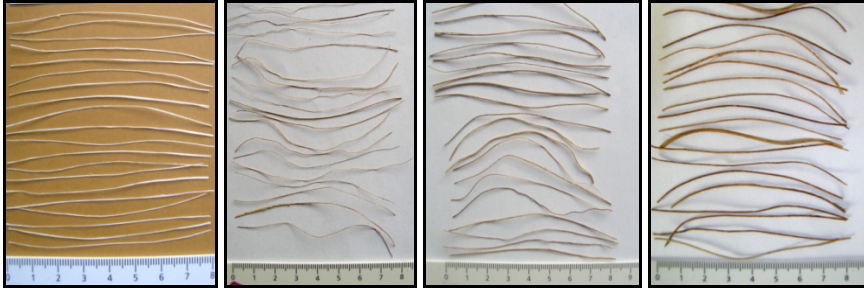
Figure 9: Sisal fibres (left) as well as fine, middle and coarse Date palm fibres.

The differences in the performance of the various fibres could result either from inherent variable tensile strength of the fibres or from different bonding conditions between fibre and surrounding clay. The tensile strength has been determined for Sisal and Date-palm fibres. While the Sisal fibres proved to be very homogenous with diameters ranging from 0.18 and 0.22 mm, the thickness of the Date-palm fibres varies considerably. Consequently, the Date-palm fibres were subdivided for the test into fine (0,15-0,30 mm) middle (0,31-0,60 mm) and coarse (0,61-0,90 mm) fibre categories.

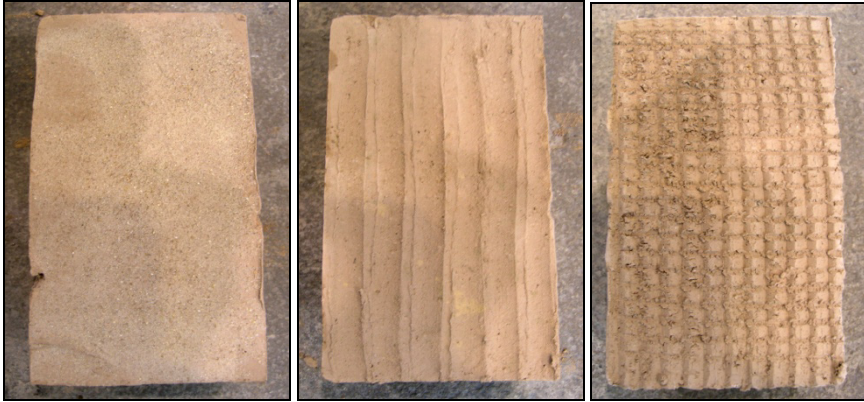
Figure 13: Sandy, finger-scratched and coarse scrapper roughened brick surfaces.

A further method to enhance the shear resistance of masonry is to increase shear and tensile strength as well as the friction coefficient between mortar and brick. Therefore several tension and shear tests of two- and three-stone-specimens with different surfaces and varying additives to the clay mortar were performed on clay brick structures. In addition to the traditional sandy and finger-scratched roughened brick surfaces, smooth, steel-brushed and two different scrapper-prepared surfaces of brick were tested. As additives, cement, lime and gypsum were chosen.
