## **Architectural qualities of Danish office buildings built between 1960 and 1980, seen in a contemporary sustainable perspective**

### **Abstract**

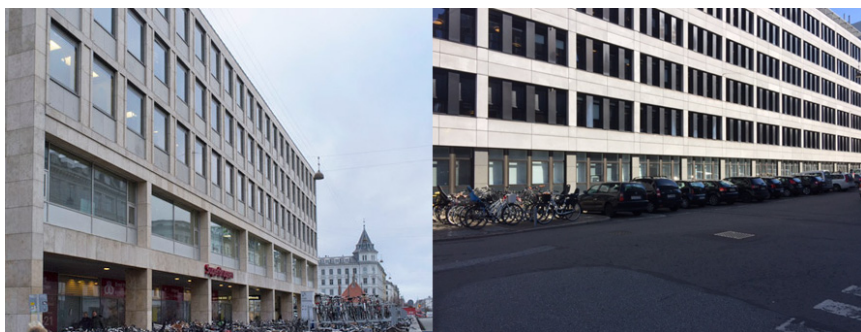
Figure 1: Concrete facades will often be dominated by white or light grey colours.

In this period, concrete was used in many buildings as a facade material, and it was thought to be a durable material. However, later it was shown that it was prone to cracking and the steel reinforcement to rust. The result was discoloration and in many situations the bearing elements were weakened and needed repairing (Dragheim [8]). Due to using different components in the facade, there was a need to use sealing materials and techniques between them. Not all of these materials showed long-term durability, and there were many problems regarding water and wind tightness. Many types of wood used were of low quality and the wood wasn't impregnated properly, which led to some parts, such as window frames, rotting within a short time (Dragheim [8]).

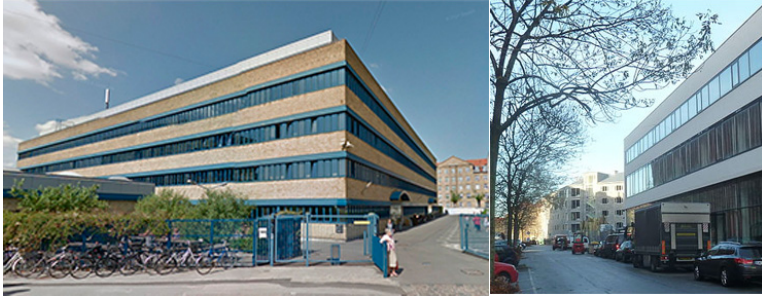
Figure 3: The dominating horizontal lines in some of the facades.

Different structural systems were used in this period, for instance beams and columns or transverse bearing walls. This had its influence on facades that featured horizontal lines and no holes in the facades and which bear only their own weight. Many facades are made of light constructions with continuous window strips and parapets, preferably based on fibre cement plate (Dragheim [8]). The new facade components, such as curtain walls and glass, have aesthetic qualities which are expressed through the concept of surface of volume. The aesthetic principle of

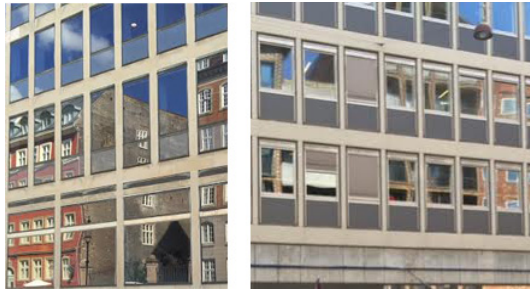
Figure 4: Some of the new cladding materials like metal and dark glass.

There was a focus on the intrinsic elegance of many materials such as aluminium, glass, and concrete, excluding all kinds of decoration with a preference for machine-made architectural details created by new technologies. The most-used materials for facade cladding are fibre cement plates, aluminium plates, steel, pressed mineral wool and glass fibre plates. Heavy materials like bricks were used only exceptionally (Dragheim [8]).

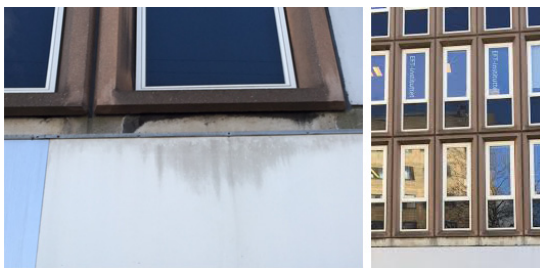
Figure 5: Problems like mould in the facade.

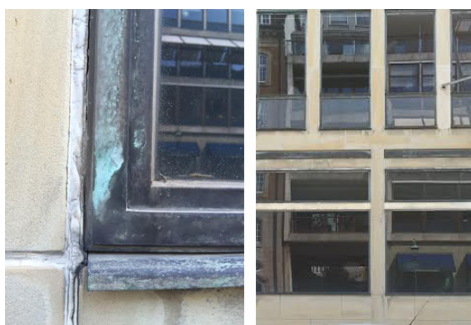
Figure 6: Problems in sealing materials in some parts of the facades.

There was a great need for industrialized building components for the construction of office buildings in the sixties and the seventies due to the large demand for office buildings in that period. There were many economic benefits and time savings with this new system, but there were also many characteristic problems that faced the office buildings later on, such as cracks in the concrete carbonates and corrosion of the reinforcements. Some parts of the facades faced problems like mould and fungus, and there were problems with sealing materials (Dragheim [8]).
