Remediation and development of a former landfill and rail yard in Virginia USA

R. P. Huguenard¹, J. M. LaVelle² & R. L. Olsen³

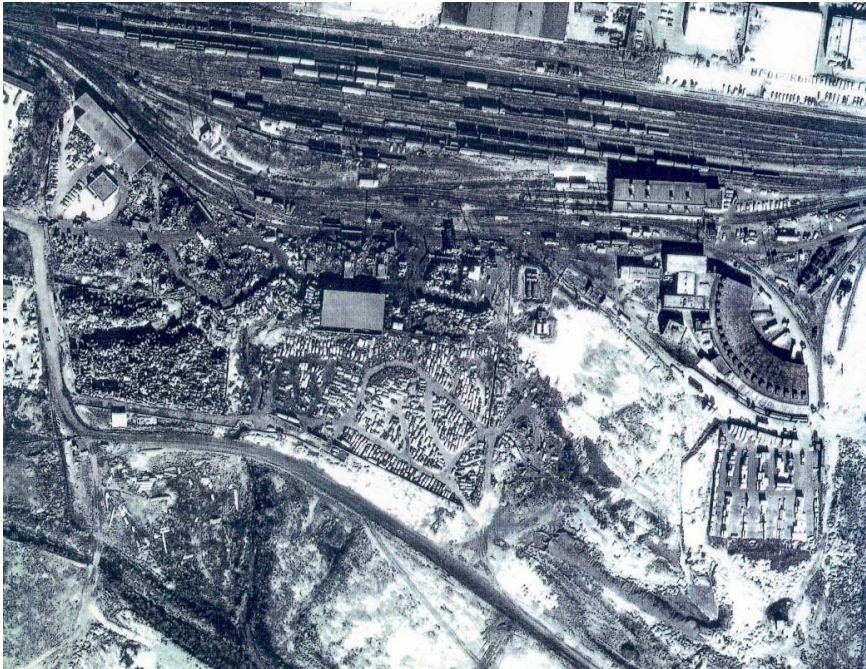
Figure 2: Aerial view prior to remediation and development.

Figure 2 provides an aerial view of the site prior to remediation and development.
