# The hydrodynamic response of beach nourishment in the Cancun Beach, Quintana Roo, México

J. C. Sanchez<sup>1</sup>, J. C. Espinal<sup>2</sup> & D. Moran<sup>3</sup>

<sup>1</sup>*Subgerente de Estudios Hidrográficos, GEIC, CFE, México*

## Abstract

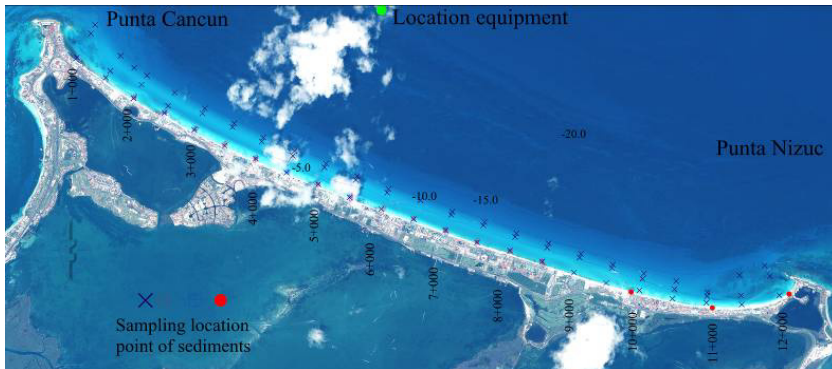
Figure 2: Measurements.

Figure 2 indicates the location equipment for wave measurements, the profile distribution along the beach and the points of sediment samples.

Site characterization was performed on previous studies and by means of collected data from measurements by the most important parameters such as topobathymetric surveys, native sediment samples, wave current measurements, and sediment samples taken on the borrow areas.

For a detailed characterization study the beach was divided in cross shore sections every 100 meters, starting with the 0+600 km section on Punta Cancun and ending on Punta Nizuc with the 12+000 km section. Topobathymetric surveys covered a 13 kilometers beachfront and reached the 20 meter depth contour.

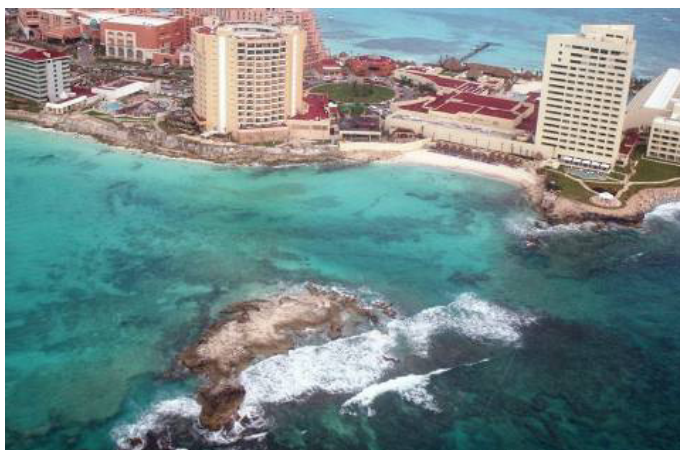
Figure 4: Punta Cancun, after Hurricane Wilma.

Wilma (2005) was the most dangerous meteorological event that hit the region. The hurricane was classified as category five in the Saffir–Simpson scale, and caused a considerably increment of the erosion processes, resulting in a loss of dry beach in some areas and total loss of beach width from the central to the northern zone. Punta Cancun area was the most damaged one, as shown in Figure 4.

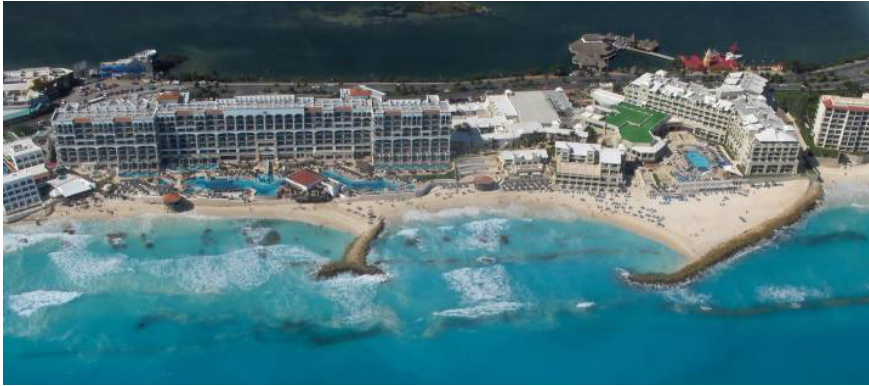
Figure 5: Jetties built without project support.

During this period (2006 to 2009) several groins and detached breakwaters were built whose location and geometric characteristics increased the erosion, instead of maintaining the original beach width, as shown in Figure 5.

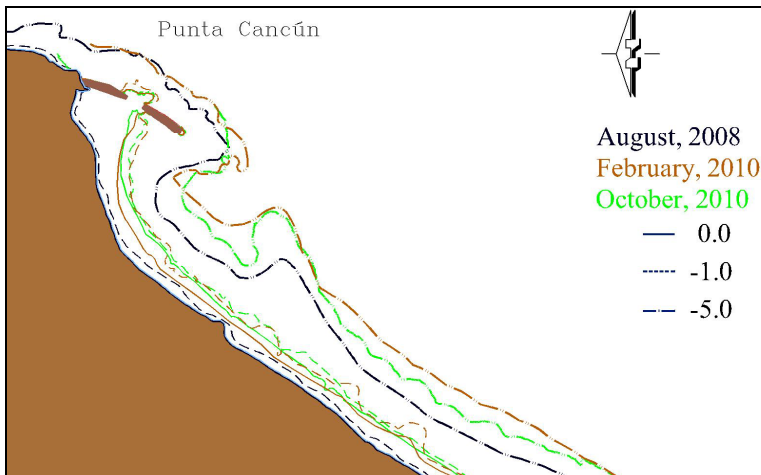
Figure 7: Seabed evolution in Punta Cancun.

From three historical detailed bathymetric surveys performed by CFE in August 2008, February and October 2010, the planform evolution was studied. The bathymetric curves for levels 0.0, -1.0 and -5.0 were selected for each bathymetric, and then a comparison of their position was performed. Figure 7 shows the different depth positions for each bathymetric survey measurement. The seabed analysis for the North Zone “Punta Cancun” is presented in this paper because Punta Cancun was the most damaged area by Hurricane Wilma. The continuous lines represent the coastline position (bathymetric curve level 0.0), the dashes one shows the bathymetric curve level -1.0 m and the composite one indicate bathymetric curve level -5.0 m.

For example in 2008 the coastline position (bathymetric curve level 0.0) was on the basement hotels, the bathymetric curve level -5.0 was located at a distance of 150 meter offshore, on average.

As shown in Figure 7, after nourishment the coastline position moves 55 meters offshore on average, consequently also the bathymetric curve level -1.0 moved 55 m offshore. The most notable changes occurred in the position of the bathymetric curve level -5.0 meter, which was located about 230 meters offshore.

The placement of 5.2 million cubic meters of sand also changed the planform slope and therefore the surf zone was moved offshore, forcing to reduce the wave energy approaching the coast, and thus increasing the beach nourishment useful life.

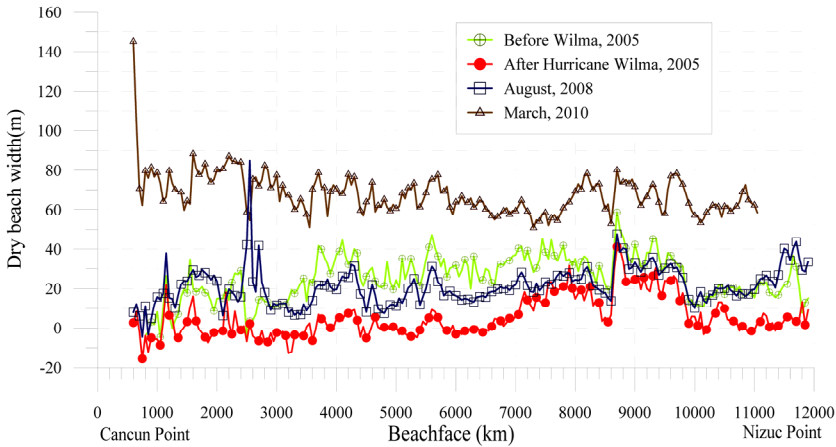
Figure 8: Coastline evolution.

The planform evolution along the project area was analyzed using historical bathymetric survey measurements. Figure 8 shows the coastline position before and after hurricane Wilma, in circular and filled circular markers, both before the emergency nourishment placement; the squared marker is the coastline position in August 2008, after the emergency nourishment and before the nourishment in 2009. Finally the coastline position after nourishment project is shown in triangular markers.

Before Hurricane Wilma, 2005 the dry beach width varied between zero to 60 meters, with 28 meters on average. This year the authors observed that there were three different beach front zones:

North zone (0+600 km to 4+000 km), the dry beach width was 18 meters. Central zone (4+000 km to 8+000 km) the dry beach width varied between 20 to 30 meters, and on South zone (8+000 km to 12+000 km) the average dry beach width was 22 meters.

After *Hurricane Wilma* hit the region, the beach width loss was 22 meters as a mean value, transforming the three beach zones to two eroded areas: The first

one named “Severe erosion” zone covers from 0+600 km section to 7+000 km section, in this beachfront, 70% of the length without dry beach was recorded. The second area covered from 7+000 km to 12+000 km sections, with a dry beach width of 18 meters as a mean value.

After beach nourishment in 2009, mean dry beach width varied from 50 to 90 meters. Nevertheless, there was a 100 m beach front with dry beach more than one hundred meters and it was located close to the closure structure (Cancun Point).

At present, the North zone shows a 70 meter mean dry beach width. The Center zone has a 60 meter mean dry beach width, and the South zone exhibits a 70 meter mean dry beach width. On South the coastline shows an apparent retreat because of the longitudinal gradient: passing from 80 meter of wide in the nourishment area to 30 meter in the un-rehabilitated area.
