## A brief history of the sand drifts on the Jæren coast, Norway

A. Tørum<sup>1</sup> & O. T. Gudmestad<sup>2</sup>

### Abstract

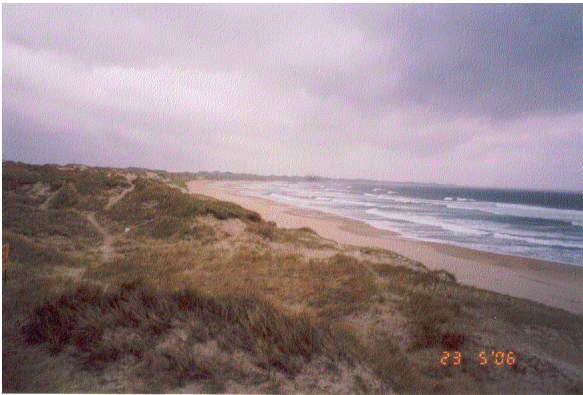
Figure 2: The beach and dunes at Bore-Sele seen towards Revtangen in 2006.

The Jæren coastline south of the city of Stavanger on the south-western tip of Norway (Figure 1) has some stretches of beaches. Figure 2 shows the beach north of Revtangen. The beach and dunes consist of fine sand, gravel and even in some cases cobbles. We should note The South Norwegian Deep Channel (Figure 1) that runs along the south coast of Norway is some 300 m deep and has been “carved” out by glaciers. The Lista stage end moraine running along the coast is an end moraine left by glaciers. Note that the bottom slope is mild close to the coast, but very steep into the South Norwegian Deep Channel.

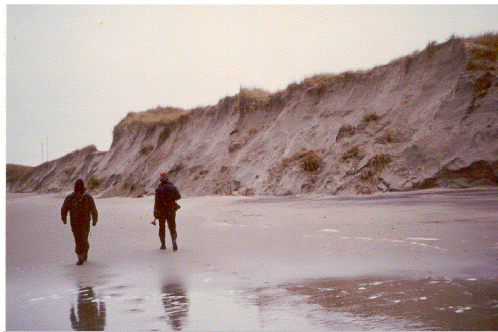
Figure 3: The sand dunes at Bore-Sele (Figure 2) seen two days after a heavy storm in November 1981. There has in this case been considerable erosion of the beach and the dunes. The dune height is estimated to be 6–8 m [4].

The beaches along the Jæren coast are apparently fairly stable with only some minor setbacks during heavy storms (Figure 3). This setback is apparently temporary as the dunes grow again.

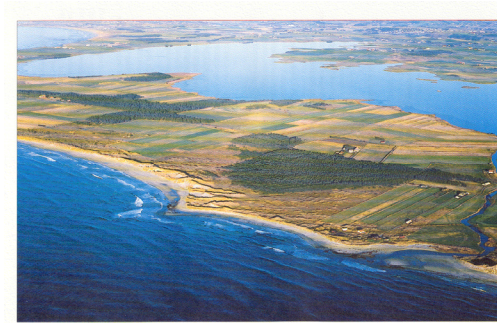
Figure 4: Orre in Klepp commune slightly south of Revtangen (Figure 1). (Courtesy Norsk fly and Flyfoto A/S, Rogaland county Governor (1995).)

Today the Jæren area is among the best farmland in Norway (Figure 4), but it has not always been the case. The area was much hampered by sand drift during heavy storms. Sand drifts forced the farmers to abandon their farms. Figure 5 shows a map from 1806 [8] of the same area shown in Figure 4. The farms are located among sand ridges/dunes.

The most important tool in the battle against the sand drifts was the planting of marram grass. A pioneer in this work was Torger Nærland [11]. Nærland contacted in about 1870 the local pastor, who advised him to write to the county governor. He again sent Martin Grude, the District Sheriff and teacher of a local agricultural school, to Denmark to study the use of marram grass to damp the sand drift. So gradually the sand ridden land was made into fertile land as it can be seen in Figure 4.

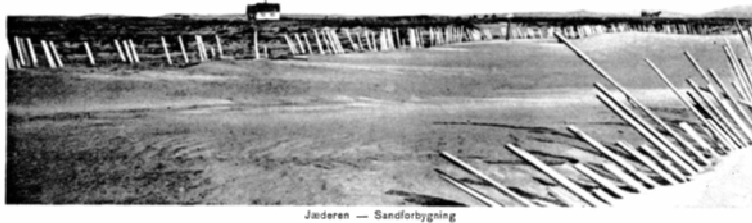
Figure 6: Attempt to stop sand drifts on Jæren by wooden fences [10].

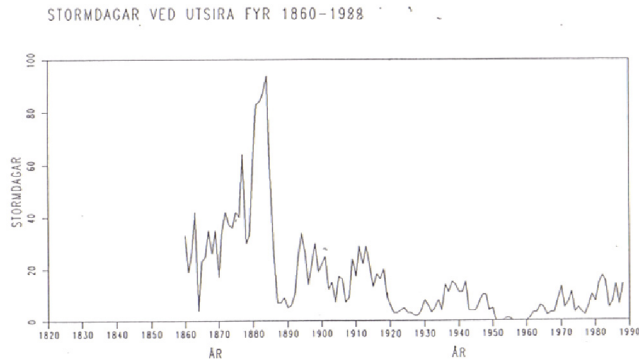
Figure 7: Number of storm days at Utsira lighthouse in the time period 1860–1988 [13].

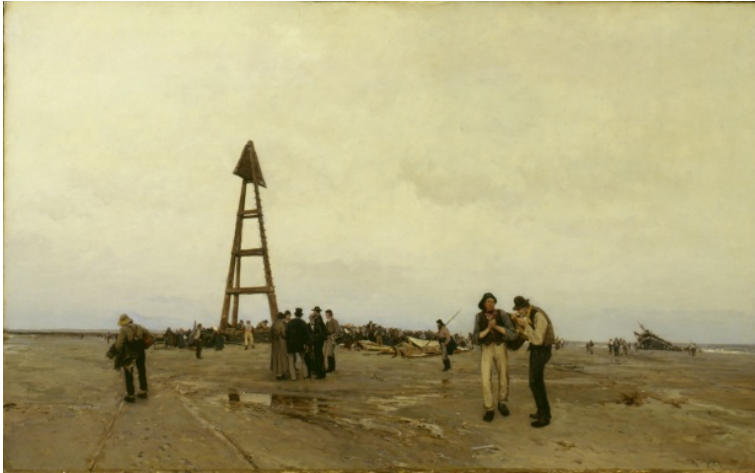
Figure 8: Ship wreck auction under the “Day-time marker” at Revtangen. Painting by Nicolai Ulfsten, 1880. (Courtesy O. Værings Eftf. AS.)

Another place where the sand dunes have grown significantly in the latter 100 years is at Reve and Revtangen (Figure 1). At about 1870 a sailing mark was erected at Reve to help ships with their navigation during day time (“Day-time marker”, no lights). Figure 8 shows an older painting from the Reve area where the “Day-time marker” is visible. Many ships went aground on the Jæren coast and whenever this happened there was an auction of the ship wrecks. The painting shows that the area at Revtangen at the end of the 19<sup>th</sup> century was rather flat. The forester Jacob Bøckmann Barth was bird hunting on Reve in 1875. He wrote (in Norwegian) an account of the landscape from one of his hunting trips at Reve: “I went from the Reve farms towards the shore plain. Then I saw a very flat area, only some few feet above the sea level. The area was approximately 4 km<sup>2</sup> and was covered with wind-driven sand. The desert like area was impressive without any plants or animals. The only sight catching item was the “Day-time marker””.

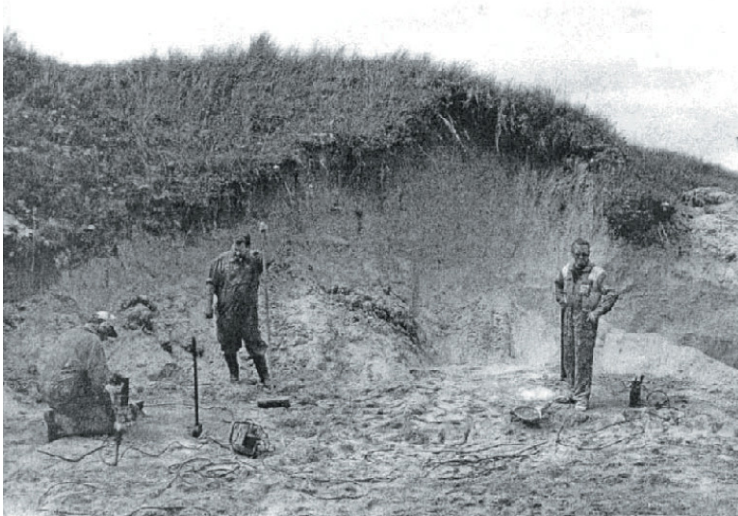
Figure 9: Uncovering of the old concrete foundations for the “Day-time marker” at Reve in 2004. (Photograph and information by Thore Refve, Reve Jæren.)

The “Day-time marker” was abandoned when new modern navigation became available in the beginning of the 20<sup>th</sup> century. It was, however, decided in 2004 to restore the “Day-time marker” as a cultural heritage. The old concrete foundations were unburied to be used for the new “Day-time marker”. Figure 9 is a photograph from the un-burying of the old foundations. The sand dunes are several meters high. The highest dunes today at Reve are approximately 7.5 m above sea level.

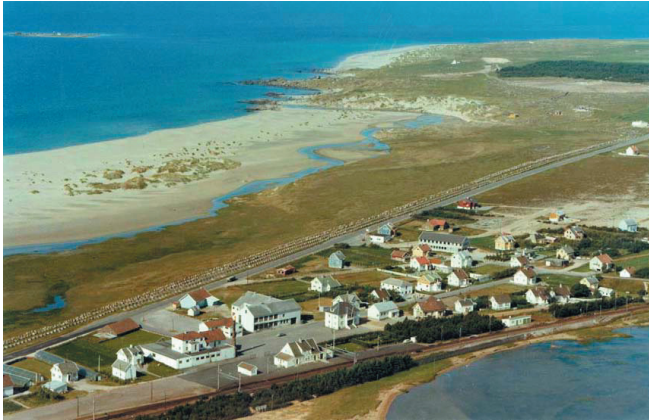
Figure 10: Brusand 1963. (Photo: Fjellanger Widerø A/S.)

Brusanden is located in the southern end of Jæren (Figure 1). Figure 10 shows a photograph of the area in 1963. It shows that there is hardly any vegetation between the small creek and the ocean.

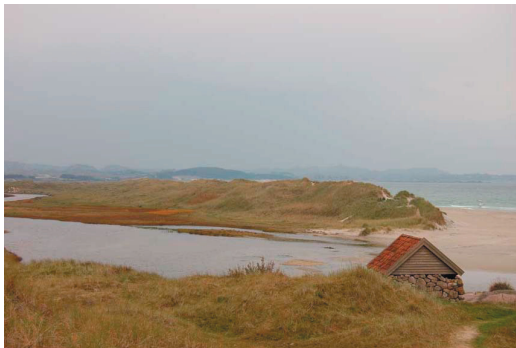
Figure 11: Northern end of Brusanden in 2007 with the outlet of the small river.

Figure 11 shows the northern end of Brusanden in 2007. Marram grass was planted on Brusanden in 1894. But this planting was not successful. Later marram grass was planted on Kvalbeinsanden slightly north of Brusanden. This planting was successful. By natural spreading the marram grass has also settled on Brusanden, which dunes have grown considerably during the last 40–50 years.

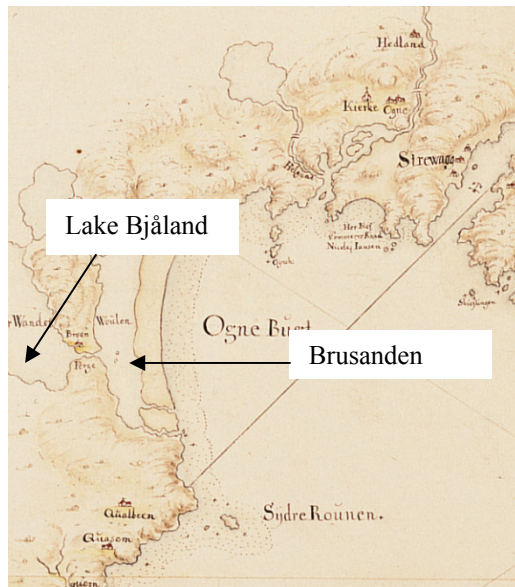
Figure 12: Section of antiquarian map by R. Juel of Jæren and Stavanger 1708-Ogne bugt. (Printed with permission from the Norwegian mapping authority.)

Figure 12 shows a map from 1708 of the Brusanden area. The map indicates that Lake Waulen was then larger than it is today. In fact, Lake Waulen is today almost dry and a small river remains.

Paper [1] discusses changes of water levels between 1839 and 1939. They indicate a sea level fall of 7 cm, but there are some uncertainties on this figure. However, the sea level was probably 10–20 cm higher in 1708 than it is today. The map of 1706 (Figure 12) was produced by the Danish Navy, which concentrated on the coastal area. The scale on land of the map from 1706 may thus vary. But as Lake Waulen is depicted on the maps it is reasonable that the lake was larger previously than it is today. This may be due to higher water levels, but it may also be due to sand drifts through the years which have caused the lake to be filled with sand as the lagoons at Lista, Reve, Bore-Selesanden and Solasanden [1].
