Geotextile tube application on beach refurbishment in UAE

A. Chien, F. Tseng & A. Tang
ACE Geosynthetics, Taiwan

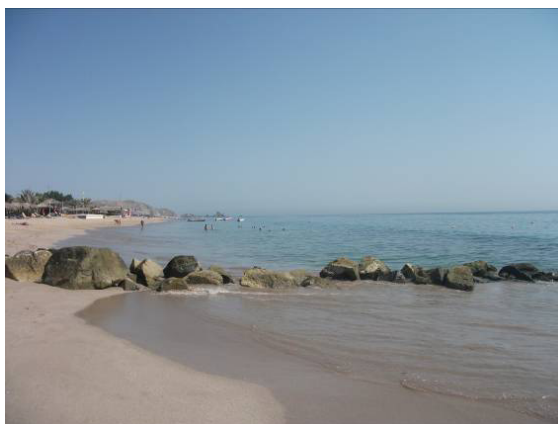
Figure 1: The rubble groin after sinking.

its original geo-morphology, will require a very long time. An erosion problem might arise if a natural disaster occurs again. In the protection area, there were two rubble groins located on the south and north sides respectively, originally to protect the beach in front of the hotel. As there was no base foundation protection of the groins, they sank gradually by perennial frequent wave erosion and unexpected hurricane. The height and length of the groins reduced yearly weakening the protection. The groin height and the length has decreased so much now that the sand interception is no longer effective (fig. 1).

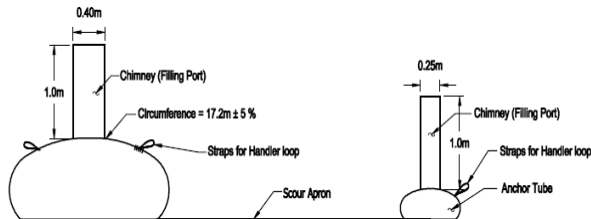
Figure 2: Type I geotextile tube drawing.

Two dimensions of geotextile tubes [5] to construct groins are used to achieve the orientation requirement of seabed profile. One, type I, with a circumference of 8.6m and 52m in length with a single scour apron and anchor tubes on one side (fig. 2) and the other, type II, with a circumference of 17.2m and 77m in length with two scour aprons and anchor tubes on each side (fig. 3).

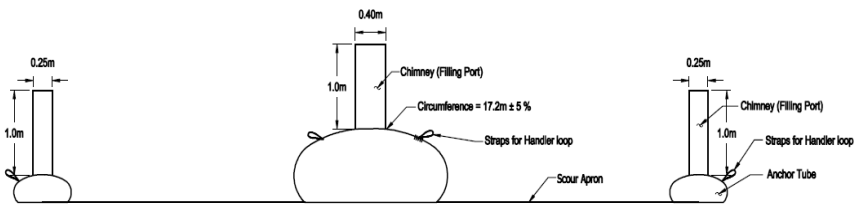
Figure 3: Type II geotextile tube drawing.

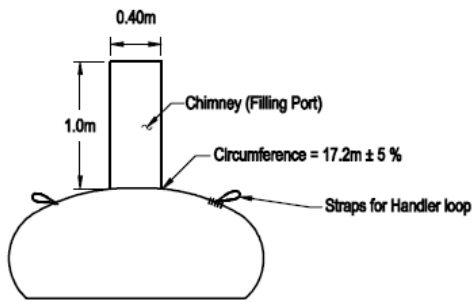
Figure 6: Type III geotextile tube drawing.

Two different type of geotextile tubes were designed for the parallel submerged breakwater, Type III were circumference 17.2m, length 77m, sole geotextile tubes (fig. 6), Type IV were circumference 17.2m, length 77m, single scour apron and anchor geotextile tubes (fig. 7). They were expected to achieve an average height of 3m.

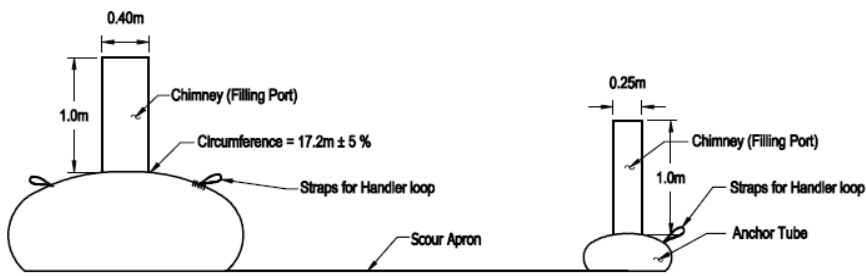
Figure 7: Type IV geotextile tube drawing.

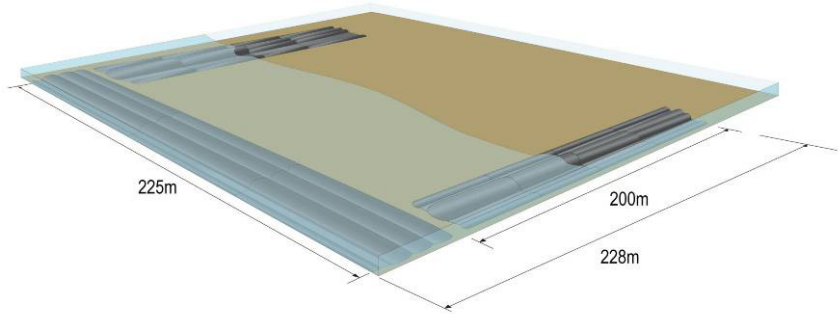
Figure 8: Overall design drawing after completion.

Deploying six Type III geotextile tubes and three type IVs side by side in 225m length, 28m width offshore submerged breakwater. The lateral geotextile tubes associated with scour aprons and anchor tubes as protection. A three-side structure forming a 228m x 225m protection area, sand was pumped into the protection zone manually as artificial refurbishment (fig. 8).

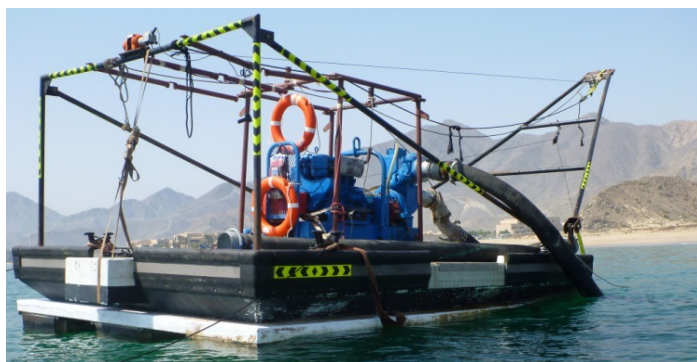
Figure 9: Dredger for this project.

The main construction equipment is dredger and a working boat. The selection of dredger must consider the specifications of the geotextile tubes and analyze data to avoid excessive output power causing rupture of the geotextile tubes or else lowering output power to delay or prolong the construction lead time. The dredger power rate is set at around 350 HP associated with an 8 inch discharge pipe to do the hydraulic filling (fig. 9).

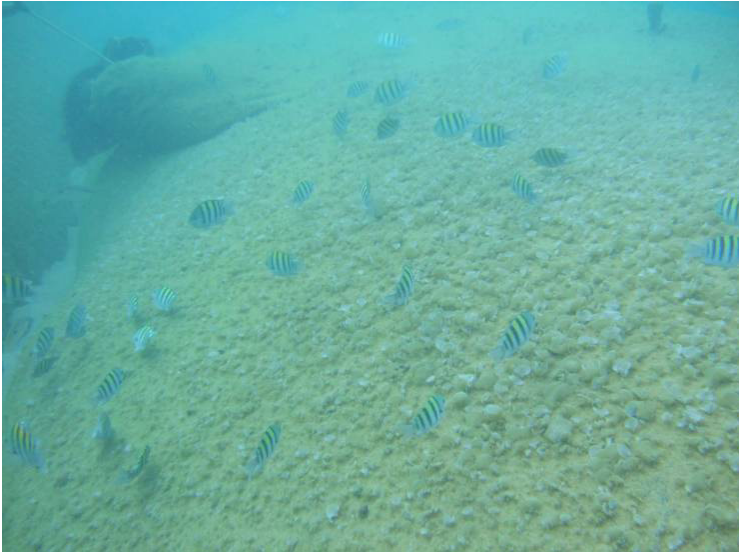
Figure 10: Algae accrete on the geotextile tube under water.

During the construction, algae [7] accrete started growing on the geotextile tubes and it was noticed that benthos moves to the area around the tubes which indicates that the material used for geotextile tubes is extremely friendly to marine ecology and could help to create an artificial reef (figs 10–12).

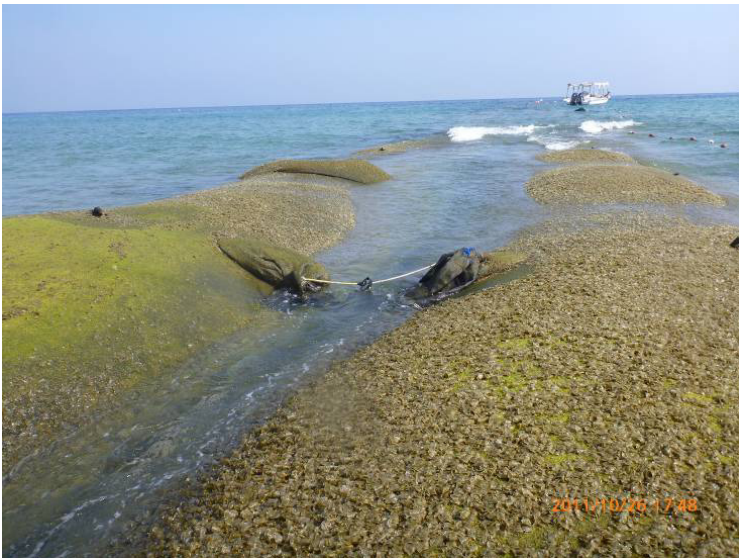
Figure 11: Algae accrete on the geotextile tube on land.

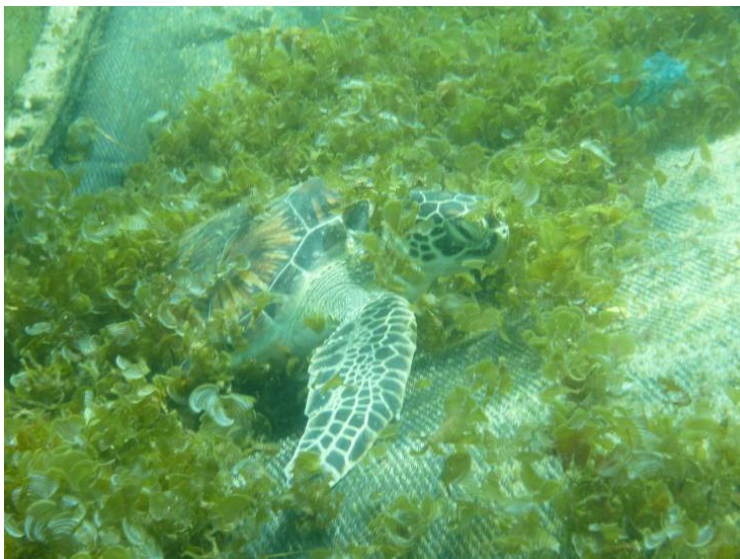
Figure 12: The associativity between herbivorous animals and geotextile tubes.
