The cause and mechanism of the fatal flood in Eleftheres, Kavala, Northern Greece

Abstract

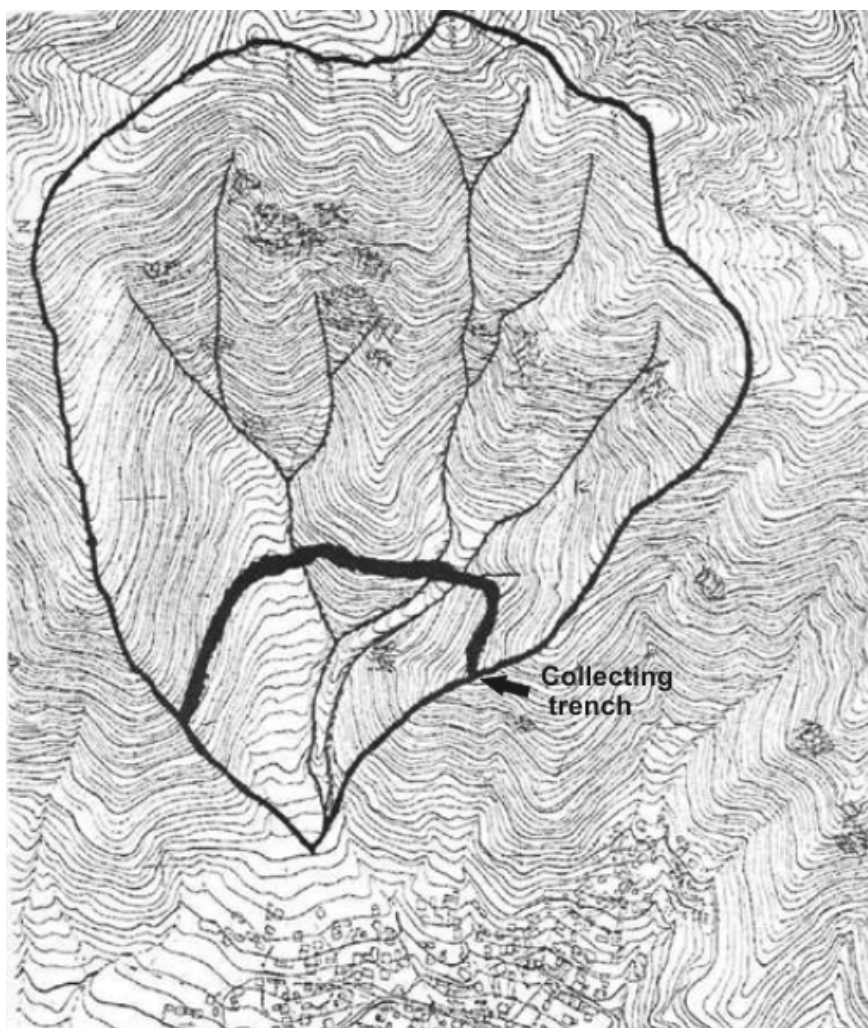
Figure 2: The drainage basin of the torrent of Eleftheres and the collecting trench.

The present paper's field area is the mountainous area over Eleftheres and, more specifically, the drainage basin of the largest of the four torrents flowing through the village in question (Fig. 2).

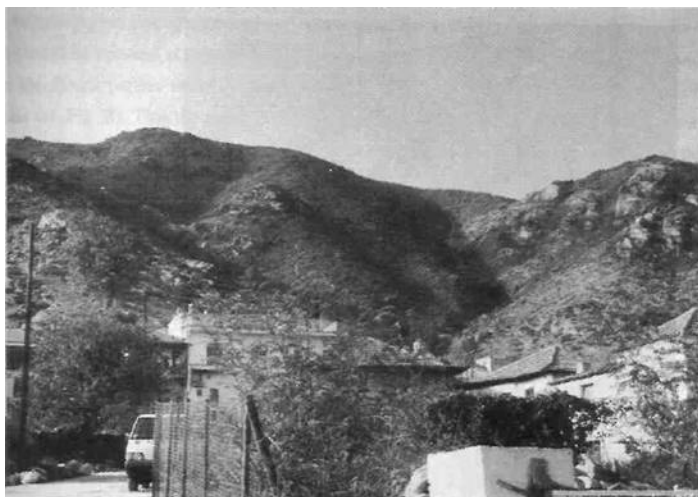
Figure 3: The position of the drainage basin with regard to the village.

Thus, the most strikingly obvious fact since the first moment of our visit in the basin was the very intense erosion and the eluviation of a rich layer of soil that existed in it, as well as the very intense fragmentation of the rock (Fig. 3). But what had caused such an intense soil development on the one hand and the fragmentation of the non - disintegrated rock on the other?

The brought material that moved downwards according to stages C on the table was the one that flooded the village of Eleftheres. Taking into consideration the position of the village with regard to the basin (cf. Photo 1), it is easily understood why houses were destroyed and why people drowned, especially when no protective works had been constructed nor had there been any torrent management.

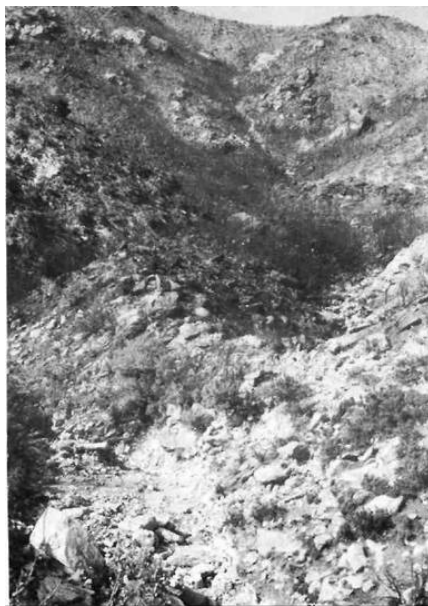
Figure 4: Fragmented and intensely disintegrated granite in the drainage basin. Stones readily detachable can be seen.

The presence of a very thick vegetation of *Quercus pubescens* in the drainage basin for over 200 years (data from the Forest Inspection Service of Kavala) resulted in the fragmentation of the underlying granite, which was already altered anyway Maratos [9] and very old.

The fragmented granite also underwent disintegration processes, which were further facilitated by the fact that granite is a rock easily flecked.

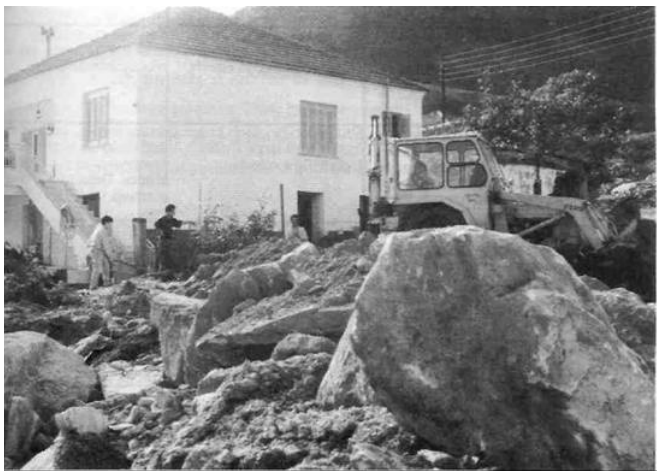
Figure 5: Debris deposited in the village. The grades of the load can be seen.

However, it was not only the Quercus and the fire that contributed to the production of material that could be transported through the bed and, consequently, to debris flow formation; it was man himself, too. It should be stressed at this point that in September 1992 (one month after the fire and two months before the flood) parties from the community of Eleftheres dug a ditch in the lines of the contour intervals (cf. Fig. 2). This ditch, according to their estimates, would be capable of draining the waters that would flow from smaller torrent beds to the central one. Of course, not only this did not happen, but also the excavations from the ditch cutting (which remained unfinished, it should be noted) were “used” by rain water to enrich the load that was mobilized in the bed. This resulted in a combination of fine and rough load from three different origins (Fig. 5).
