# Debris flow hazards and emergency response in Taiwan

C.-Y. Chen<sup>1</sup>, W.-C. Lee<sup>1</sup> & F.-C. Yu<sup>2</sup>

<sup>1</sup>*National Science and Technology Center for Disaster Reduction (NCDR), Taipei, Taiwan, Republic of China*

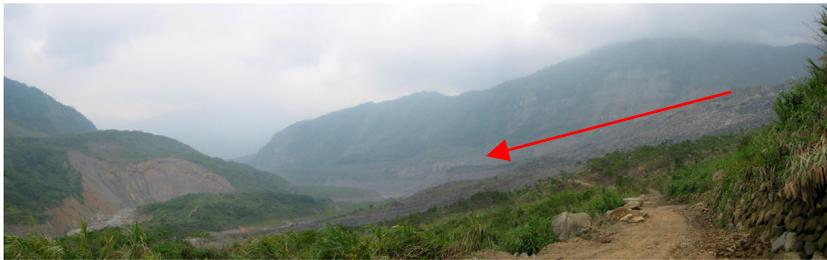
Figure 2: Seismic induced dip slope sliding in the Chaolin township (photo by C.-Y. Chen).

There were two huge landslide dammed lakes that were formed after the seismic shaking of the Chi-Chi earthquake initiated landslides. These sequentially extended their exposed areas following the subsequent rainstorms. Fig. 2 shows the dip slope sliding at Chaolin township of 4 km<sup>2</sup> in area and its landslide dammed lake (fig. 3) [3, 4]. Fig. 4 presents another dip slope failure at Jiufenershan township of 2 km<sup>2</sup> in area [6, 7] and its landslide-dammed lake (fig. 5).

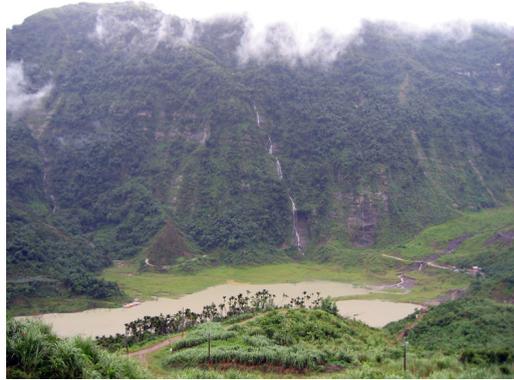
Figure 3: The landslide lake in the Chaolin township (photo by C.-Y. Chen).

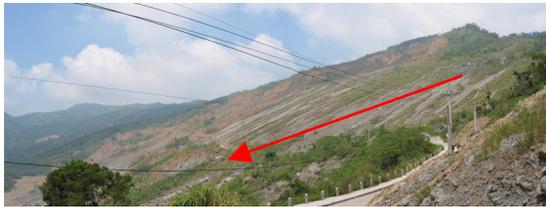
Figure 4: Seismic induced dip slope failure in the Jiufenershan township (photo by C.-Y. Chen).

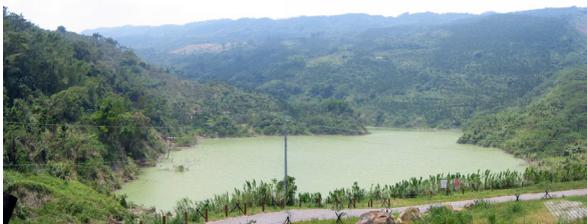
Figure 5: The dammed lake in the Jiufenershan township (photo by C.-Y. Chen).

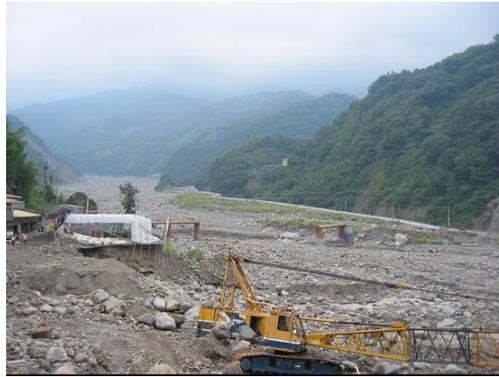
Figure 6: Repeated debris flow in the Chenyoulan river (photo by C.-Y. Chen).

Most of the repeated debris flows in history are located in the seismic affected areas in the middle of Taiwan. Fig. 6 shows one of the re-occurring debris flows in Chenyoutan river, Nantou County, in which the repeated debris flow was attributed to the abundant amount of debris in the streambed from the upland to the lower reaches.

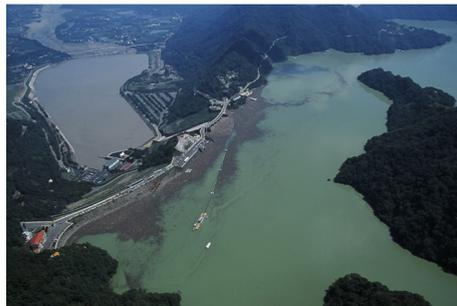
Figure 7: Turbid water and floating timbers from upland to the Shihmen reservoir following Typhoon Mindulle (photo by Council of Agriculture).

Fig. 7 presents the turbid water and floating timbers in the Shihmen reservoir after Typhoon Mindulle. The silt accumulation induced turbid water sources from the upland landslides and streamside scouring by torrential rain stopping the outlet and jamming the water supply pipes for a couple of days. This event reoccurred after the rainstorms induced by Typhoon Aere, Haima in 2004 and Matsa in 2005.

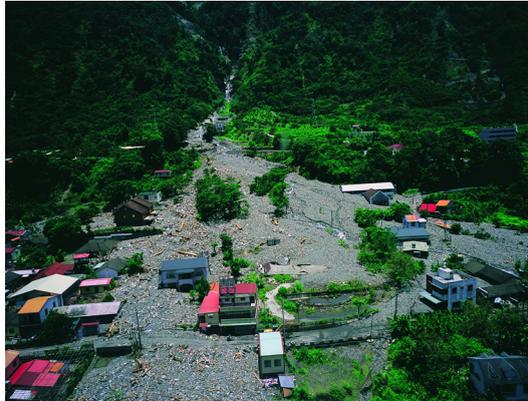
Figure 8: Debris flow hazard at Songher Tribute following Typhoon Mindulle (photo by Council of Agriculture).

Fig. 8 shows the debris flow hazards in Songher Tribute, Taichung County, when Typhoon Aere hit Taiwan in July, 2004. In this event, there were 43 houses buried by debris, and one further victim among the one thousand evacuated residents. This debris flow hazard originated from the Chi-Chi earthquake induced upland landslides and led to debris flow during Typhoon Aere and repeated hazards initiated by Haitang (in June) and Matsa (in Aug.) in 2005.

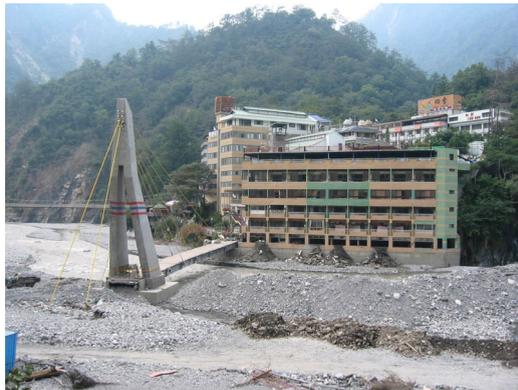
Figure 9: Deposited sediments at downstream of Dajia river following Typhoon Mindulle (photo by C.-Y. Chen).

The Dajia river watershed, in the middle of Taiwan, suffered from torrential rains during Typhoon Mindulle in 2004 and the following rainstorms when Aere, Haima and Matsa in 2005 hit Taiwan. The severe seismic landslides in the upland during the Chi-Chi earthquake cut-off the traffic and the debris masses migrated to lower reaches during the torrential rains. The depositional masses raised the downstream riverbed and inundated the buildings on the riverside during the torrential rains (fig. 9).

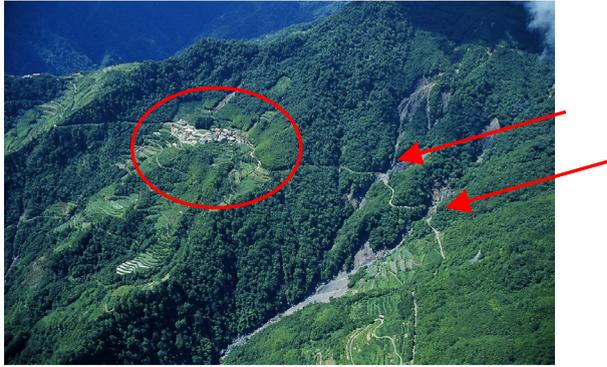
Figure 10: The isolated village after Typhoon Mindulle induced torrential rains in the upland area of the Shihmen reservoir watershed (photo by Council of Agriculture).

Fig. 10 shows the isolated village after Typhoon Mindulle induced torrential rains in the upland of Shihmen reservoir watershed. Most of the villages were

cut-off because of landslides or debris flows from more than 1,000 mm of torrential rains in recent years.
