The effects of large wood elements during an extreme flood in a small tropical basin of Costa Rica

Abstract

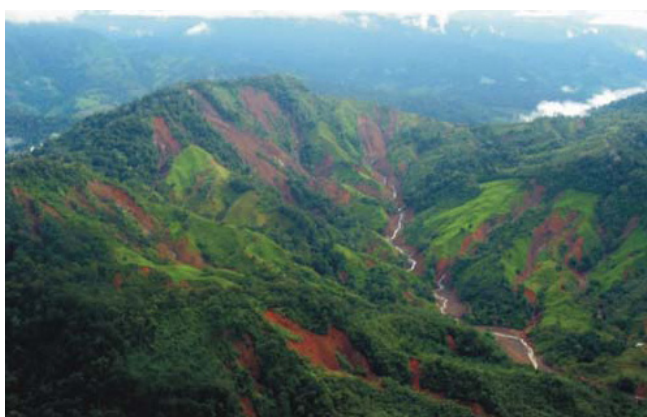
Figure 2: Multiple landslides triggered by the September 2005 event in the Río Guabás. The general condition of the Río Portalón has been reported to be similar (photo taken from [3]).

The basin features steep hillslopes, with widespread landslides and debris flows. Soils are generally very thick, ranging from 3 to 10 m in depth, and the underneath bedrock is mainly a turbiditic sedimentary rock of the Tertiary age [24]. In September 2005, the passage of the hurricane Rita generated diffuse flooding and mass wasting on the whole Central pacific area of Costa Rica, creating major economic and social impacts on the area [24]. In the Río Portalón basin, several landslides were triggered as a consequence of the intense precipitations (Fig. 2). The landslides supplied the main channel and the tributaries with large quantities of sediment and large mature trees.

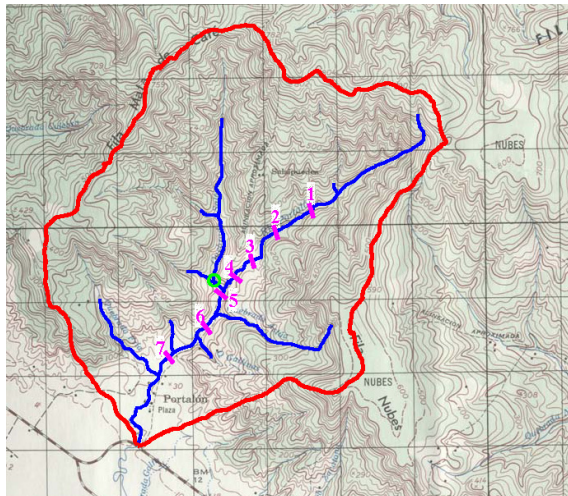
Figure 3: The Río Portalón basin and the location of the seven cross-sections where the peak flood has been estimated.

A field survey along the Río Portalón main channel was carried out on February 2008, in order to test the hypothesis that a dam-break surge was released by the collapse of a LW jam (the “wood plug” reported by the inhabitants). After an inspection of the entire channel, 7 reaches were identified (Fig. 3). Seven cross-sections were measured along with the longitudinal bed slope. High-water marks (i.e. deposited driftwood, scars on trees, gravel deposits) were used to estimate the peak stage for each cross-section (Fig. 4). Bed slope ranges between 0.015 and 0.05, whereas bankfull width varies between 16 m and 23 m.

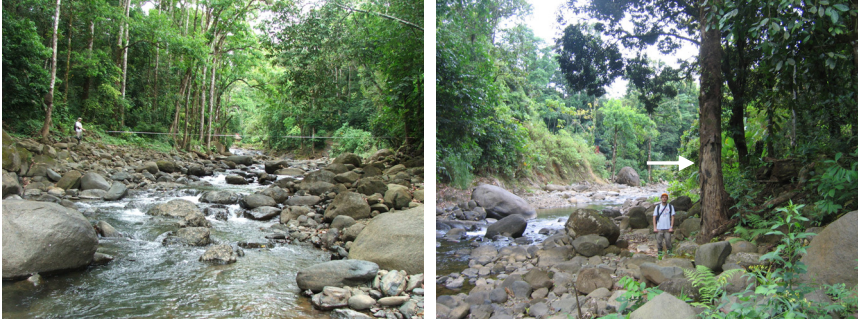
Figure 4: Field survey of cross-sections (left) and an example of flood mark (tree scar, right) Note the presence of very large boulders ($D > 1.5$ m) within the channel.

The third method is based on flow competence, i.e. the maximum clast size of the transported sediments. This was assumed to be the largest boulders still lying on the bed surface and that had been transported by the event. The intermediate axis diameters of the 10 largest boulders found around the cross-section were measured. The critical velocity required to move the averaged maximum clast diameter (D , in m) was calculated by the empirical formula of Costa [12]:

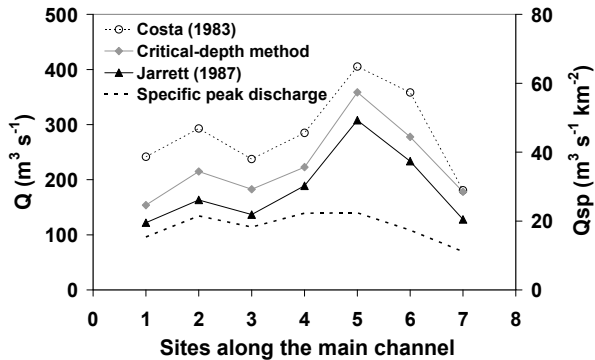
Figure 5: Estimated peak flood discharges (Q) along the Río Portalón main channel, from upstream (1) to downstream (7) cross-sections. The specific peak discharge (Q_{sp}) trend based on the critical-depth discharge calculated values is also showed.

The three mentioned methods used to estimate the peak discharge led to rather different results in absolute terms (Fig. 5). The method based on flow competence represents an upper estimate for peak discharges, whereas the Jarrett's formula provides values of Q which are, on average, lower by 8% than the critical-depth method which is considered to be the most reliable one. However, it is worth noting that the relative longitudinal trend showed by all methods is consistent.

Looking at Fig. 5, peak discharge appears to steadily increase downstream due to the larger catchment area down to section 4. Peak discharge then nearly doubles (from 220 to 360 $\text{m}^3 \text{s}^{-1}$) passing from section 4 to 5, i.e. just after the confluence with a right tributary, the Quebrada Salto, to abruptly decrease at downstream sections 6-7.

The collapse of such jam (about 4m-high) during the flood event may have caused a small surge wave transporting sediment and wood into the main channel, and the impulsive nature of the flood at its peak was indicated by local people during the interviews. However, the sharp increase in peak discharge at section 5 is nevertheless consistent with the augmented drainage area (Fig. 3). On the other hand, the sudden drop in the estimated peak discharges at section 6 hints to a rapid attenuation of the flood wave typical of small dam-breaks in mountain rivers (Fig. 5). As to the even lower discharge value at section 7, it can be attributed to the attenuation due to some overbank flows occurred on the left side of the channel between cross-section 6 and 7.

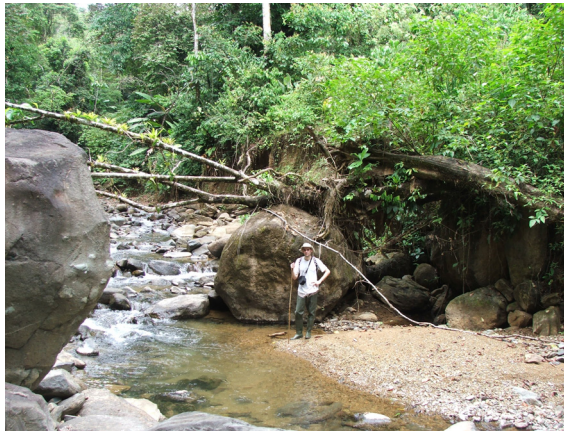
Figure 6: Boulders and wood pieces in one of the likely locations of the log jams.

A field inspection revealed that the basin drained by the Quebrada Salto was heavily affected by landslides which supplied large amount of sediments and large tress to that tributary. The narrow width of the Quebrada Salto has likely led to the formation of temporary jams of logs and boulders, with a considerable capacity to store water and sediments behind them. Despite the lush vegetation which rapidly grew at the channel margins after the flood, some evidences of the presence of large log jams were observed in at least 2 sites along the Quebrada Salto. In particular, the presence of several wood pieces just in front of the confluence with small debris flow channel, along with immobile boulders and sediment accumulation upstream reveals the likely position of one of this log jam (Fig. 6), a few hundred meters upstream of the junction with the Río Portalón (circle on Fig. 3). However, it is worth noting the large specific peak discharge ($\sim 20 \text{ m}^3 \text{s}^{-1} \text{km}^{-2}$) characterizing the event already upstream of the Quebrada

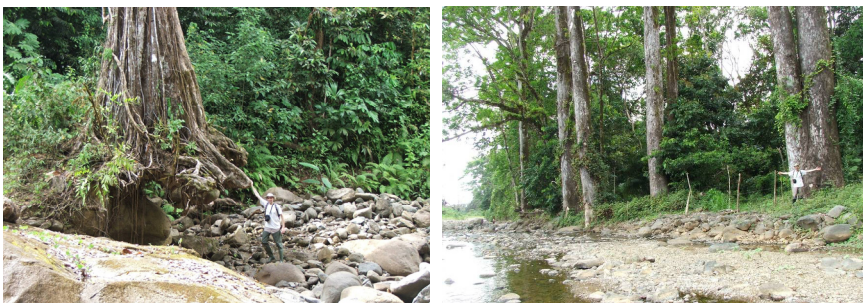
Figure 7: Large trees growing at the margins of the Río Portalón main channel.

Wood elements were relatively large, with an average length and diameter of 6.2 m and 0.37 m, respectively. However very large trees are ready to be recruited at channel margins (Fig. 6).

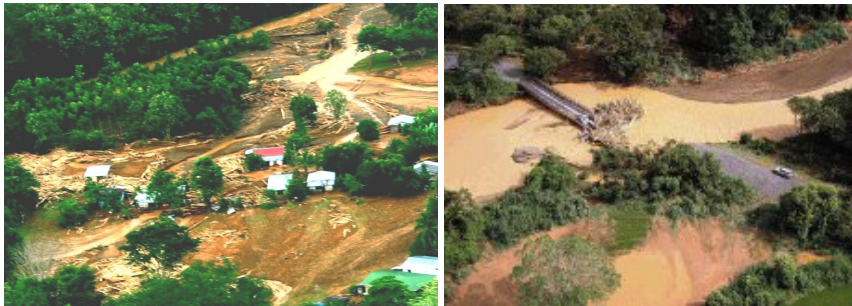
Figure 8: Wood elements lying on the flooded portion of the Portalón village (left) and accumulated on the collapsed bridge (right). The photos have been taken from the on-line version of the newspaper *Al Día* (26th September 2005).

decision of river managers to “clean-up” the river network from in-channel wood and to periodically cut riparian vegetation on floodplain. This practice is detrimental to stream ecology but on the other hand has also dubious effectiveness to reduce the hazards of high magnitude flood events. As showed by the Río Portalón case, wood stored in channels is only a little portion of the wood transported during extreme events, and the movement of in-channel logs is much reduced during low to moderate floods. Thus, for most period of time the in-channel wood lies relatively stable in the river system contributing to stabilize the bed, to limit the sediment transport and to create discontinuities that provide habitats for fishes and macroinvertebrates communities. Considerable amount of wood, which can create unstable jams, is recruited from slopes instabilities spread on the basin and eroded banks only during high magnitude floods. These infrequent floods are able to transport substantial loads of sediments and modify substantially the river bed due to erosion/deposition processes, which can represent the main threat even without any floating wood.

A more effective management option against flood risk – not only due to floating wood – would be to avoid any reconstruction or building of valuable structure in flood-prone areas. The adoption of a careful land use planning should of course be negotiated with local communities in order to achieve a prevalent social acceptance. As a compatible strategy for flood hazard reduction, wood recruitment and transport processes have been recently modelled [18] and considered in hazard mapping [22, 26]. However, these mapping methods usually require the availability of well calibrated probabilistic regional curves for flood-design estimation and detailed maps of landslide prone areas land use and forest vegetation typologies [22], and have been implemented experimentally only in Alpine areas.
