Protection against debris flows with 13 flexible barriers in the Milibach River (Canton Berne, Switzerland) and first event analysis

C. Wendeler & B. Vjekoslav
Geobrugg AG, Switzerland

Abstract

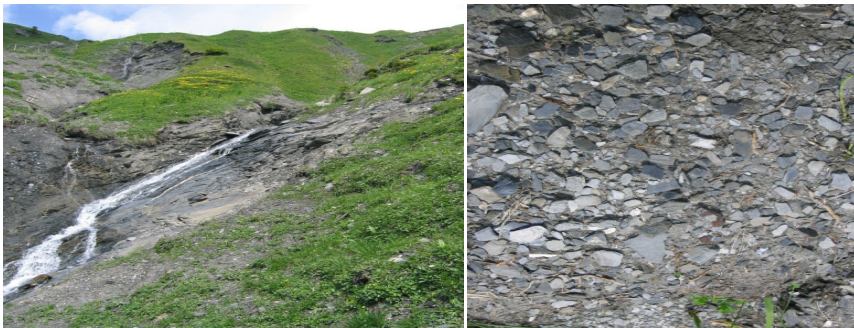
Figure 2: Catchment area with the Milibach in the Gummen region (left), alénien schist material (right).

The valley of Gummen is made of slope parallel black clay rich alénien schist (Alénienschiefer). Sometimes there are some parts of sandstone in between. The slope parallel schist is very sensitive to weather and acts as an aquiclude [1].

This formation is overlaid by a weathered, several meter thick debris layer. This layer forms the origin for the debris flow material and consists of the weathered part of the upper Doggers. Parts of moraines occur only infrequently within the debris.

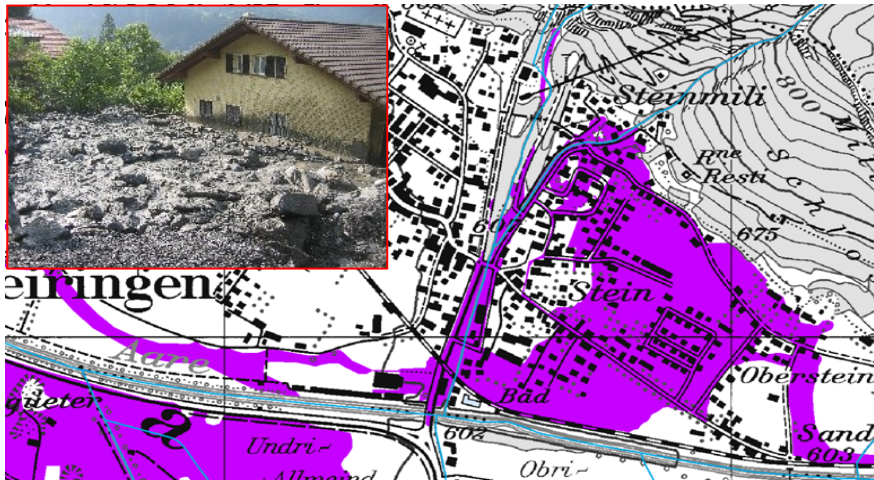
Figure 3: Deposited debris in the village of Meiringen (violet) caused major damage to infrastructure and houses.

In August 2005 during heavy rainfalls the settlements of Hasliberg Reuti and Meiringen were flooded. The debris flows initialised at the Gummen catchment area caused main disaster of human infrastructure (figure 3).

Around $13,000 \text{ m}^3$ of the weathered schist material in the catchment were mobilized during the intensive rainfall and were transported within 3 surges down the channel. Along its way down a further $25,000 \text{ m}^3$ were picked up by erosion processes and expanded the total volume of the flow up to $40,000 \text{ m}^3$.

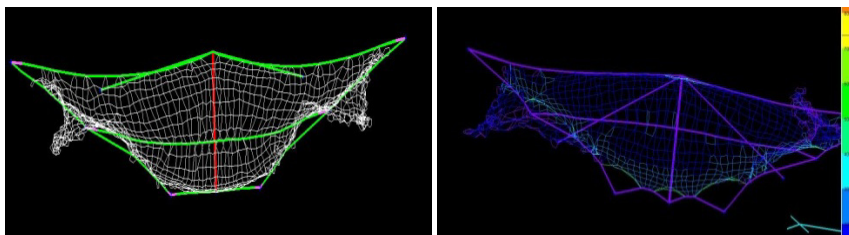
Figure 4: Simulation of representative barrier for project Gummen using the software FARO.

The dimensioning of the flexible ringnet barriers was carried out using the finite element software FARO [4]. Using the results of the test site Illgraben [5, 9] for validation, this software initially developed for rockfall simulations has

been adapted to the debris flow load case. Compared to rockfall, debris flows are characterized by distributed loads instead of a punctual load, longer braking time, smaller deflection and several surges arriving onto the net.

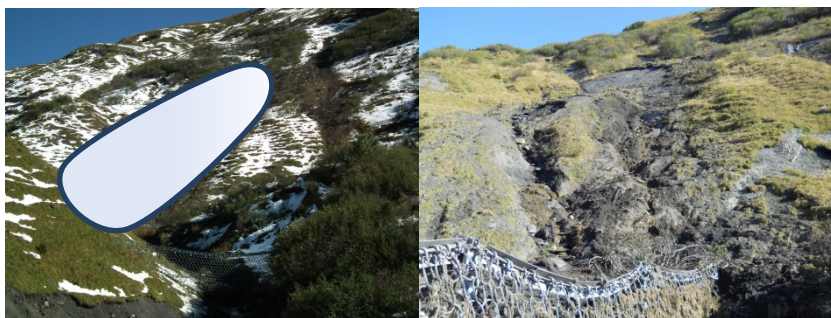
Figure 6: Shallow landslide close to flexible barrier No 2 caused the filling of this barrier.

In the Gummen catchment area around 2,000 m³ of material got mobilized 10th October, most of the material brought by a shallow landslide close to flexible ringnet barrier No 2 (see figure 5).

The customer as well as the project involved geologist decided to leave barrier No 2 filled in the torrent for the next time to stabilize the foot of the shallow landslide at the slope to the right view river upstream (see figure 5). Without the retention capacity of barrier No 2 the complete provided volume of the concept will be indeed reduced a bit but therefore the eroded slope can stabilize itself by nature grass covering. Barrier No 5 will be cleaned with normal water flow, some maintenance work will be required caused by eroded anchors at this barrier. But this aspect is hard to avoid in an event case in such a loose soil condition of alénien schist material which is easily eroded by water infiltration.

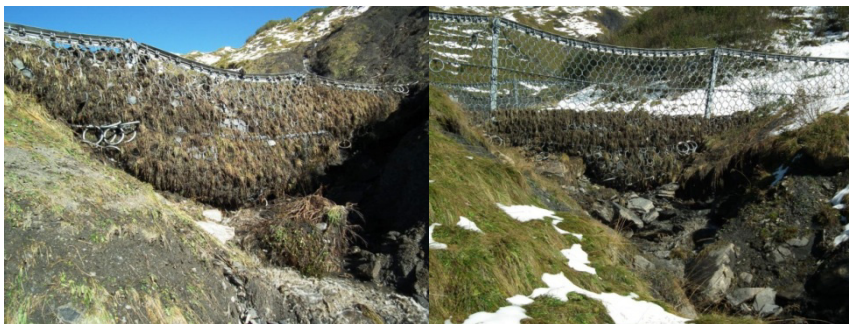
Flexible ringnet barrier No 2 got filled up to the max. level and flexible ringnet barrier No 5 filled up to half (see figure 6). The nets in between did not fill up because of their higher basal opening, the gap between the lower support rope and the river bed.

Figure 7: Stopped material behind barrier No 2 and barrier No 5.

Also the complete developed design concept of the dimensioned barriers was proven by this event. No failure of the directly impacted barrier No 2 was happening even the shallow landslide brought a total volume of around 2000 m³ at once impacting the barrier. The material retained behind the barrier look dense with an estimated density of the slide of around 2,000 kg/m³. To recalculate the impact forces of the slide to the barrier the velocity plays an important role. In that case for 30° inclined slope it can be estimated to max. 10 m/s. Flow height of the slide are much harder to estimate and cannot be declared thus impact pressure acted on the barrier No 2 unluckily cannot be back calculated precisely.
