# Study of the liquefaction phenomenon due to an earthquake: case study of Urayasu city

This paper describes some remarkable damage against the structures due to the liquefaction by the earthquake, and indicates the possibility of liquefaction by current determination methods using published soil profile and N value of SPT (Standard Penetration Test). The authors also carried out a series of laboratory liquefaction tests (the cyclic undrained triaxial test) in order to make clear the characteristics of liquefaction, using Urayasu sand taken from the liquefied site in Urayasu city.

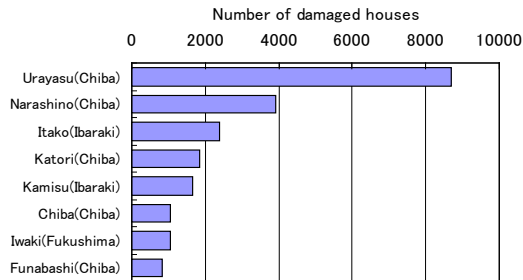
Figure 3: Number of damaged houses caused by liquefaction [2].

From Figures 2 and 3, it can be seen that the liquefaction damage in the Kanto area is not only around the Tokyo Bay coast, but also the coastal areas with reclaimed soft ground in Tone River, Arakawa River and Kasumigaura which used to be a river, pond or sea. The highest amount of liquefaction damage occurred in Urayasu city where about 8,700 houses were damaged.

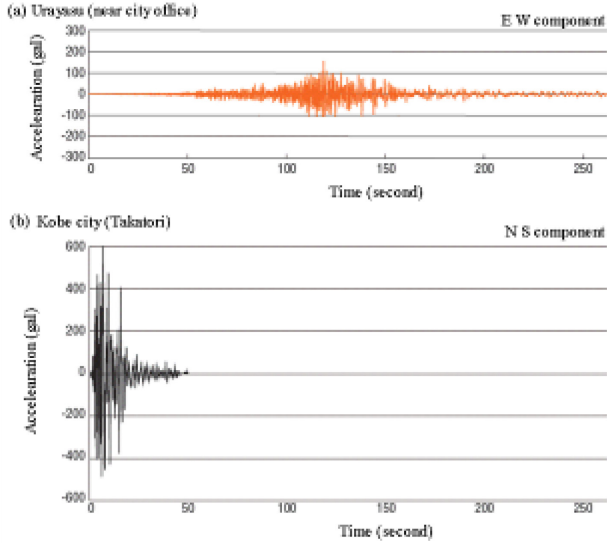
Figure 4(a) shows the acceleration-time history of the Great East Japan Earthquake observed in Urayasu city near the city office. The seismic wave was about 150 gal at maximum acceleration and not so large, but the duration of seismic waves was more than 70 seconds and long compared to previous earthquakes. Urayasu city is located facing Tokyo Bay, and about 75% of the land of the city was reclaimed after the 1960s, and the reclaimed area was devastated largely by the earthquake. For the comparison, Figure 4(b) shows an acceleration-time history observed at the time of the Great Hanshin-Awaji earthquake in Kobe city in 1995. The seismic wave's characteristic of the Great Hanshin-Awaji earthquake is that acceleration exceeding 400gal for about 20 seconds, and it is relatively short. Liquefaction at the Great Hanshin-Awaji earthquake was limited in the area with more than seismic intensity 6, but in Urayasu city during the Great East Japan earthquake there was a seismic

Figure 4: Observed acceleration time histories [3]: (a) The Great East Japan earthquake (2011); (b) The Great Hanshin-Awaji earthquake (1995).

intensity of 5+. Therefore, long seismic wave duration is considered to be contributing to the occurrence of liquefaction. In addition, the three aftershocks (Mw=7.0, 7.4, 7.2) after the main earthquake occurred without much time difference (approximately 20 to 35 minutes) and it might also have contributed to the liquefaction.

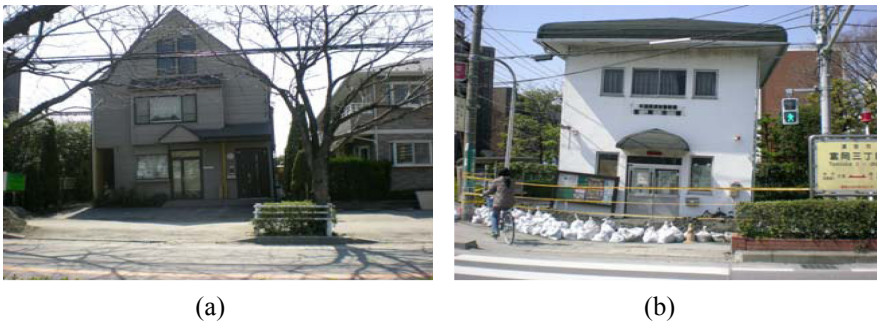
The ground which lost its bearing capacity by liquefaction could not support structures, and caused settlement and tilting of small residences based on spread foundation. Also, by boiling effect, sand eruptions were found in many places (Figures 5(a) and (b)).

Figure 5: (a) Tilting of a small residence. (b) Tilting of a police station.

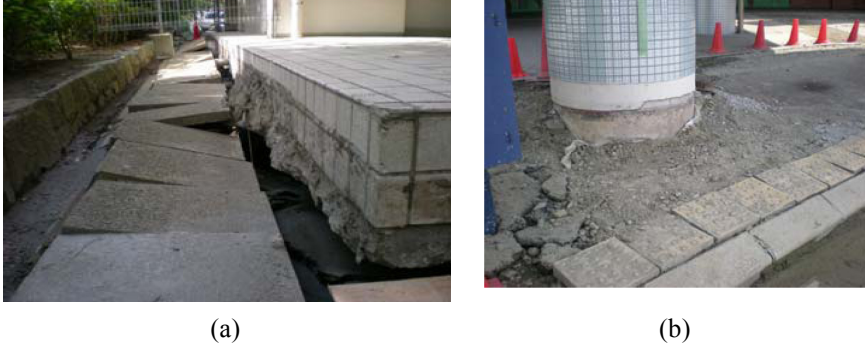
Collective housing and large-scale buildings adopted a pile foundation around this area, so the damage was, relatively, not seen. However, at the contact point of the foundations and ground, there was frequent damage relating to lifelines such as drain pipes shutting off (Figure 6(a) and (b))

Figure 6: (a) Contact point of foundation and ground. (b) Contact point of footing and ground.

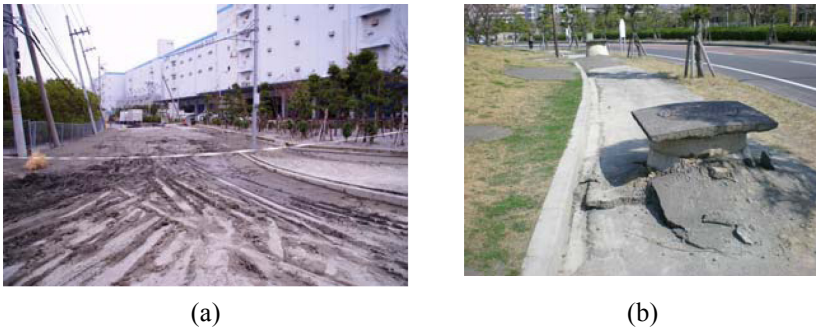
In the road, a sand boiling effect was seen all over from cracks in the pavement. In addition, a manhole, once lying underground was lifted by buoyancy and caused damage (Figure 7(a) and (b)).

Figure 7: (a) Boiled sand on the road. (b) Lifted manhole.

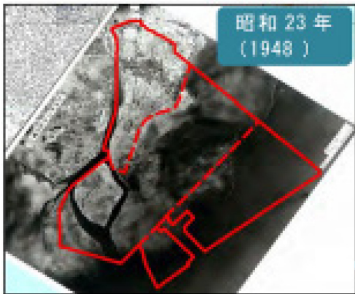
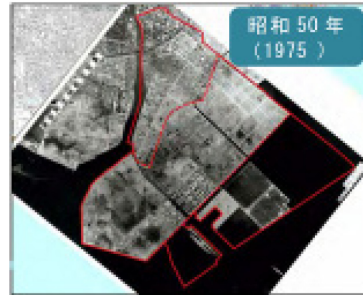
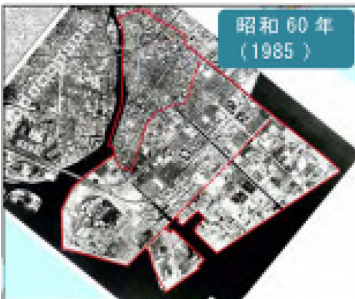
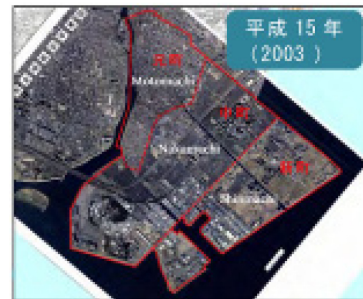
Figures 9–12 [4] are aerial photographs that show the status of the landfill in Urayasu from 1948 to the current time. As a result of reclamation, these photographs show how the city area has expanded to four times its original size.

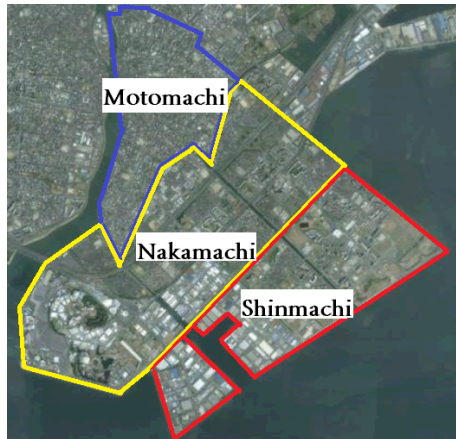
The land in Urayasu city can be divided into 3 parts; Motomachi, Nakamachi and Shinmachi which means, respectively, Old Town, Middle Town and New Town in Japanese. Motomachi is inside the blue line in Figure 13, and is the

Edogawa River Delta made by river deposit; it is an old town which previously flourished as a fishing village. Nakamachi is inside the yellow line in Figure 13, and reclamation started from 1964. Newest Shinmachi is inside the red line, and its reclamation took place between 1972 and 1980; this is the newest land.

Figure 13: Three part sof Urayasu city (blue, yellow and red).

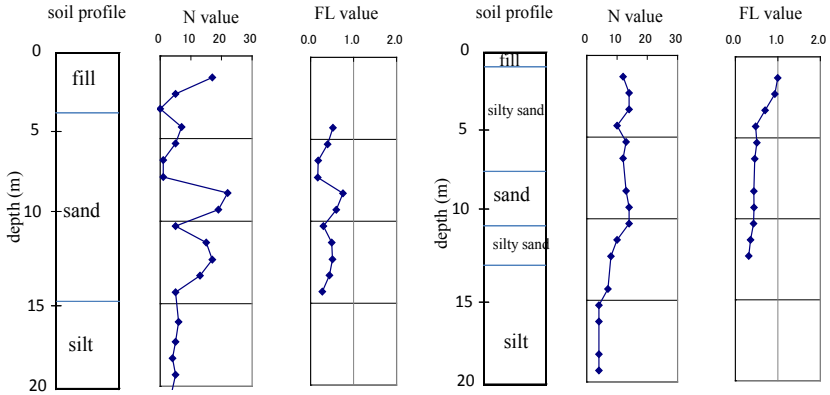
Figures 14–16 show the calculated FL value of three sites (Shinmachi, Nakamachi and Motomachi) in Urayasu city by using published boring data [7]. These figures show the data at Hinode in the Shinmachi area, at Mihama in the Nakamachi area and at Kitasakae in the Motomachi area, respectively. The PL values of these sites are shown in Table 2 by Eq. (2). From these figures and table, the calculated FL values are lower than 1.0 at any depth in the Hinode and Mihama areas which are the new reclamation lands of Shinmachi and Nakamachi. At the former fishing village of Kitasakae in Motomachi, some FL values are higher than 1.0, or the ground consists of silt deposit so that analysis of the liquefaction is not necessary. While the possibilities of liquefaction at Hinode and Mihama are “very high” because the PL values are higher than 15, at Kitasakae in Motomachi, the PL value is lower than 15, and the liquefaction possibility is “high” by Table 2.

Figure 14: Calculated FL value – Hinode (Shinmachi). Figure 15: Calculated FL value – Mihama (Nakamachi).

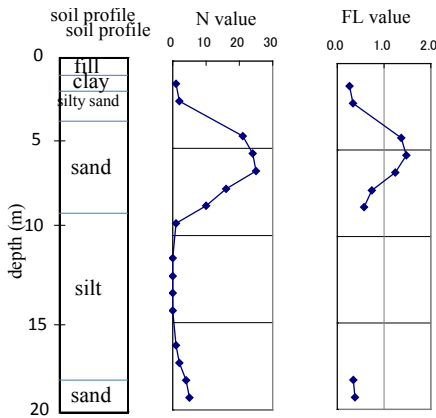
Figure 16: Calculated FL value – Kitasakae (Motomachi).

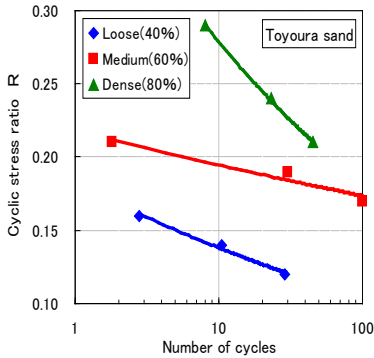
Figure 19: Relationship between cyclic stress ratio and number of cycles (Toyoura sand).

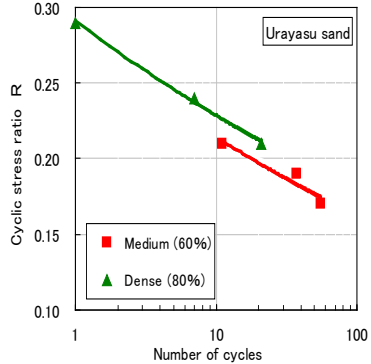
Figure 20: Relationship between cyclic stress ratio and number of cycles (Urayasu sand).

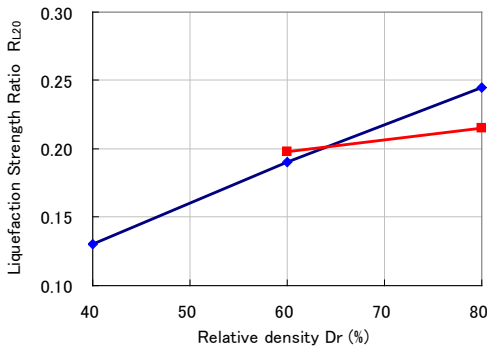
Figure 21 plots the relation of liquefaction strength and relative density of Urayasu sand and Toyoura sand. For a medium sample ( $Dr=60\%$ ), there is no difference, but in a dense sample ( $Dr=80\%$ ), Urayasu sand has a tendency for smaller liquefaction strength. This tendency can be understood due to the above fine fraction content.

Figure 21: Relationship between liquefaction strength and relative density.
