Bordj Hamza, description, pathology and restoration

Abstract

The fortress of Bouira Bordj Hamza is one of the last Ottoman fortresses in the region of Kabylie in Algeria, which remain more or less preserved and not processed. It was built during the reign of the pasha Hassan Corso who ordered between 1540 and 1541 the implant of several fortifications at strategic points in the territory of Constantine to control and monitor the Eastern territory. The fort is the only one authentic monument in this site and later on the city of Bouira, town built for the French settlers, close to it. It was the scene of clashes between the Ottoman and the Kabyle tribes rebelled against the regency and between the Algerians and the French troops until 1871. The fort suffered from much destruction between the 19th and 20th Century while some restorations occurred at the same period of time. After the Algerian independence it was abandoned and looted from its materials, then squatted and turned into a slum which caused its destruction and only its imposing outer wall is still standing. Today, the restorations of the walls are in progress, the project consists of the repair and the strengthening of t

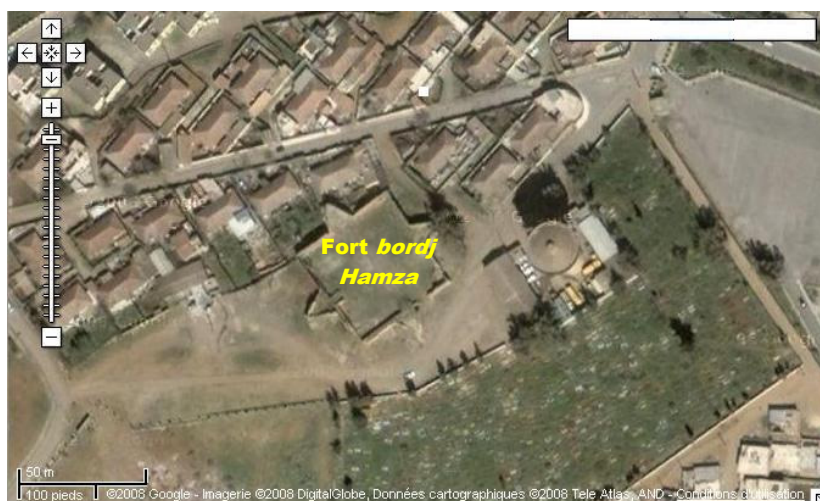
Figure 1: Bordj Hamza in Bouira-2010.

During the period of French colonialism, the town of Bouira developed around the fortress bordj Hamza and today, it is situated in a residential area, Draa el Bordj, to the south of the town. The fortress, built on a dominant hillside, overlooks the rest of the town. It is surrounded by individual dwellings in the north and a cemetery and agriculture land in the south (Fig. 1).

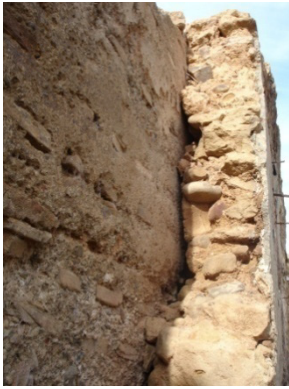
Figure 8: French and Ottoman back to back wall.

In 1848, the French military engineers surrounded the fortress with a second store wall built back to back with the first (fig. 8) increased its height and crowned it with battlements and apertures for their canons (fig. 9). As the Ottoman wall remained mostly protected on its outside face, the consolidation work today concerns the parching up of the French wall on the exterior face of

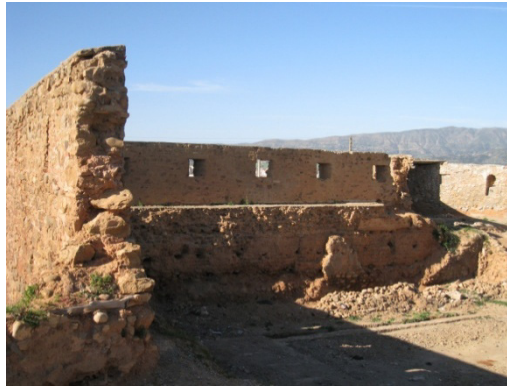
Figure 9: French battlements and apertures.

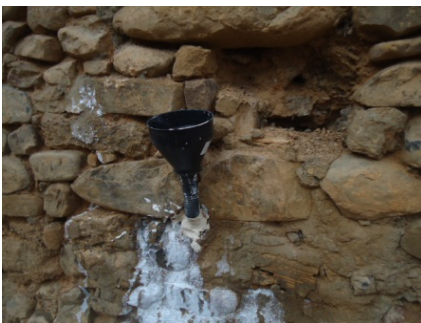
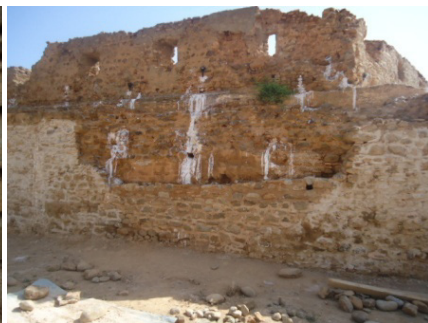
Figure 10: Funnel used for filling liquid mortar into the walls.

The operation of the cementation of the walls using a fluid mortar of limestone base was done from top to bottom and by successive layers until the whole of the interior cavities was filled (fig. 10).

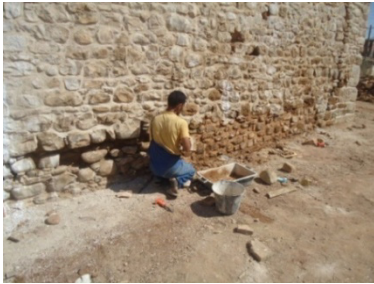
Figure 11: Reconstruction of fragments of crumbled masonry.

The second operation consisted of strengthening the walls by filling a “banchage” with the same materials of the original and reconstructing holes in the masonry (figs. 11, 12).

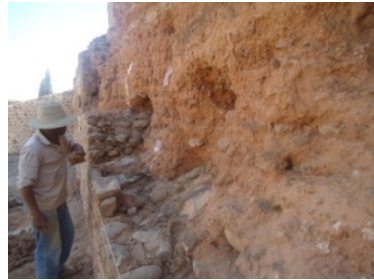
Figure 12: Reconstruction of the inside Ottoman rampart.

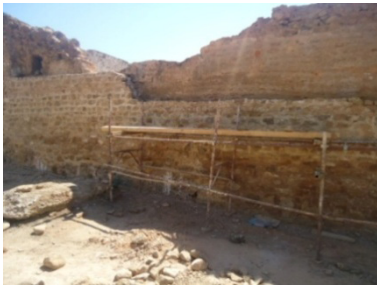
Figure 13: Repair of the outside French wall.

Then the operation of consolidation to physically replace damaged parts (reconstructing portions of the walls by using the same material) (figs. 13–15).

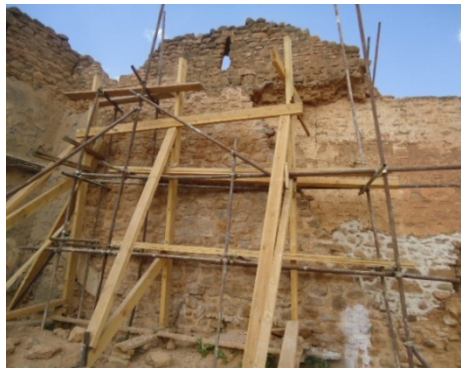
Figure 15: The wall fragments were reconstructed using a masonry of rough stones continuity of existing materials and joints.

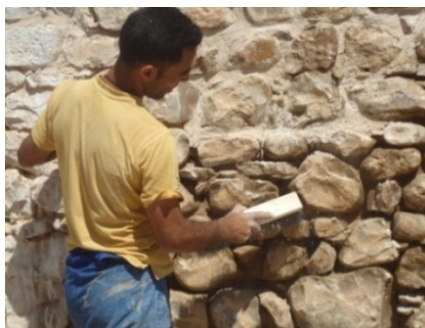
Figure 16: Repair of joints.

As for the pointing of the masonry, the existing joints were rubbed down 3cm by hand then a limestone based mortar was spread along the thickness of the cavities and smoothed out in such a way so as to avoid protuberance of the mortar (fig. 16) followed by laying a periphery outside drain to avoid leaks (fig. 17).

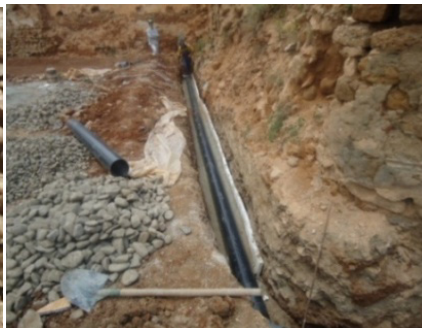
Figure 17: Laying of the periphery drain.

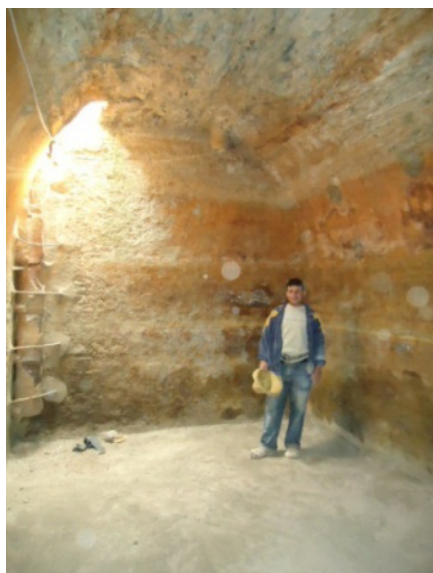
Figure 18: The Ottoman underground cistern.

Another step was the total cleaning and jointing of the walls of the Ottoman underground cistern or djeb (fig. 18) as well as the restoration of its access (fig. 19).

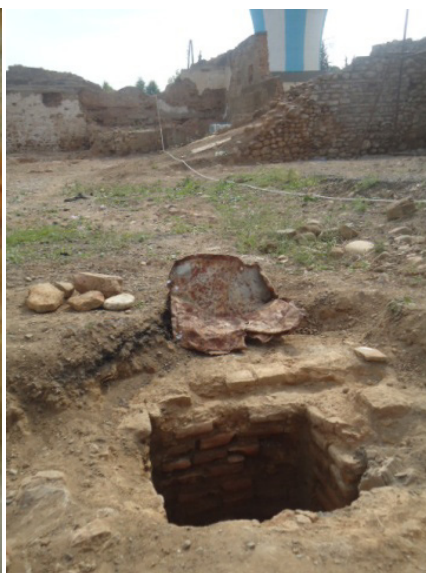
Figure 19: The cistern access.

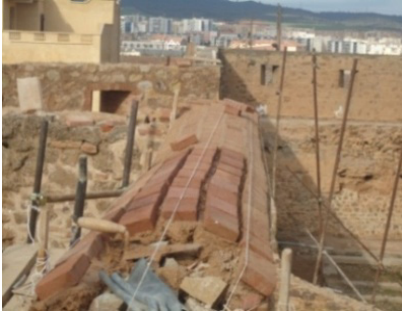
Figure 20: Curved brick to repair the top of the walls.

The top of the walls are stabilized by repairing and restoring the masonry with a line of curved bricks (fig. 20). Treatment of the battlements and canon apertures consisted of a cleaning operation. The stones and bricks were brushed and the most damaged were replaced (fig. 21). Finally the contour line was restored by a limestone based mortar.

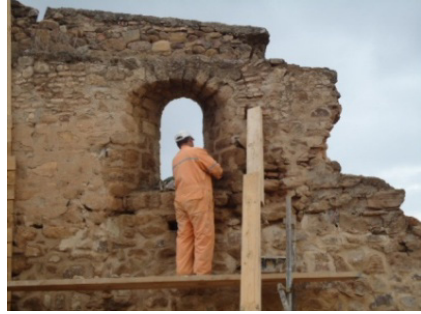
Figure 21: Treatment of the battlements and canon apertures.

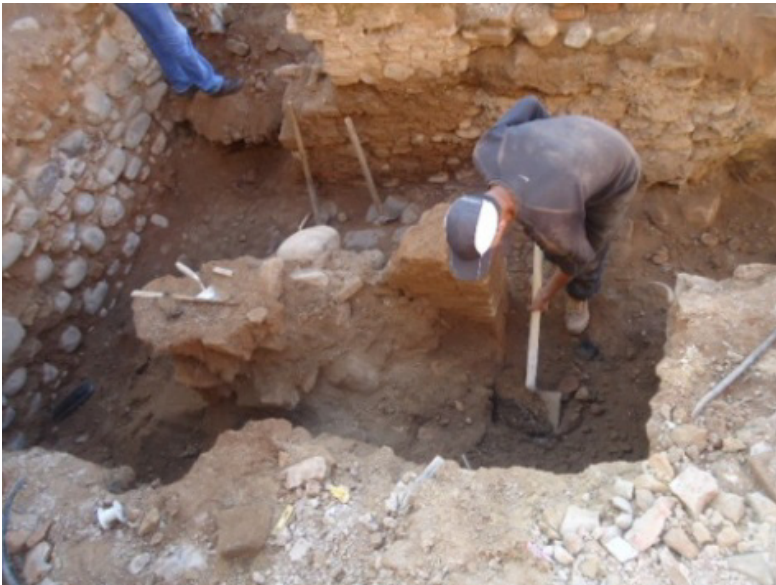
Excavation and clearing away of the soil in the eastern angle of the fortress brought to light three low boundary walls; not exceeding 1.20m in height, along three sides of the gunpowder depot (fig. 22).

Figure 22: The brought to light of the gunpowder depot.

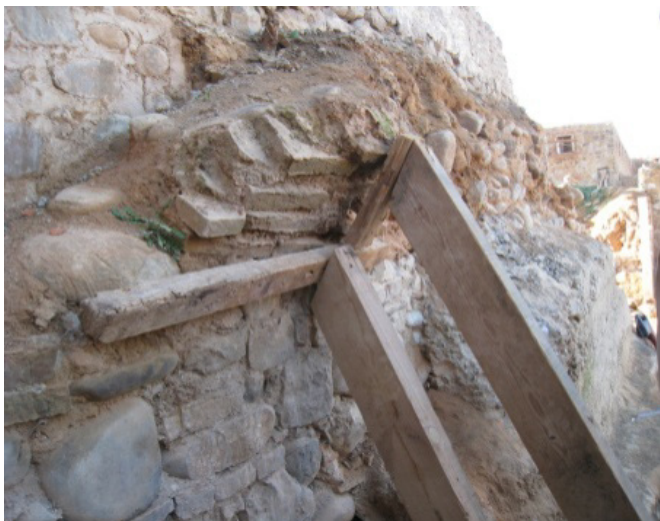
Figure 23: In the entrance to the depot a fragment of a semi-circular archway was equally uncovered.

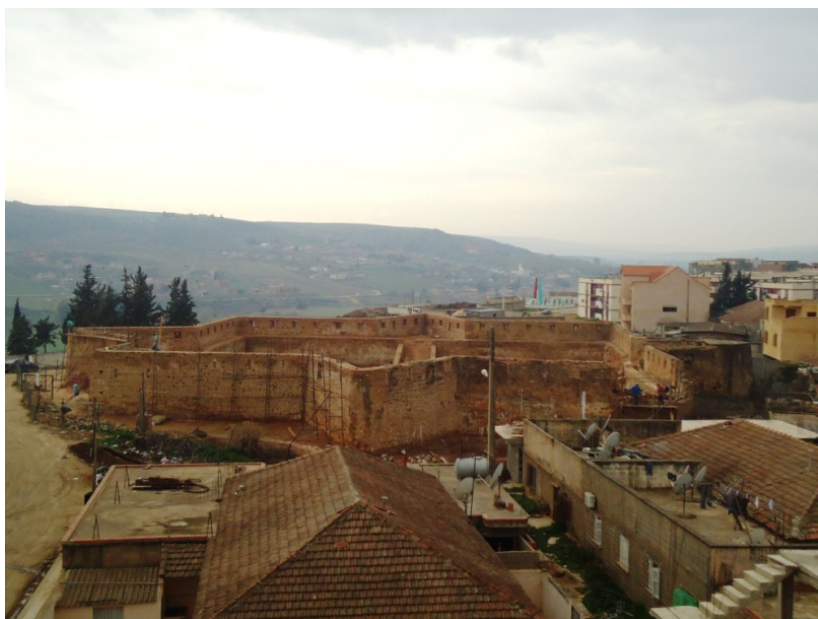
Figure 24: The general appearance of Bordj Hamza during the restoration in January 2012.
