RESTORING A DEGRADED COASTAL WETLAND IN THE CITY OF CAROLINA, PUERTO RICO: A CASE STUDY

ABSTRACT

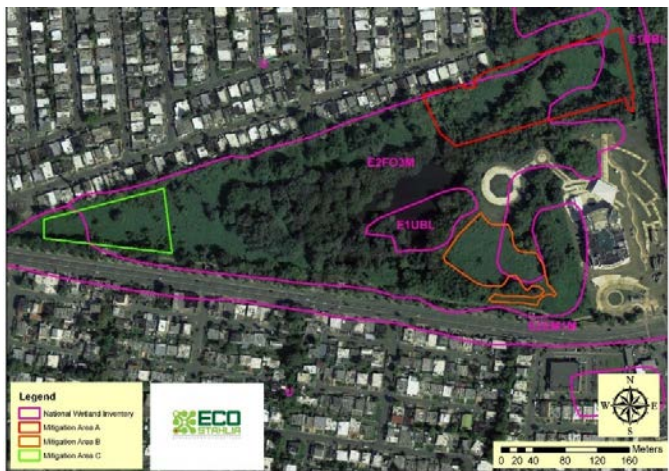
Figure 2: Aerial photo of CM wetland Mitigation Areas.

The proposed compensatory mitigation sites included tree wetland areas (Fig. 2). Mitigation Area A consists in the establishment of a canal approximately 0.045 acres (184.1 m^2) that connects approximately 1.8 acres (7367.7 m^2) of forested wetlands to main source of water, Canal Blasina. This forested wetland was established by enhancing an existing degraded herbaceous wetland. In addition, approximately 0.2 acres (929.5 m^2) of forested wetland (mostly red mangrove) was created along the slopes of the canal to be constructed. A forested upland buffer zone of approximately 0.46 acres (1845.6 m^2) was established along the eastern perimeter of Mitigation Area A. Total Mitigation Area A including mitigation works (2.5 acres) and existing forested wetlands were 5 acres.

Mitigation Area B consisted of the enhancement of another degraded herbaceous wetland located west of the Children Museum. Total area of Mitigation Area B is approximately 2 acres (8025 m²) and construction in the site begun in 2019. Mitigation Area C consisted in the enhancement of a degraded herbaceous wetland located west of Mitigation Area A. Total area of Mitigation Area C is approximately 2 acres (8085.6 m²) and wetland enhancement activities in the site begun in 2019. The combined area of the three compensatory mitigation sites was 9 acres. A conservation easement of the three mitigation sites (A, B and C) was created to ensure its protection.

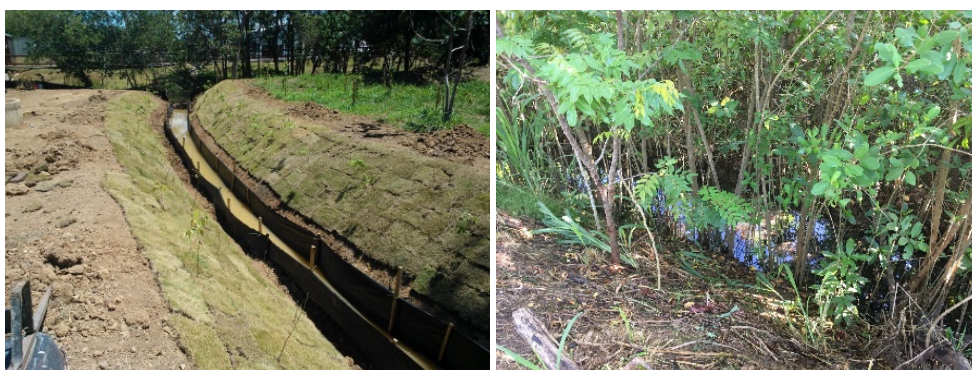
Figure 3: Before and after of the open water canal connecting Mitigation Area A with secondary freshwater canal.

This compensation method provided open water functions and values to the forested wetland creation and wetland enhancement areas; the latter being enhanced also to forested wetlands. Using heavy equipment (excavator), a 2 m wide and 100 m long canal was dig up to connect the forested wetlands of the enhancement areas to a secondary canal that connects to an open water pond of Canal Blasina outside the mitigation site. This structure allowed the influx of water into the existing degraded wetland. The constructed canal has an area of approximately 0.045 acres (184.1 m²) and was constructed mostly on uplands (Fig. 3). The canal connects the new reforested and enhanced upland and wetland areas to a secondary canal that discharges into the Canal Blasina. The bottom of the canal had an elevation of -0.2 m below mean sea level; therefore, it was permanently inundated. Wetland tree species like Red mangrove (*Rhizophora mangle*), White mangrove (*Laguncularia racemosa*) and Black mangrove (*Avicennia germinans*) were planted along the slopes of the canal. This method was carried out at Mitigation Area A.

During construction activities, no site grading was necessary, except for the construction of the upland water canal section at Mitigation Area A. Water from the secondary canal reached Mitigation Area A enhanced wetlands through the new canal providing the necessary hydrologic regime for the site. In contrast, Mitigation Areas B and C were near the water table and elevations of existing canals; therefore, the hydrology source already existed within both sites. Once the construction of the canal was completed, the planting plan was developed. The plan relied upon planting selected plant species to establish the plant community, seed bank, natural recruitment, and control or management of undesirable invasive exotic species. Most of the planted species produce fruits or seeds that are important food source to wildlife. This technique assured a higher ecosystem productivity and increase wildlife diversity.

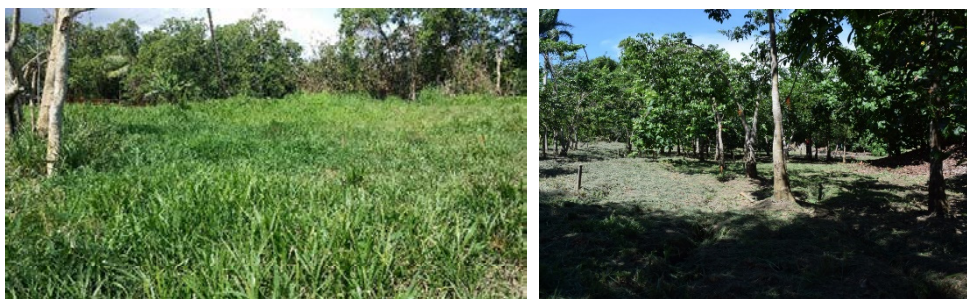
Figure 4: Before and after view of a section of Mitigation Area A with 4.5-year old Bloodwood trees.

This method was carried out within Mitigation Area A, and its being implemented also in Mitigation Areas B and C. Approximately 1.8 acres (7367.7 m²) of degraded herbaceous wetlands within Mitigation Area A were enhanced by planting approximately 2,335 wetland tree species. This area was hydrologically connected to the constructed open water canal and was planted with wetland adapted and transitional species such: Swamp apple (*Annona glabra*) and Bloodwood (*Pterocarpus officinalis*; (Fig. 4)). In Mitigation Areas B and C, with a total area of approximately 4 acres (16,075.6 m²), 4,019 trees will be planted by the end of March 2020.

Although tree mortality was recorded in all species, we observed an unexpected high mortality in *Pterocarpus officinalis*, *Annona glabra* and *Calophyllum antillanum*. The first two species are known to be adapted to wetland conditions and are relative common in the island wetlands, whereas *Calophyllum* is a common species planted in roads and ornamental gardens and is tolerant to anthropogenic disturbance [11]. Our findings showed a preliminary 63.9% of tree mortality which is way above the 15% maximum tree mortality required by the permit issued by the USACE.
