Empirical fragility curves for Peruvian school buildings

A. Muñoz, M. Blondet, R. Aguilar & M.-A. Astorga

Department of Civil Engineering, Catholic University of Peru, Peru

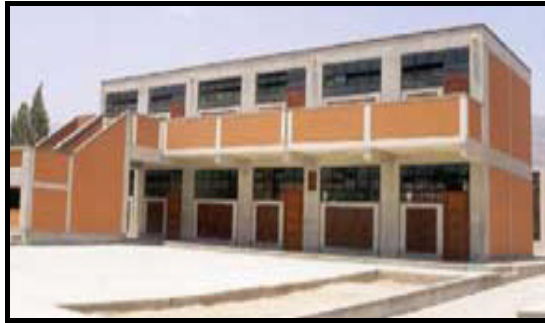
This type has been built since 1997 following the Peruvian seismic code, which in that year significantly raised the rigidity and lateral resistance requirements. The typical building has a rectangular plan, with one, two or three stories and

7.80m x 7.80m square classrooms. In the longitudinal direction, the building has two frames with big columns; and in the transverse direction, confined masonry walls. The roofs are lightened unidirectional slabs 0.20m thick.

Figure 2: 780 Modern buildings.

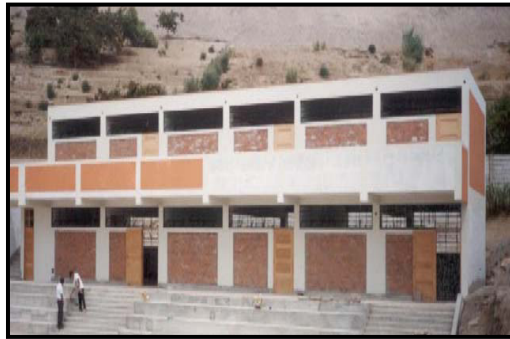
This type had been built prior to 1997 (Figure 3). Its architecture is similar to the 780 modern building. In the longitudinal direction the building has two frames with weak columns and in the transverse direction confined masonry walls. The roofs are lightened unidirectional slabs 0.20m thick. This type of building has suffered significant damage in past earthquakes. The problems were mainly due to the limited lateral rigidity that triggers the “short column” problem.

Figure 3: 780 pre Seismic Design 1997 Code buildings.

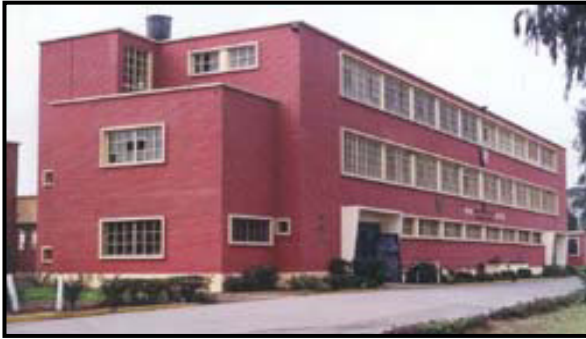
These buildings were built 50 years ago (Figure 4). They have two or three stories with approximately 10m-long classrooms. Its plan area is more than double that of the 780 buildings. In the longitudinal direction the building has

three edges of columns and in the transverse direction confined masonry walls. The roofs are lightened unidirectional slabs 0.20m thick.

Figure 4: Big school buildings.

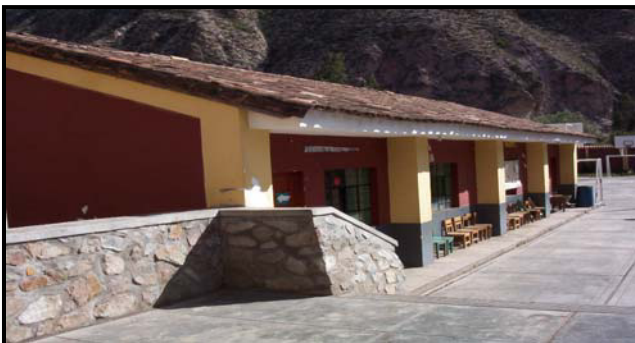
These buildings vary greatly in dimensions and quality of materials. The Government does not have a typical module. For our purposes, we have considered as the typical building a single story rectangular plan with two or three classrooms (Figure 5). The walls are orthogonal to each other and are 0.40m thick. The roof is light and tilted.

Figure 5: Adobe buildings.

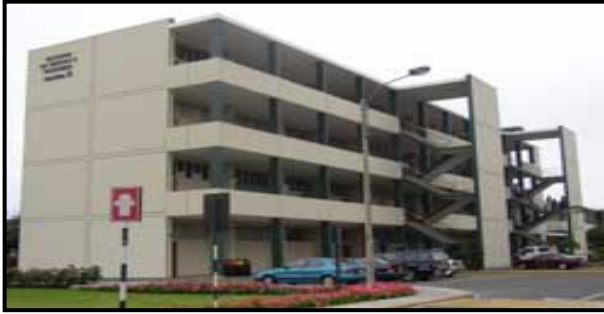
These are two- to five-story buildings (Figure 6) with rectangular plan similar to the big school buildings. The structural system consists of three reinforced concrete frames in the longitudinal direction and confined masonry walls in the transverse direction. The roofs are lightened unidirectional slabs 0.20m thick.

Figure 6: High educational pre 1997- SDC buildings.

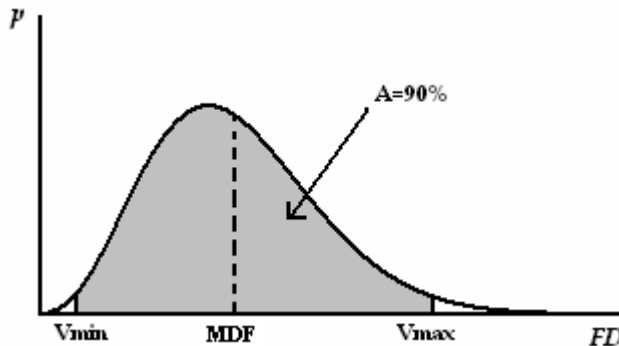
Damage distribution was modeled using the Beta Function because of its simplicity and adaptability to the information of the group of experts (Figure 8). We assumed that the estimation of the mean damage factor (MDF) corresponds to the mean value of the Beta Distribution and that 90% of the occurrence's probability is between the extreme values V_{max} and V_{min} [3].

Figure 8: Beta function assumed to represent the damage distribution.

With the mean values obtained from the group of experts, damage probability distribution functions (p) were created for each intensity and for each type of Peruvian school building.

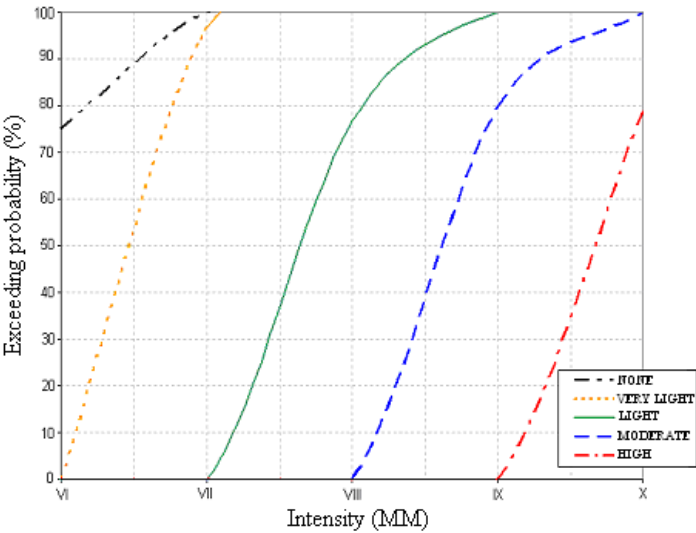
As a result of this procedure, we obtained fragility curves and damage matrices corresponding to the five types of Peruvian school buildings. Figure 9 and Table 3 show the results for the 780 modern building.

Figure 9: Fragility curves for 780 modern building.

Fragility curves were determined computing the exceeding probabilities (E.P) corresponding to the extreme value of each damage limit in each seismic intensity, eqn. (2). For the damage matrices it was necessary to determine the occurrence's probability (q) of each damage state in each intensity, eqn. (3).
