Evaluating the retrofitting process for Imam (Soltani) Mosque monument after Silakhor Plan earthquake damage (31 March 2006)

H. R. Vosoughifar

*Civil Engineering Department, Faculty of Technology,
Islamic Azad University, Tehran South Branch, Tehran, Iran*

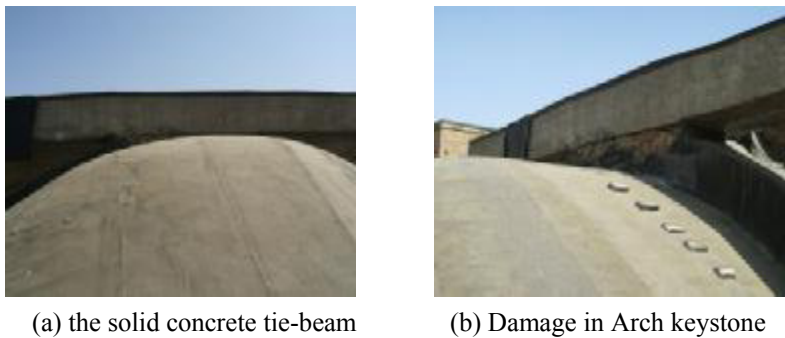
Figure 2: The solid concrete tie-beam over the main arch in the south *eivan*.

The concrete tie-beam on the south *eivan* of Imam Mosque has aggravated the impact of the earthquake on the structure as during the construction the keystone of the original arch has also been weakened. This tie-beam should be replaced by a more resilient system of reinforcement.

- Tie beam on dynamic behaviour of south *eivan* of Imam Mosque prevents flexible behaviour and this has caused more damage in south *eivan* than north *eivan*. Therefore mistakes in the retrofitting process will cause increased damage at earthquake time.

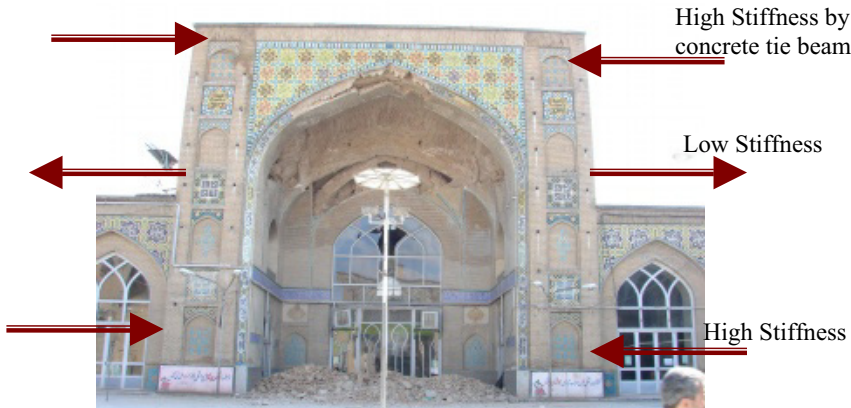
Figure 3 shows the effect of the concrete tie beam on dynamic behaviour of south *eivan* of Imam Mosque. This beam prevents flexible behaviour and this has caused more damage in the south *eivan* than the north *eivan*.

Figure 3: Effect of concrete tie beam on dynamic behaviour.

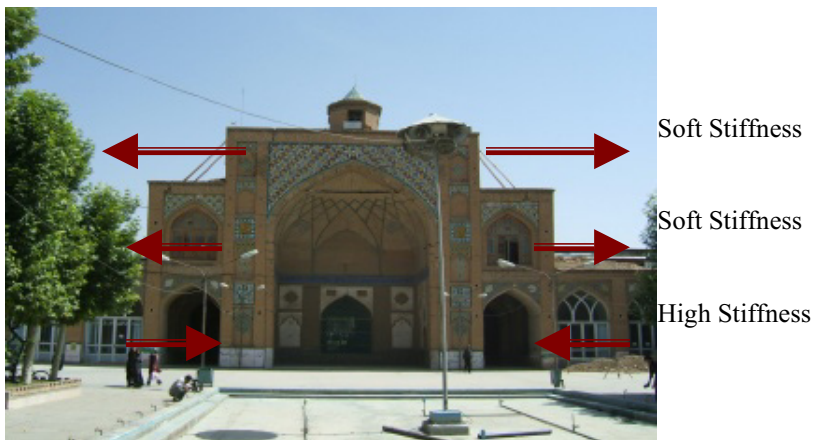
Figure 4: The north *eivan* after the earthquake.

Figure 4 shows north *eivan* behaviour against earthquake. This *eivan* had soft, flexible and suitable dynamic behaviour.

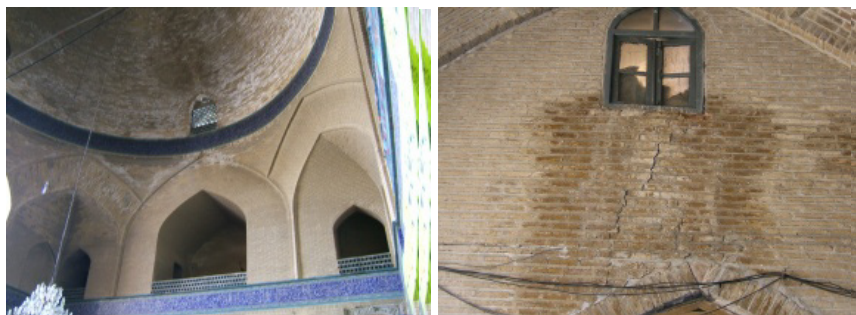
The earthquake has damaged the intermediary structures between the vaults and the finished floor opening the way for penetration of water. Internal decorations in particular the *mihrab* inscribed in the Imam Mosque are more exposed to water damage. Figure 5 shows water seepage in this monument.

Figure 5: Water damage after earthquake.

Given the type of mortar used in the monuments penetration of water can cause several kinds of damage: changing colour; damage to ornament; and increasing structural weaknesses at earthquake time. In Imam Mosque the damp-proof measures to protect the building against the humidity are ineffective and have further aggravated the situation. There is a need to replace the bituminous mats by an appropriate method in line with the traditional water insulation techniques. There is a need to provide temporary light-weight roofing (corrugated sheets) for emergency protection of the roofs against the coming autumn precipitation. This might be used as a general approach for all parts of

roof, if time constrains encourages it. Contractors of Imam Mosque involved in repairing the roofing, need to be warned not to dump debris on the roofs. This may cause new visible or invisible damage.
